**UNITED STATES
DEPARTMENT OF LABOR
MINE SAFETY AND HEALTH ADMINISTRATION**

**REPORT OF INVESTIGATION
Surface Coal Mine
Fatal Powered Haulage Accident
November 28, 2006**

**Spring Creek Coal Company Mine
Spring Creek Coal Company
Decker, Big Horn County, Montana
ID No. 24-01457**

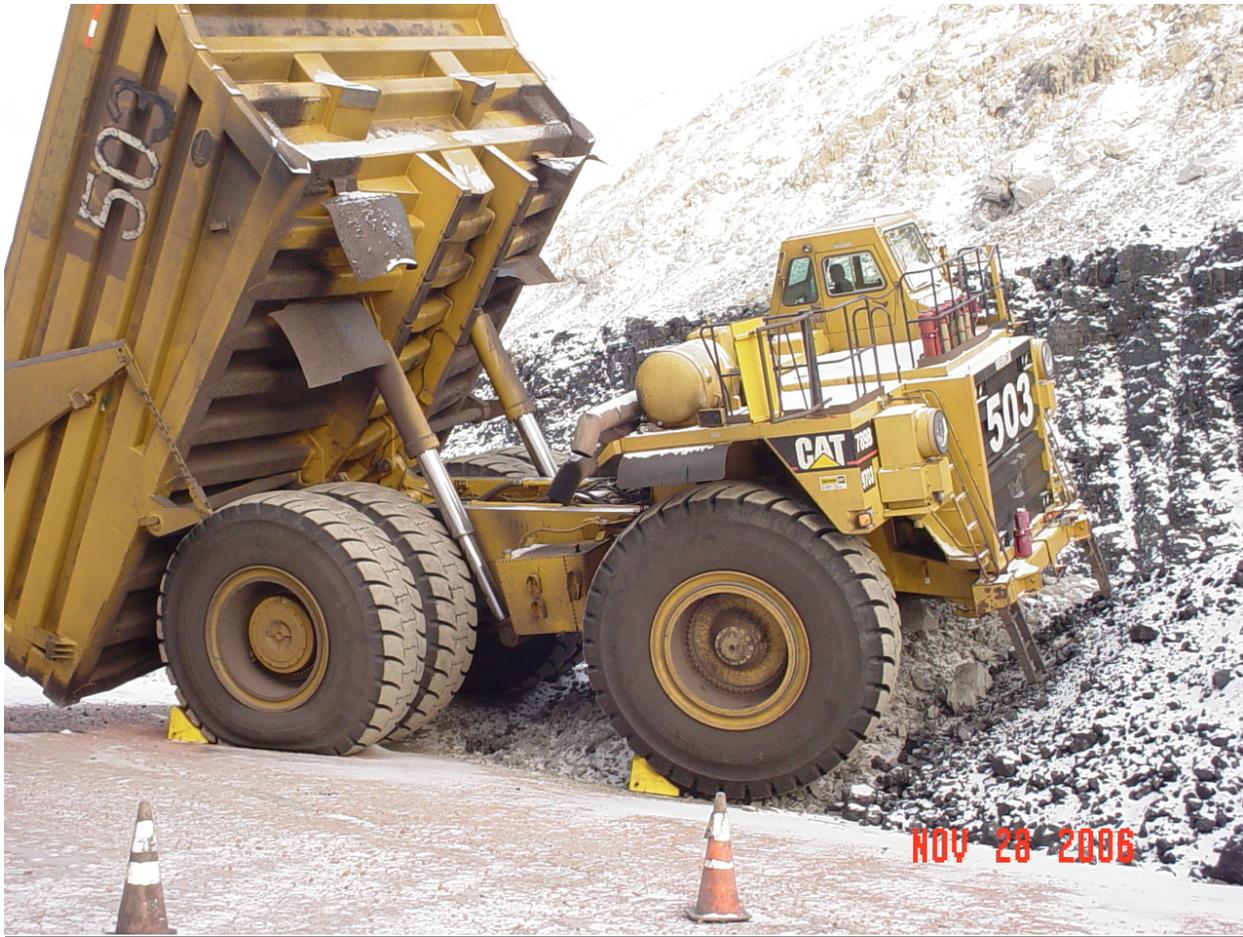
PHOTO OF ACCIDENT SCENE
Caterpillar 789B Haul Truck
Pit 3 West

VICTIM LOCATED UNDER LEFT REAR DUAL TIRES

The accident occurred when the frozen parking brakes released unexpectedly allowing the truck to roll forward downgrade into the berm. Corriveau was either thrown from the truck and was struck and crushed by the left rear dual tires or he was on the ground and struck and crushed by the tires. The accident occurred due to an ineffective program to ensure that truck operators set the parking brake before exiting the cab of the truck. This allowed Corriveau to exit the truck cab and not return the parking brake toggle switch to the "on" position after the switch had been put in the "off" position to move forward to finish dumping the load. Management did not have effective maintenance procedures to ensure that water was drained from and not allowed to accumulate in the air tank/system and caused the freezing problem that was experienced at the time of the accident when the parking brakes would not release.

had been taken to warm the engine to allow it to start in the severe cold weather. These are factors that tend to correct problems caused by frozen moisture which is a known cause of operational problems in air systems. When the accident occurred, the temperature was near 0°F. It was concluded that the parking brake did not release at the time of the accident because of moisture freezing in the air system. This prevented air pressure from reaching or moving the air actuated spool in the parking and secondary brake valve allowing hydraulic flow to release the parking brake.

2. **Root Cause:** Ineffective maintenance procedures allowed water to accumulate in the air tank/system causing the accident.

Corrective Action: The mine operator should revise and enforce equipment maintenance procedures to require air tanks to be drained according to manufacturer's recommended time frequencies.

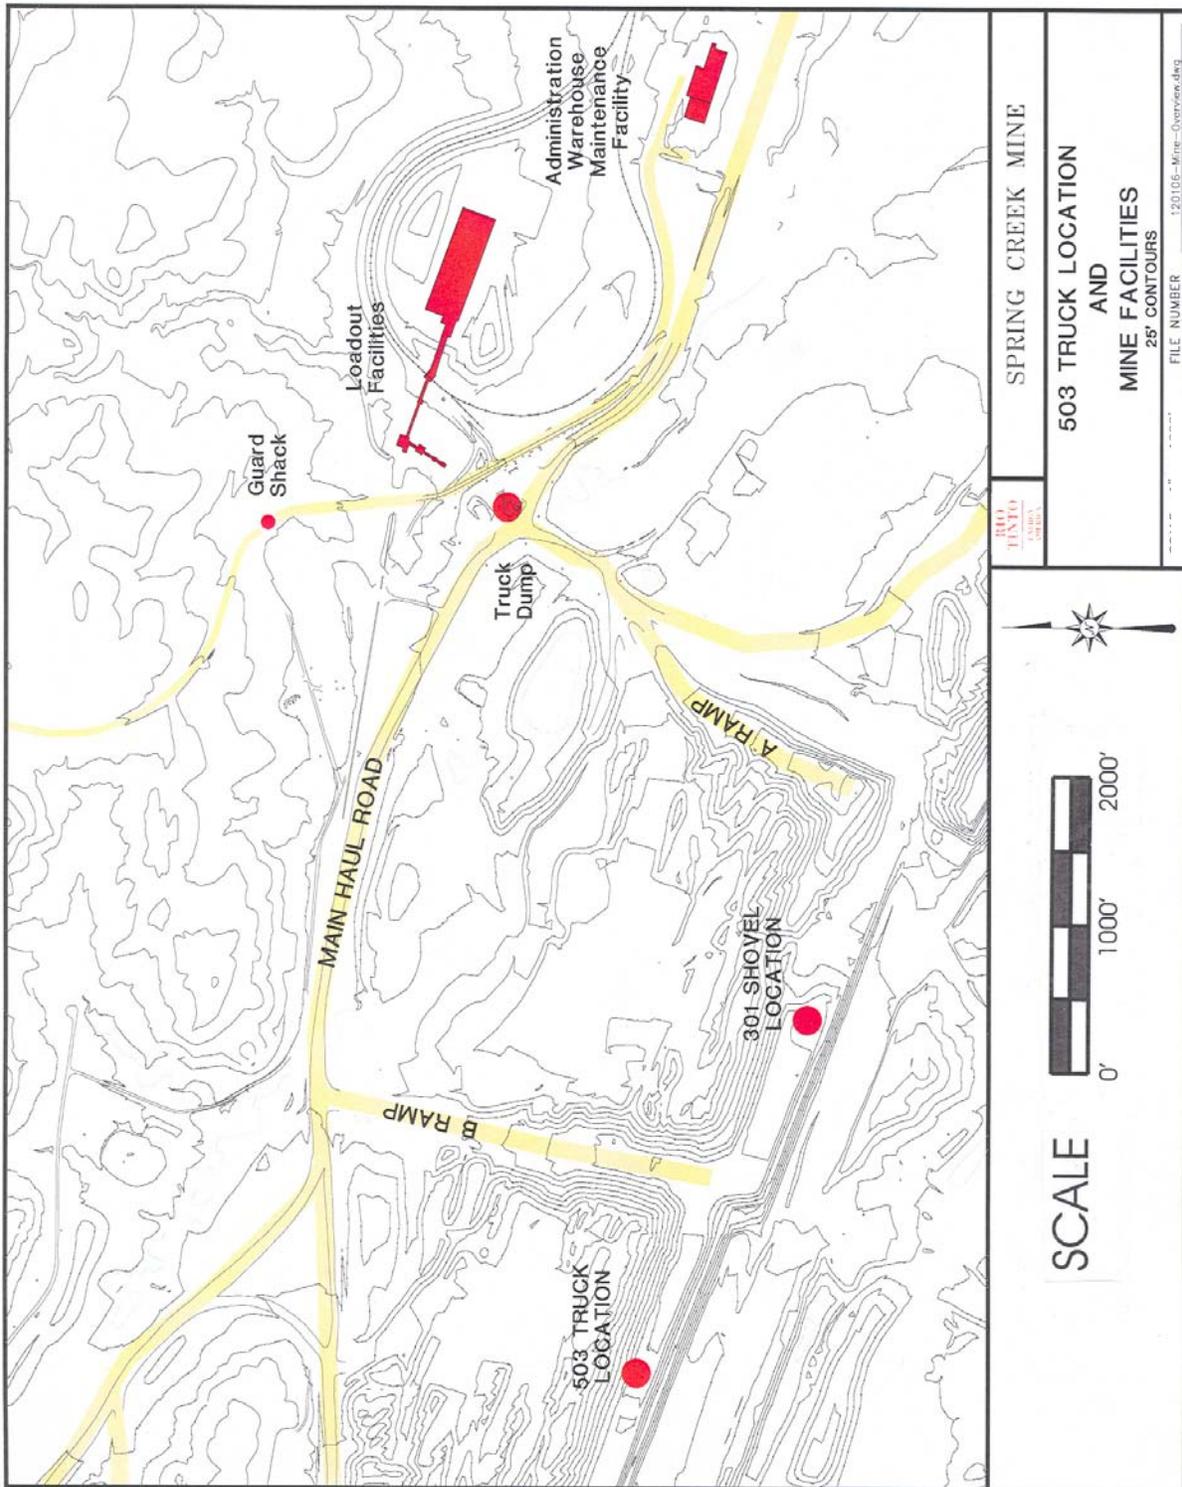
MAP SHOWING LOCATION OF NO. 503 TRUCK AND NO. 301 SHOVEL IN PIT 3

The accident occurred in Pit 3 West at an area where waste coal was being dumped. Coal hauling operations were occurring in Pit 3 East at shovel No. 301 approximately 2800 feet from the accident site. See Appendix B for a map showing these locations in relation to other mine facilities.

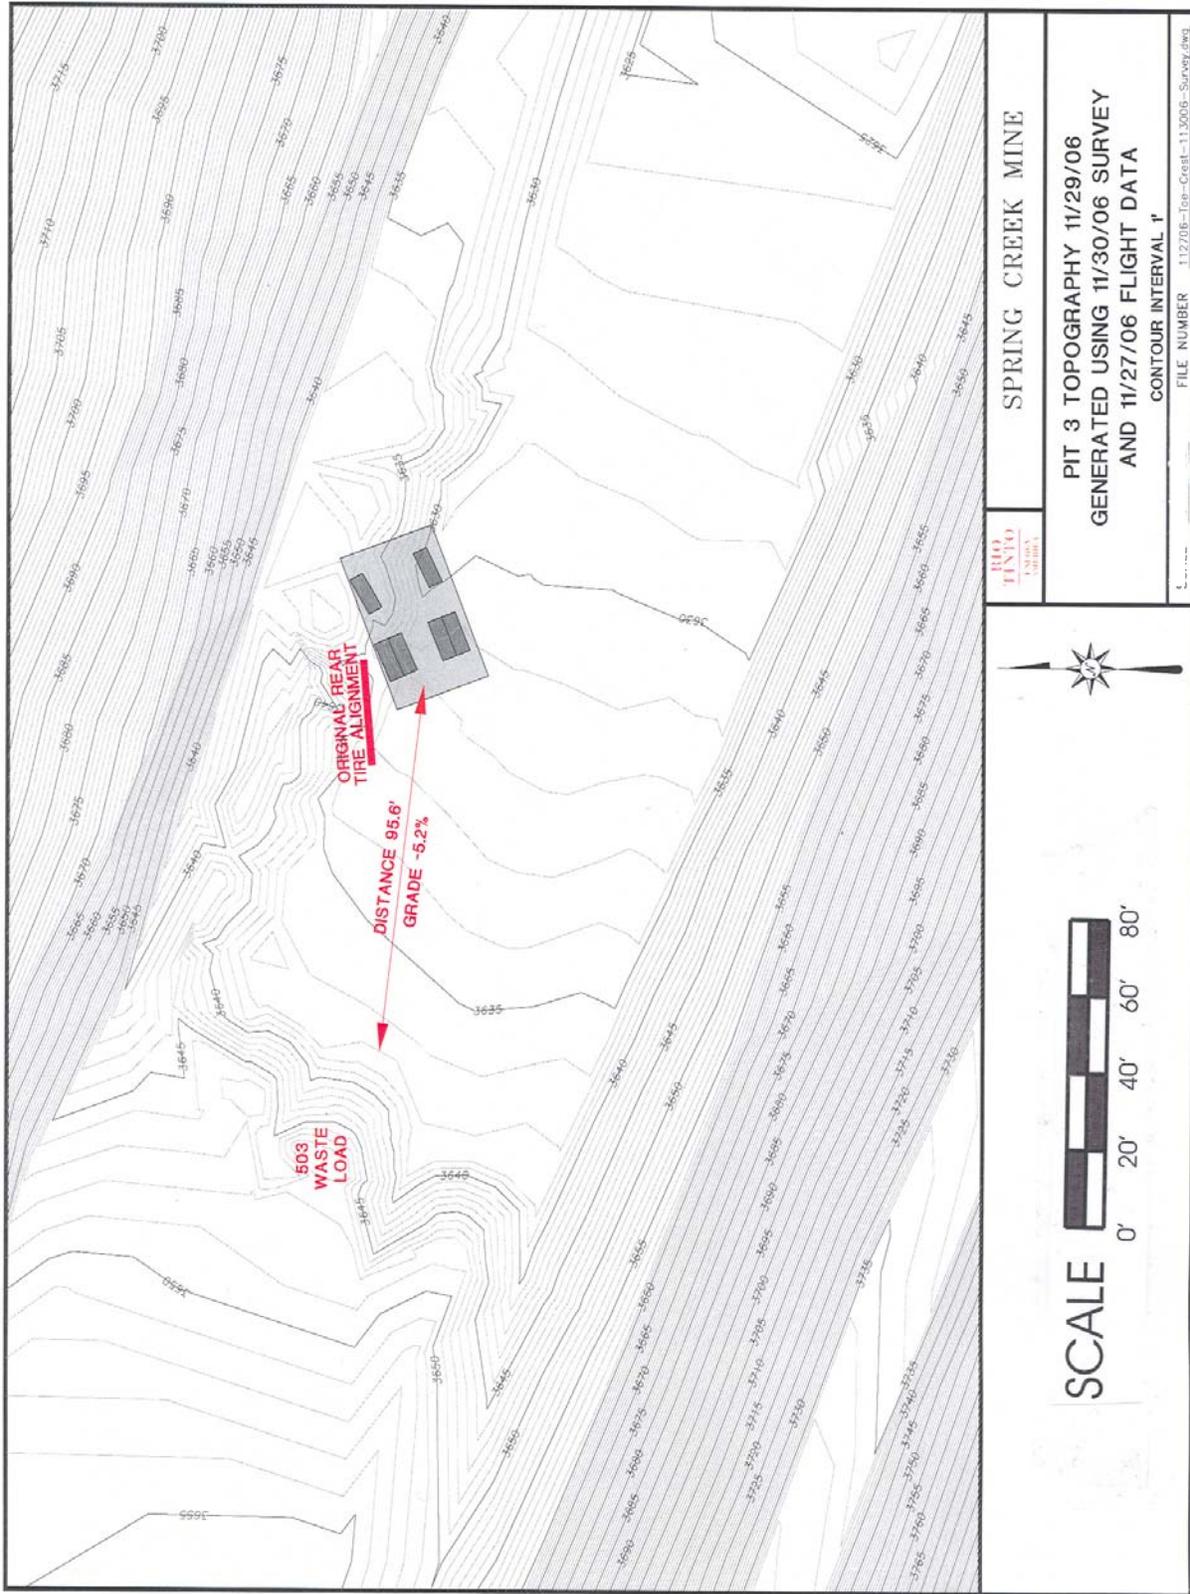
MAP OF ACCIDENT SITE IN PIT 3 WEST

Appendix C shows a map of the accident site. Truck No. 503 traveled 95.6 feet down a 5.2% grade from the point where Corriveau dumped the waste load. When it came to rest, the front of the truck was tilted 20.9 degrees down from the left to right side. The pit ramp was relatively smooth compacted scoria, free of debris and irregularities. The front of the truck came to rest on waste material that was piled on the side of the ramp against the adjacent spoil bank. The ramp was between 80 to 90 feet wide.
