Coal Mine Fatal Accident 2007-08

Operator:	Twin Pines Coal Company Inc.
Mine:	Mine #2, #3, #4
Accident Date:	July 2, 2007
Classification:	Powered Haulage
Location:	Dist. 11, Cullman County, Alabama
Mine Type:	Surface Coal Mine
Employment:	66
Production:	50,000 clean tons/month

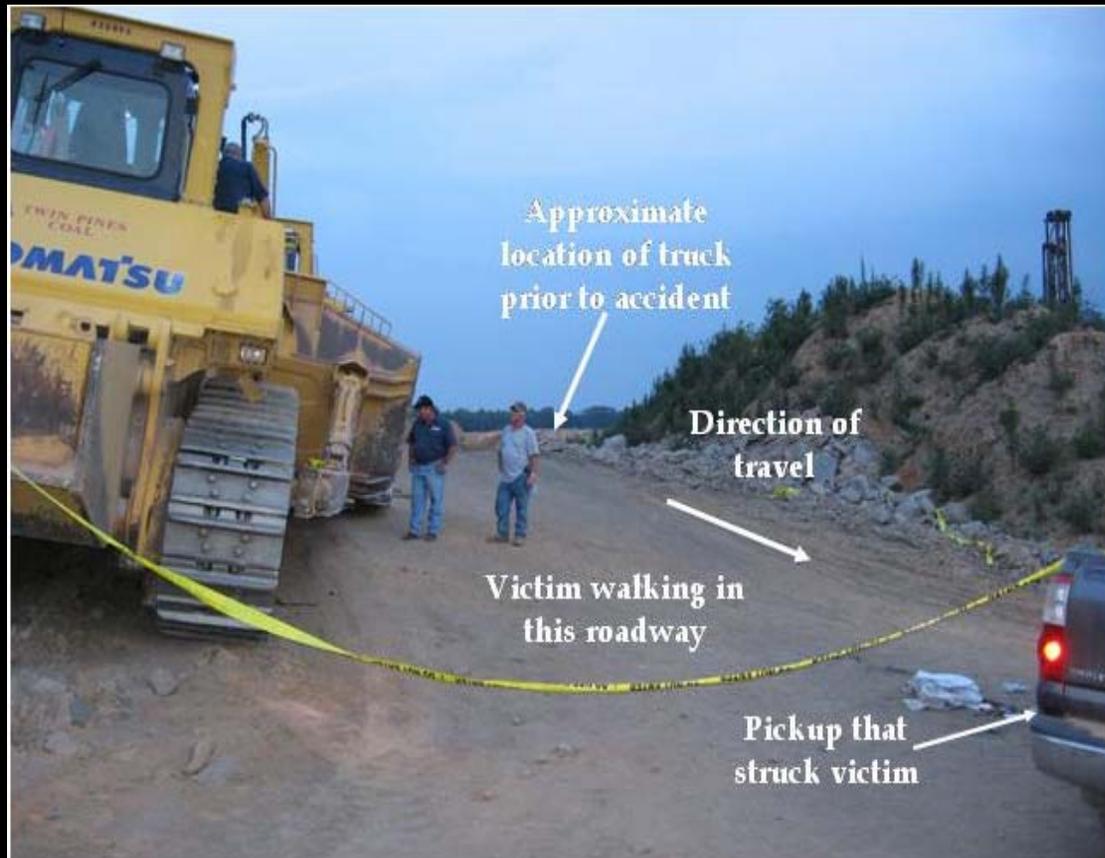
On July 2, 2007, a 59 year old bulldozer operator with over 35 years experience was fatally injured when struck by a pickup truck operating in reverse (being backed-up). The victim and two other bulldozer operators were at their personal vehicles, which were parked in front of, and to the right of, their bulldozers.

The bulldozers were parked in a line along the drill ground access road (see picture). The pit foreman drove up to the three operators and instructed them to move their bulldozers to an area across the entrance road in preparation for a highwall shot. The victim was walking back to his bulldozer when the foreman, who was using only the side view mirrors of the pickup truck, backed over him. The accident occurred because all available means (looking over the driver's shoulder and using the inside rearview mirror) were not used to assure that it was safe to operate the truck in a reverse direction.

Root Cause: The driver of the pickup truck did not make certain that persons were clear before proceeding in a reverse direction on the drill ground road. An effective policy or procedure was not in place to assure that persons were clear before placing vehicles in motion.

Corrective Action: The mine operator shall train all persons operating pickup trucks on mine property to make certain that prior to moving their vehicle they will assure, by all means necessary, and by using all available safety equipment installed within their vehicles, i.e. mirrors and horns, that persons are clear of the intended path of the operating vehicle.
