**UNITED STATES  
DEPARTMENT OF LABOR  
MINE SAFETY AND HEALTH ADMINISTRATION  
COAL MINE SAFETY AND HEALTH**

**REPORT OF INVESTIGATION  
Underground Coal Mine  
Fatal Handling Material Accident  
January 6, 2007**

**Elk Creek Mine  
Oxbow Mining, LLC  
Somerset, Gunnison County, Colorado  
ID No. 05-04674**

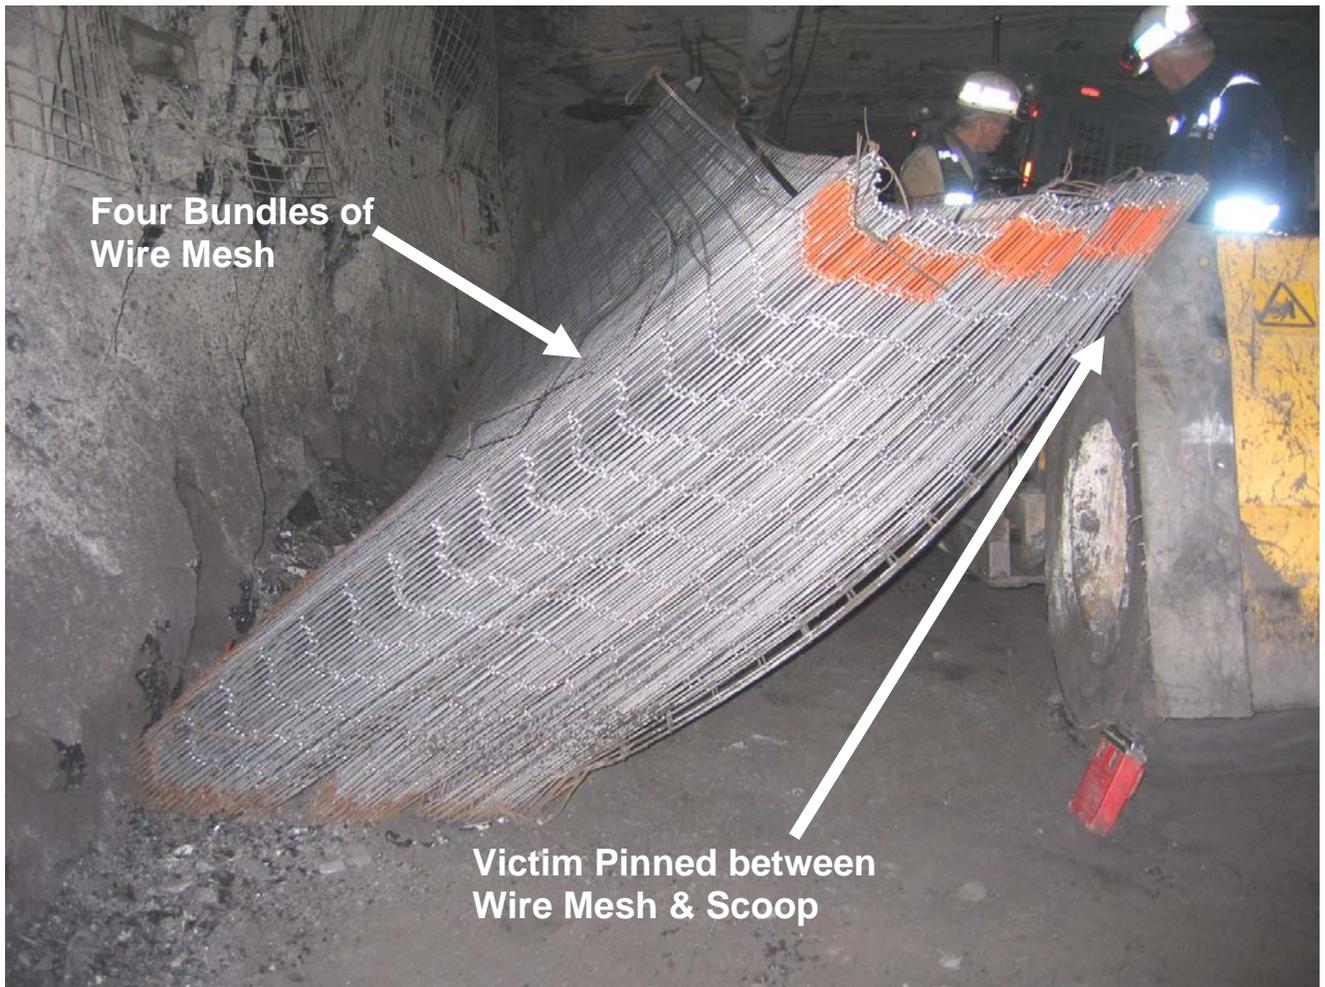
**PHOTO OF ACCIDENT SCENE**  
**11 WEST HG SECTION, NO. 2 ENTRY, CROSSCUTS 33-34**

The mine floor where the wire mesh bundles were placed sloped down and away from the rib at a 9.5% grade. The entry was approximately 11 to 12 feet high. The scoop was parked facing inby in the entry with the bucket and front wheels parallel to and approximately 4 to 5 feet away from the bundles. Garcia positioned himself between the bundles and the left front wheel of the scoop to cut the top metal strap holding the bundles together at that location. Garcia was found pinned against the wheel fender facing the bundles with his back against the fender. The top of the fender was 44 inches above the ground.

Wire mesh panels were bolted to the coal rib at the accident site. The group of bundles had been secured to the rib wire mesh with one hanger webbing strap at the inby end and a piece of 9 gauge wire at the outby end (Garcia's end) of the bundles. The strap was found loose with one end hanging from the rib wire mesh. One of the hooks on the strap was spread wider than the original opening as compared with a strap from the warehouse. The 9 gauge wire was found detached from the rib wire mesh and was hanging from the wires on top of the bundles. The rib wire mesh was deformed but not broken at the location where the wire had been attached, approximately 68 inches above the mine floor. See Appendix D for a picture of the outby end of the bundles showing the wire that was used to secure the bundles to the rib and the steel strap that was cut by Garcia.

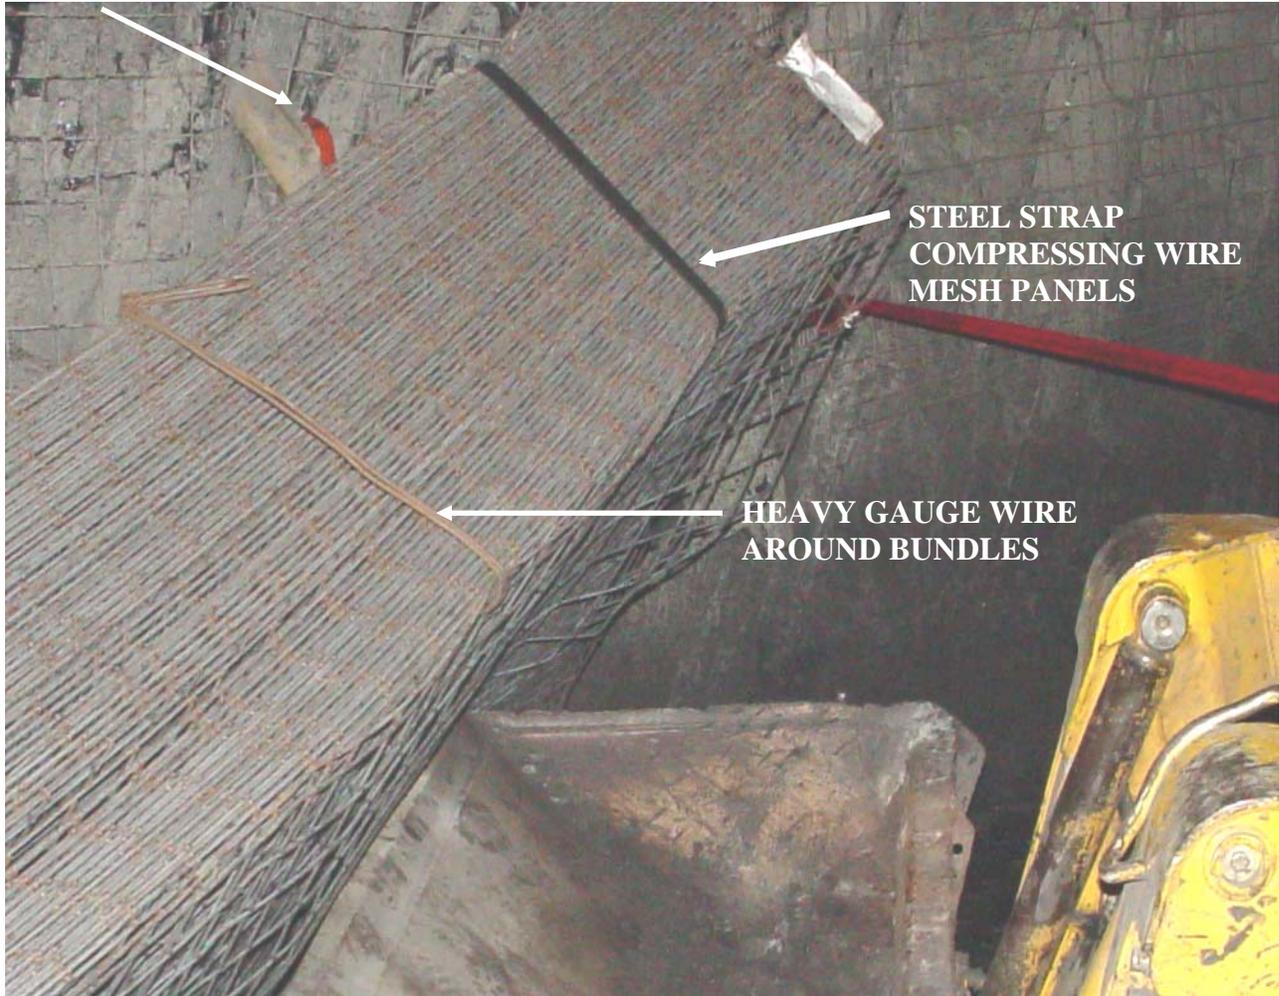
### PICTURE OF STEEL STRAP ON INBY END OF BUNDLES

The panels were manufactured by Raynel Company, Inc., Santa Ana, California, and were shipped in bundles of 25 each with four bundles connected together in a group. Each bundle weighed approximately 1,500 pounds, with the four bundles weighing approximately 6,000 pounds. Each bundle was tied together with 9 gauge wire and the four bundles were secured by four Signod steel straps. The straps, 1.25-inches wide and 0.029-inches thick, were coursed through the bundles at four locations, two on each long side near the ends. The straps were secured by the manufacturer using an air-pressure device at 90 psi creating 1,400 pounds of pressure at the secure point. This banding of the bundles compressed the group of wire mesh panels, creating stored energy within the bundles that was released when the straps were cut. In addition to the steel straps, four heavy gauge wires were used to hold the bundles together. See Appendix C for a picture of one of the straps and heavy gauge wires in place on the four bundles.

**WEBBING STRAP USED TO SECURE BUNDLES TO RIB**

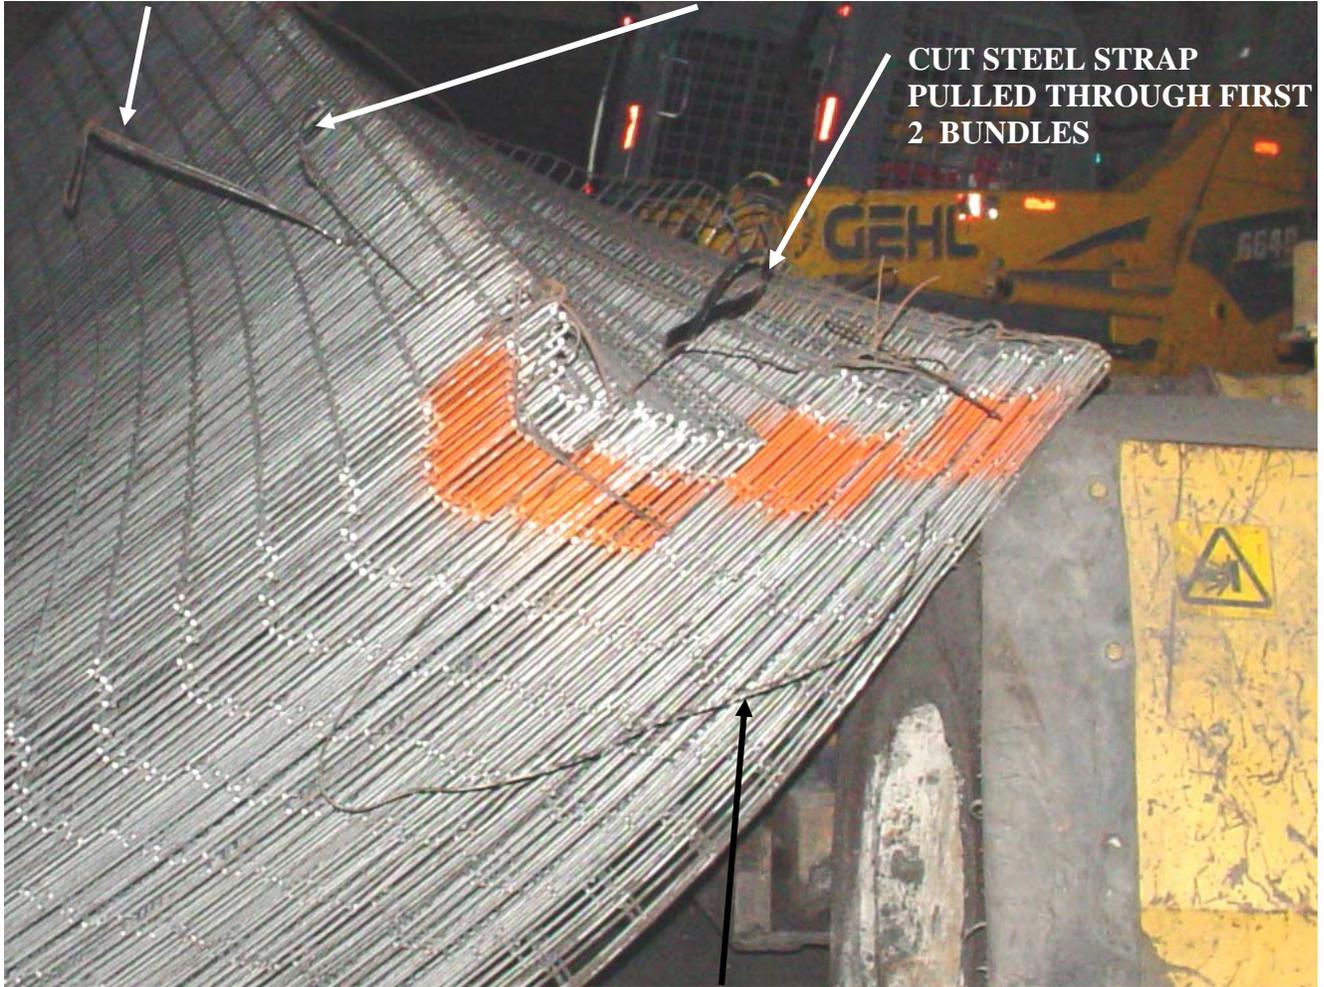
**PICTURE OF OUTBY END OF BUNDLES SHOWING CUT STEEL STRAP AND WIRE USED TO SECURE BUNDLES TO RIB**

**LOOSE END OF HEAVY GAUGE WIRE**

**CUT END OF STEEL STRAP**

**CUT STEEL STRAP  
PULLED THROUGH FIRST  
2 BUNDLES**

**WIRE USED TO SECURE BUNDLES TO RIB**

*Corrective Action:* The mine operator adopted written procedures/instructions for handling wire mesh panels which included using chains to secure upright bundles to the rib, securing the bundles with a piece of mining equipment when cutting the steel straps, and not working between the equipment and the upright bundles when cutting the straps. A Safeguard was also issued related to this corrective action.

1. If the bunk of screens is unloaded whole and placed in an upright position against the coal rib, the screens shall be leaned against the rib at a stable angle and shall be secured from falling by chaining the bunk to the rib or rib support in a manner to adequately support the load. The chains or other devices used for this purpose shall be rated to hold the load. The rib attachments shall be adequate to hold the load.
2. When the bunk is broken into smaller bundles, the screens shall be held in position with a piece of mobile mining equipment while the bands are being cut. Bottom bands shall be cut first.
3. The person cutting the metal bands shall not be located between the screens and the equipment.
4. Prior to moving the mobile mining equipment away from the bunk, the remaining screens shall be secured as per Item 1.
