REPORT OF INVESTIGATION

Surface Coal Mine

Fatal Powered Haulage Accident
July 2, 2007

Mine #2, #3, #4
Twin Pines Coal Company, Inc.
Bremen, Cullman County, Alabama
I.D. No. 01-03117

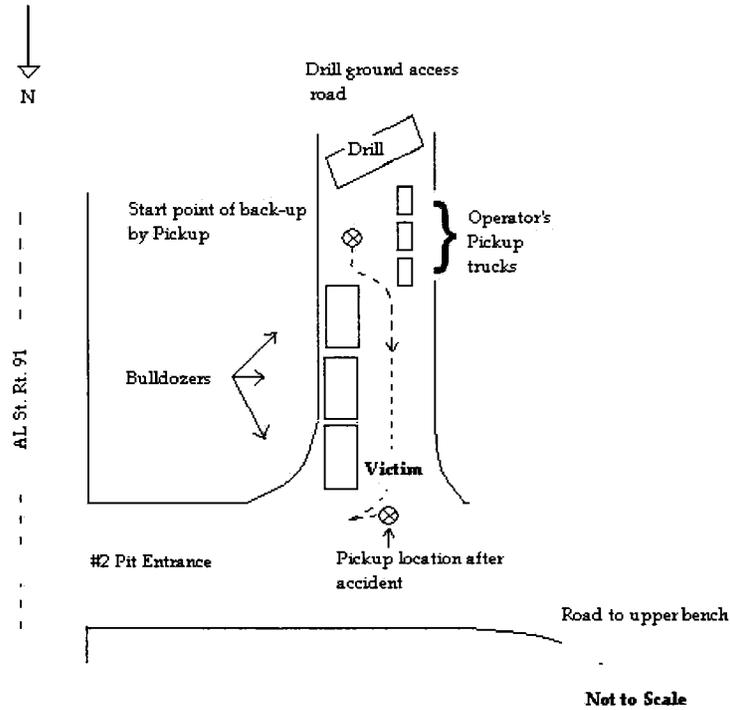
OVERVIEW

On the day of the accident, Linton and two other bulldozer operators had driven their bulldozers to the drill ground access road, which runs south of the main entrance road of the mine (see Overview Sketch). The bulldozers were parked on the left side of the road with Linton's bulldozer parked first in line, as depicted in the overview sketch. The three operators were standing at their personal vehicles, which were parked on the right side of the drill ground access road in front of the bulldozers. The pit foreman drove up and instructed the men to move their bulldozers to the upper bench, to the right of the main entrance road. The bulldozers needed to be moved to allow the rock drill to be moved away from an intended blast area. The rock drill had been out of service for approximately two shifts, was now repaired, and was idling in the roadway, approximately 100 feet from their location.

The area of the accident site was an access road leading to drill ground on the south end of the #2 pit. The road ran in a southerly direction turning left from the mine entrance road at a point approximately 180 feet from Alabama State Route 91. The road continued from this point approximately 140 feet up a slight grade, then remained relatively level from this point to the drill ground area. The road was constructed of shot rock, well compacted, approximately 25 feet in width, with no irregularities. There was no dust observed on this road surface that would become airborne and obscure visibility. Weather conditions on the day of the accident were sunny and hot, in the 90 degree range, and dry, with little to no wind. There was however, an idling rock drill

The foreman did not begin to back out of the area for several seconds after telling the bulldozer operators to move. When he began backing, he used only his side view mirrors, due to the reduced width (approximately 15 feet) of the road resulting from the location of the parked bulldozers. His main concern was hitting either a bulldozer blade, or the berm opposite the bulldozers. By using only the side view mirrors, there existed a blind spot behind and in the center of the trucks rear sight line for a distance of 16 to 20 feet (see Appendix C). The bulldozer operators began walking from the site, one toward his personal vehicle, the victim and the other toward their respective bulldozers. It was determined that when the one operator stopped the foreman to give him time slips, the victim kept walking toward his bulldozer. This delayed the foreman approximately 3 to 4 seconds, allowing the victim, who was walking in the middle of the roadway, just enough time to get into the blind spot of the foreman's side view mirrors. When he resumed backing, he could not see the victim in his mirrors. He struck and ran over the victim, inflicting fatal injuries.

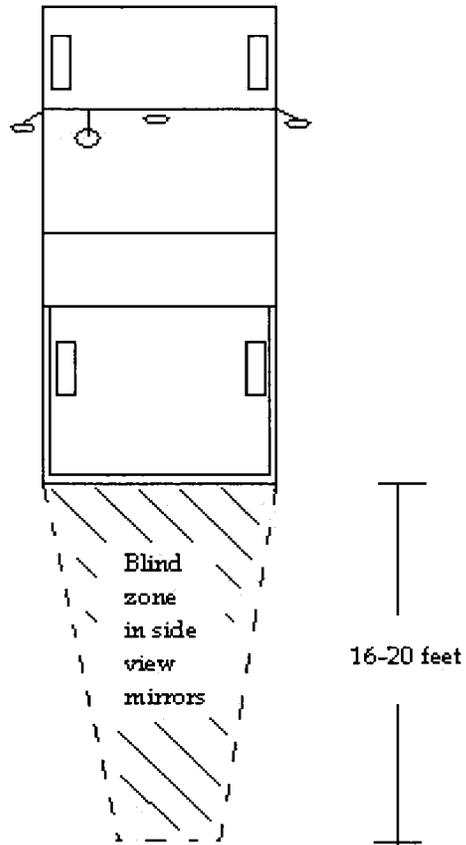
Operator Visibility Behind Pickup Truck

Root Cause: The driver of the pickup truck did not make certain that persons were clear before proceeding in a reverse direction on the drill ground road. An effective policy or procedure was not in place to assure that persons were clear before placing vehicles in motion.

On July 2, 2007 at approximately 3:15 pm, a foreman operating a 2005 Toyota Tundra pickup truck, failed to be certain by signal or other means, that all persons were clear before moving. This failure resulted in the foreman striking a bulldozer operator who was walking toward his bulldozer on the drill ground access road, fatally injuring him. The foreman stated to MSHA accident investigators that while he was backing his truck down the drill ground road he never looked in the center rear view mirror of the pickup. This condition resulted in the bulldozer operator being in the truck operator's blind spot.

Corrective Action: The mine operator shall train all persons operating pickup trucks on mine property to make certain that prior to moving their vehicle they will assure, by all means necessary, and by using all available safety equipment installed within their vehicles, i.e. mirrors and horns, that persons are clear of the intended path of the operating vehicle.
