REPORT OF INVESTIGATION

Fatal Surface Blasting Accident
July 16, 2007

CAM Mining, LLC
Three Mile Mine #1
Ashcamp, Pike County, Kentucky
I.D. No. 15-17659

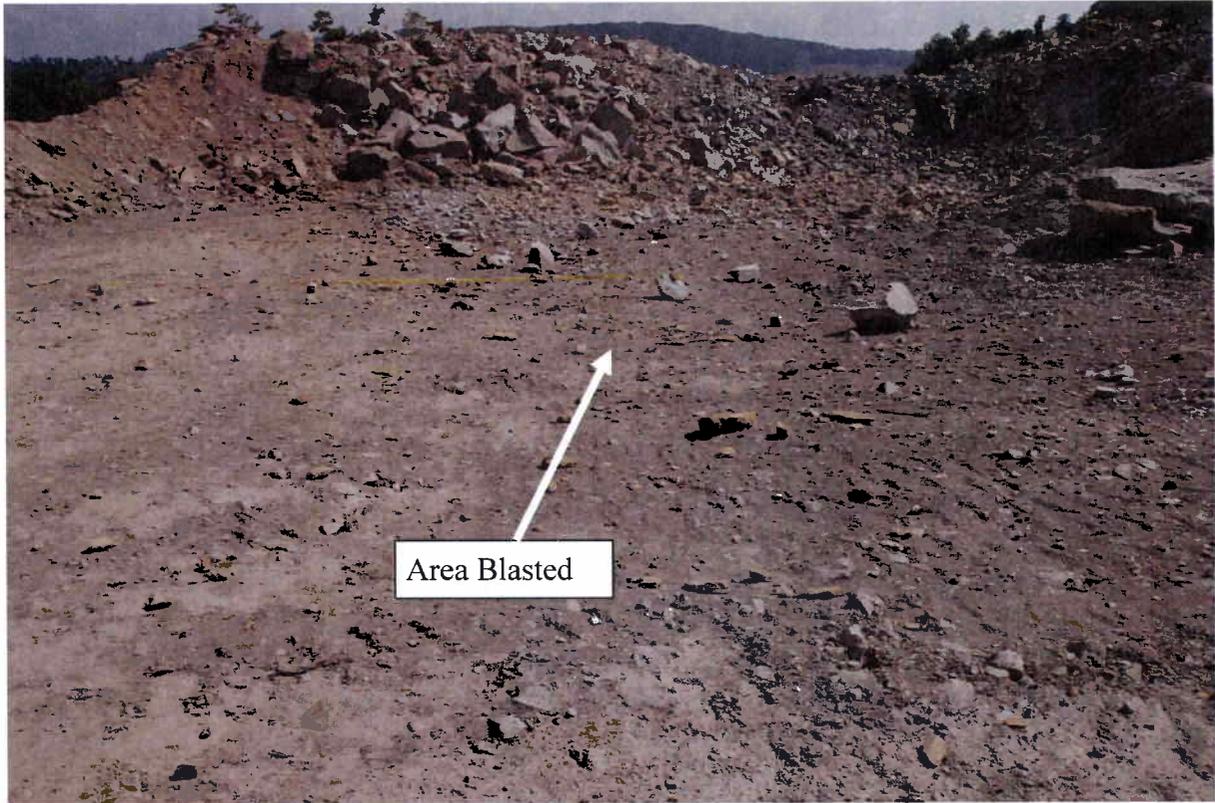
Photograph No. 1 - Blast Area

The blast was initiated at the north end of the mine. Fly rock traveled approximately 1,586 feet south east to the staging area. The weather at that time was dry, clear and sunny, 95° Fahrenheit, with a wind velocity of 0 to 3 mph from the north.

Insufficient burden type fly rock usually has a lower trajectory angle than does the cratering type of fly rock. The fly rock involved in the accident was a high angle blow-out type of fly rock resulting from a condition known as back break which is fracturing of the area adjacent to the blast site. Back break is typically noticed by the driller during drilling as a loss of air pressure, jumping of the drill stem, and otherwise difficult drill penetration. These conditions should be noted in a drill log - which was not being maintained at this mine. Back break and/or loose burdens can result in fly rock since they do not provide the required confinement typical to consolidated burden.

Root Cause: The mine operator did not maintain safe control of the mining pit. Fly rock from the mining pit traveled more than 1500 feet to a staging area where equipment was being fueled and routine service was being performed. No procedure was in place to demarcate the 'Blast Site' from other production areas during the load-out crews overburden removal procedures. This increased the probability that the highwall would be 'Over Dug,' reducing the burden from its original thickness. The type of fly rock that occurred at this site was the result of insufficient burden at the opening of the blast #1 (the first blast holes that were detonated.)

Corrective actions: The mine operator developed and implemented a plan to prevent a similar occurrence of this accident. The plan includes a revision to the ground control plan that requires that the drillers log the blast holes as they are drilled and provide this log to the blaster who will include this log with the blast report. The revision also requires that adequate burden along the edge and free face of the blast site equal to or greater than 25 times the hole diameter (measured in inches) divided by twelve and that the burden along the edges of the blast site will be measured with a burden pole. The plan also requires training to be provided to the employees on the revised ground control plan and hazards associated with blasting operations.

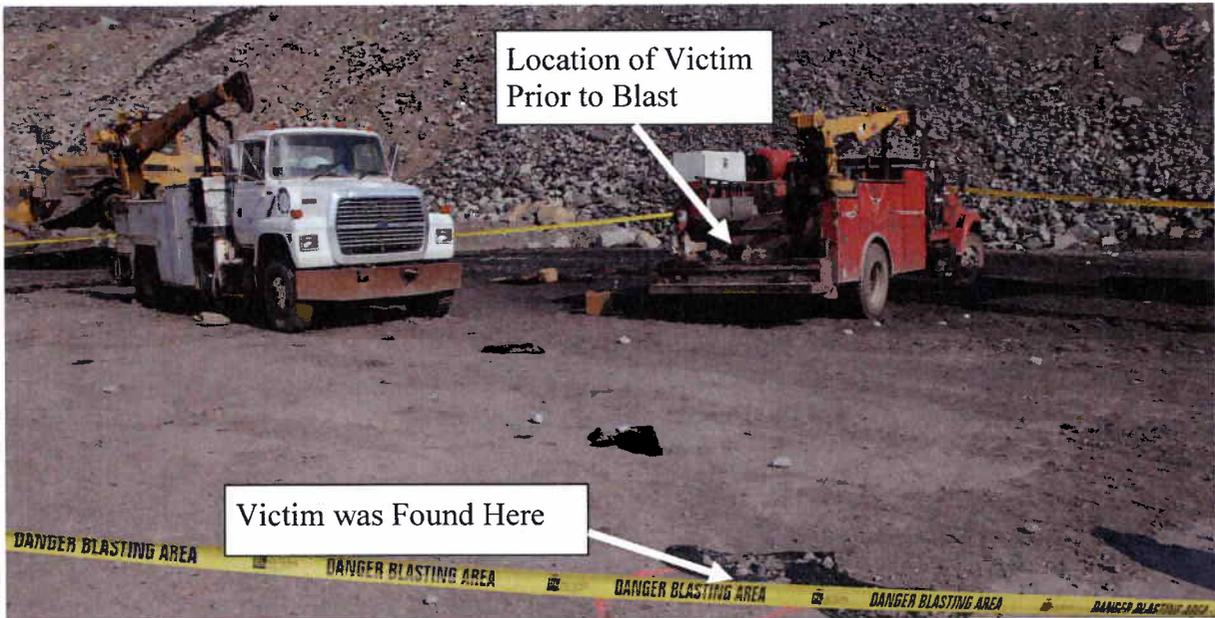
Photograph No. 2 - Victim Location

Other pieces of fly rock, including one approximately 16 inches x 20 inches (as measured from an imprint in ground) hit within a few feet of where the men were standing. The rock appeared to have broken on impact with the ground, with smaller pieces bouncing in a fan like direction. Fly rock also struck the adjacent mechanic's truck resulting in several areas of damage.

Information from an autopsy conducted on July 17, 2007, indicated that the victim was fatally injured by blunt force trauma near the base of the skull. The nature and extent of the injuries indicated the object (fly rock) came from behind, above and to the left of the victim. This is consistent with fly rock from the blast site.

Corrective actions: The mine operator developed and implemented a plan to prevent a similar occurrence of this accident. The plan includes a revision to the ground control plan that stipulates that all persons within 2000 feet of the blast site will be in shelters and that the shelters will be at least 1000 feet from the blast site. The plan also requires training to be provided to the employees on the revised ground control plan and hazards associated with blasting operations.
