REPORT OF INVESTIGATION

Surface Area of an Underground Coal Mine

Fatal Fall of Person Accident
July 30, 2007

Jim Walter Resources, Inc.
No. 3 Mine
Adger, Jefferson County, Alabama
I.D. No. 01-00758

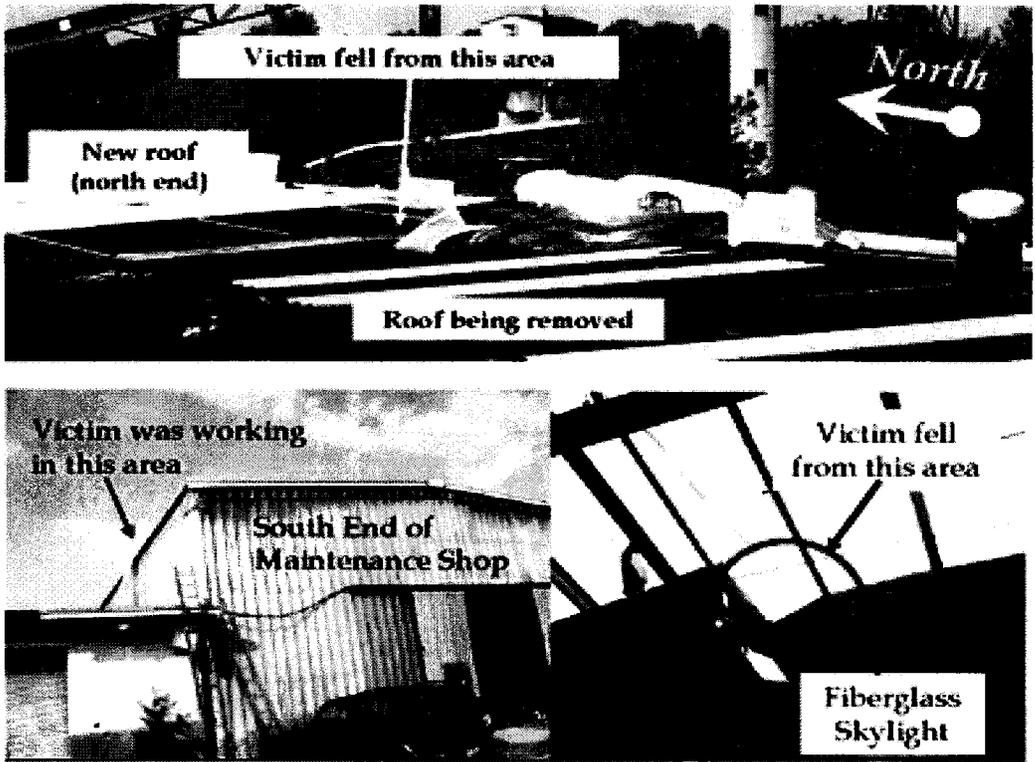
On July 30, 2007, a 27-year old contract laborer with six years experience was fatally injured when he fell through the roof (skylight) of a shop building. Roofing panels were being removed in preparation for a new roof. While a panel was being removed, the victim apparently stepped on a fiberglass skylight panel, and fell approximately 28-feet to the shop floor.

The accident occurred because the victim, although wearing a safety harness, did not have a harness lanyard secured while working in an area where there was a danger of falling. Management officials for the contractor did not comply with the applicable regulation governing the use of fall protection.

The contractor was to re-roof the former maintenance shop, now being used for storage. The old metal roofing panels were to be removed and replaced. The building was constructed of steel, with a low angle roof. The roof panels were supported by steel purlins, that ran over the top and perpendicular to the steel roof trusses. The victim was part of a three man crew removing the old roof panels. Another worker was operating a forklift, delivering supplies and removing the old panels, while another was on the ground assisting with the supplies. Work proceeded in a systematic manner, the victim using an electric drill to remove the roofing screws to free the panel, while the other crew members stacked the old panels on the roof edge to be removed by the forklift operator. The crew took a short (approximately 10-minutes) break at approximately 2:15 p.m., and resumed work. At approximately 2:30 p.m., a co-worker observed the victim in the process of removing a panel. He appeared to have one foot resting on an exposed purlin, the other on a fiberglass skylight. As he bent forward to unscrew the panel, the skylight gave way, causing him to fall approximately 28-feet to the concrete floor below.

Corrective Action: The contractor developed and implemented a fall protection plan that included the placement of anchorage points that were used by all workers when roofing activities were allowed to continue.

Corrective Action: JWR personnel provided training to all contractor personnel on MSHA requirements for fall protection.
