REPORT OF INVESTIGATION

Surface Nonmetal Mine  
(Limestone)

Fatal Handling Material Accident

Twin State Sand & Gravel Co., Inc.  
Twin State Sand & Gravel Company, Inc.  
West Lebanon, Grafton County, New Hampshire  
Mine I.D. No. 27-00070

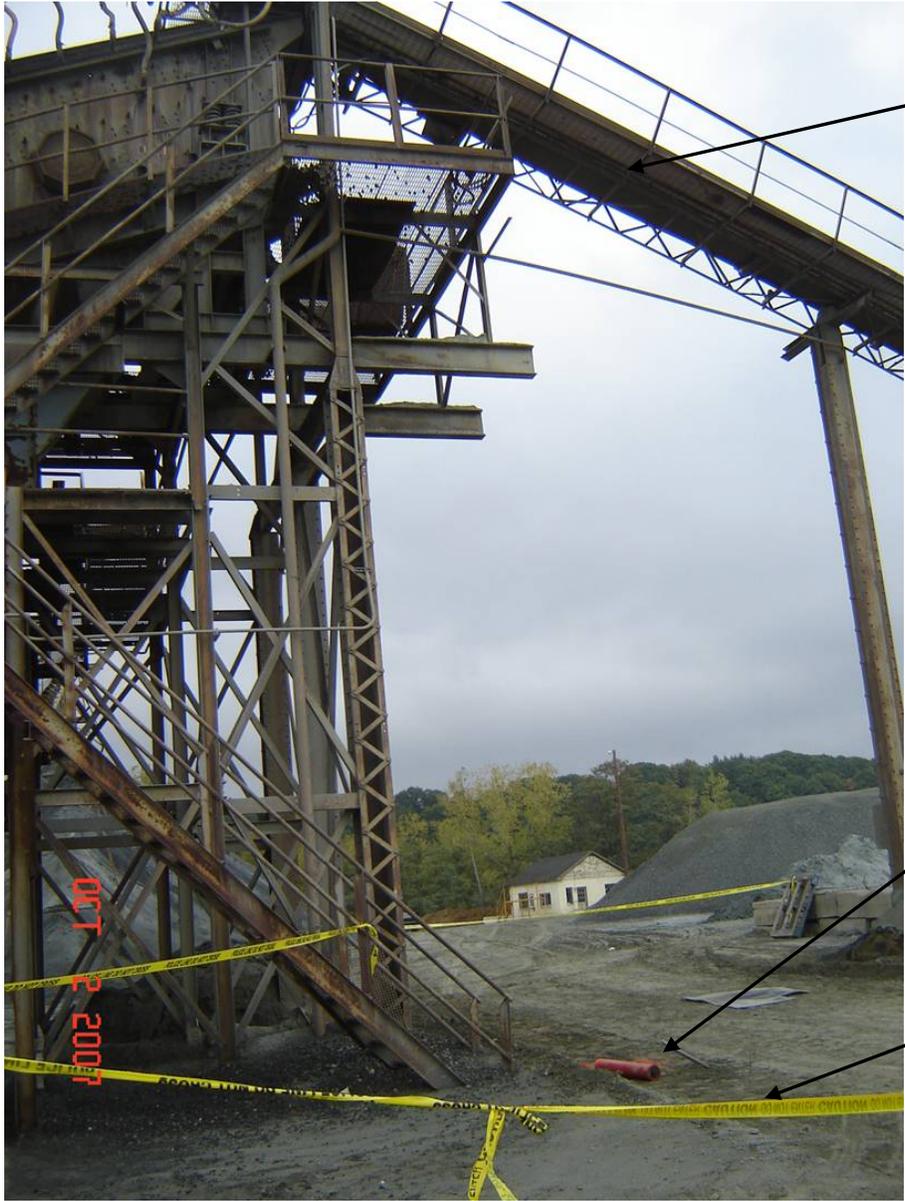
Location of roller being installed

Location of victim

Caution tape installed after accident.

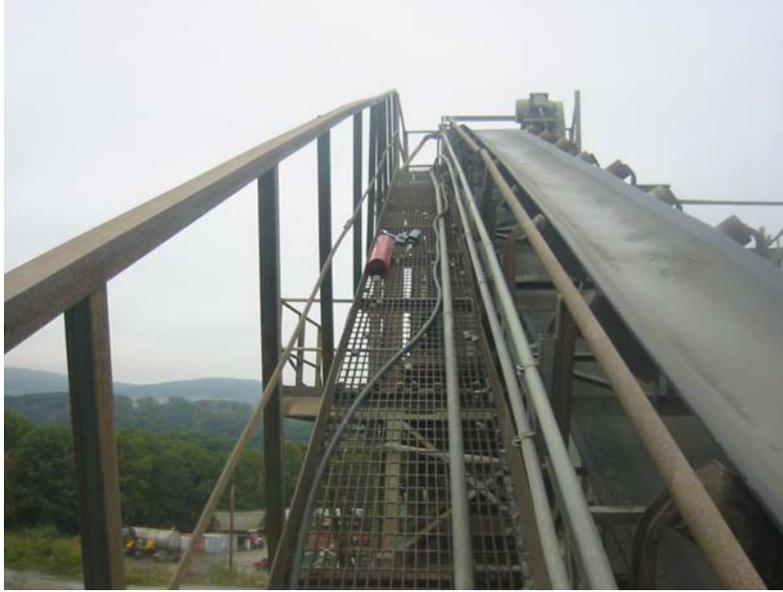
The method being used to install the return roller required a person to lay on the cat-walk parallel to the conveyor belt, guide the roller under the belt, and lift the roller and belt while attempting to insert the roller ends into the slotted brackets. Clearance to complete this installation was limited to approximately 5 inches between the bracket slot and a support angle (Appendix C). The travel way underneath the long belt was not barricaded or posted with warning signs during the repair. The victim was wearing a hardhat.

Photograph 1: Cat-walk and roller installation location

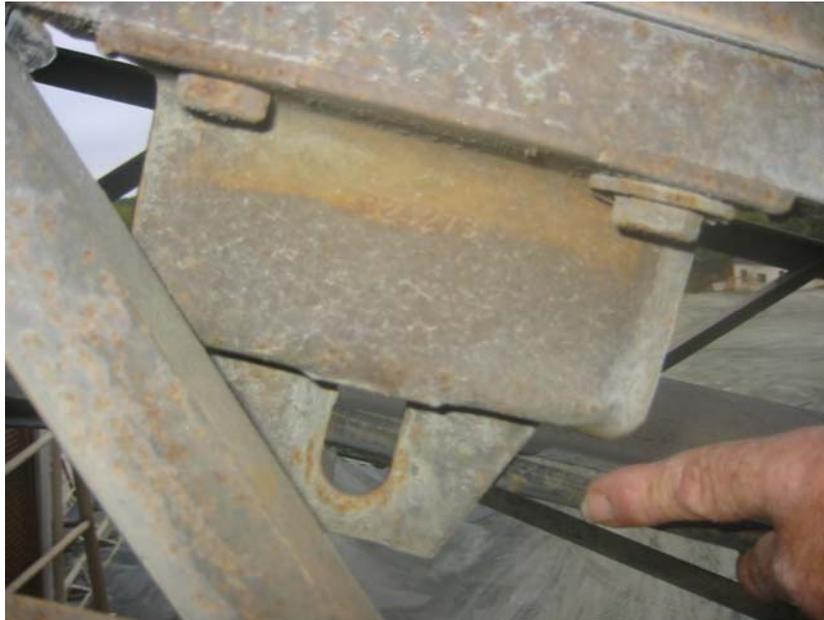
Photograph 2: Return roller bracket adjacent to cat-walk

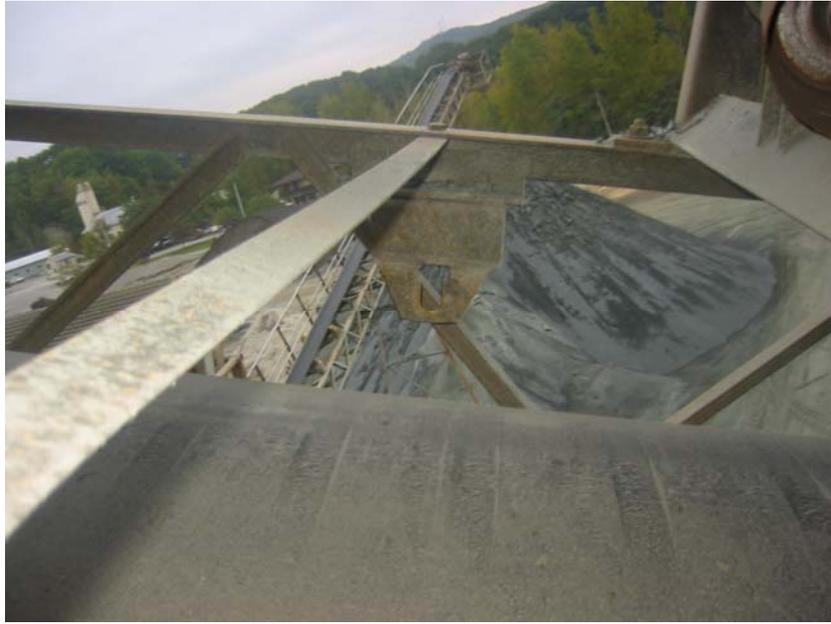
Photograph 3: return roller bracket opposite cat-walk

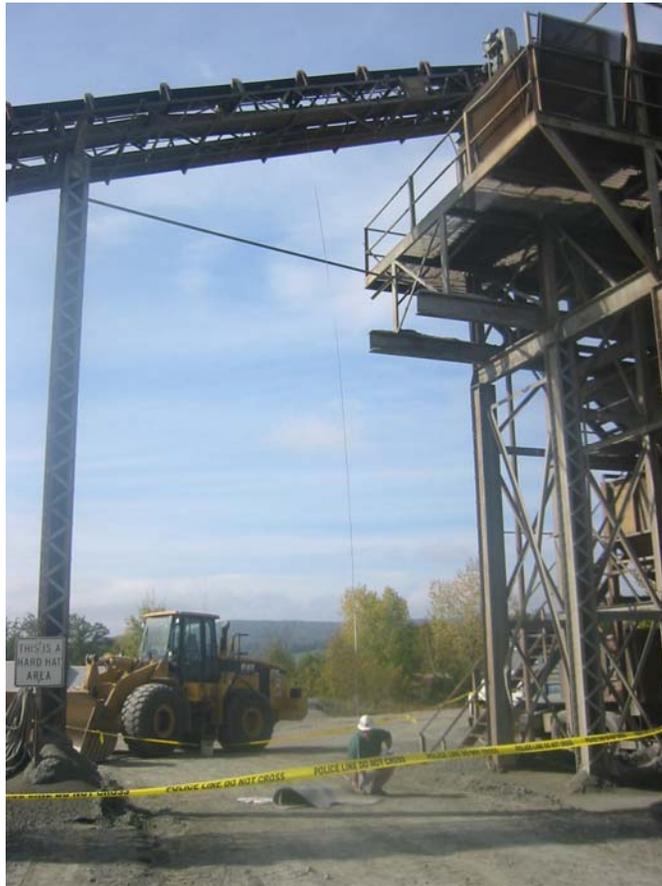
At about 7:40 a.m., Hughes went to the crusher to get a pry bar to remove the snub roller. Martin and Richardson were attempting to install one end of the return roller in a bracket and just as Hughes walked under the conveyor, the return roller slipped out of their hands and fell striking him.

**Root Cause:** Management failed to perform a risk assessment of the maintenance task being performed. All hazards associated with the task of changing rollers were not removed to ensure that persons could safely perform the task. Management failed to barricade or post warning signs in the work area to prevent persons from walking or traveling under the belt conveyor.

Photograph 4: Accident Scene

**Corrective Action:** Maintenance policies and procedures should be established to include conducting a risk assessment before performing work. Hazards should be identified and safe work procedures implemented to protect persons. The procedures should be discussed with all persons assigned to maintenance tasks.
