Fatality #4 - February 18, 2008
Electrical - Facility - Pennsylvania
Consolidation Coal Company - Consolidation Coal Co 14-N Impoundment

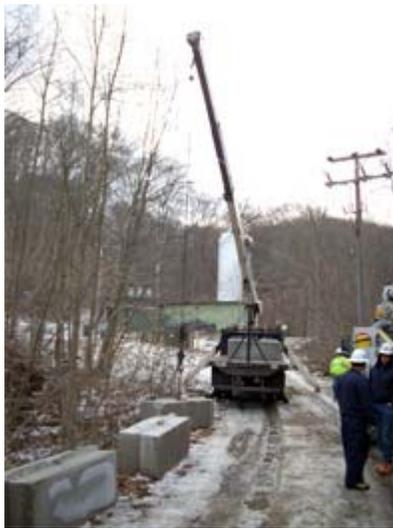
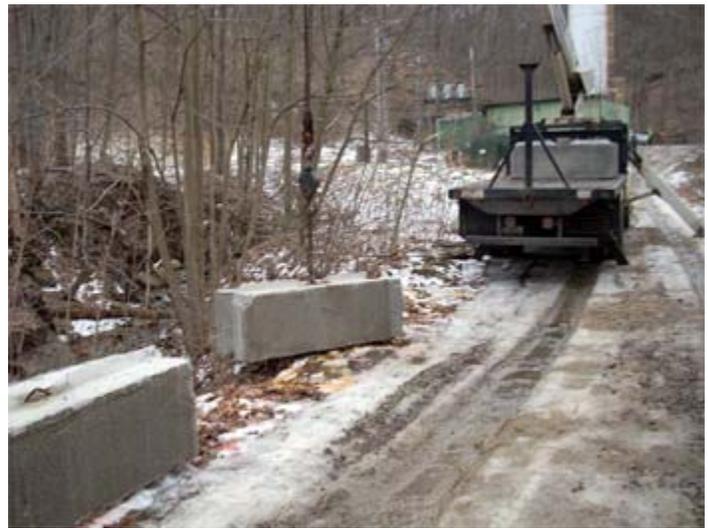
COAL MINE FATALITY - On Monday, February 18, 2008, a 51-year old outside service technician (contractor) with one year of experience was fatally injured while placing concrete barriers along a mine access road. A rubber-tired boom truck was being used to move the concrete barriers into place. The victim was electrocuted while standing on the ground, touching a suspended concrete barrier, when the boom came in contact with an energized 14,500 volt overhead power wire. The operator of the boom truck was treated and released.

- Ensure that booms or masts of equipment are not operated within 10 feet of any energized overhead powerline.
- Identify hazards associated with tasks prior to work assignments.
- Ensure that one person on the ground is designated to give signals to the crane operator and watch placement and proximity of the mast.
- Use non-conducting tag lines to steady loads when operating cranes where overhead power lines are present.
