REPORT OF INVESTIGATION

Fatal Fall of Material Accident
October 29, 2008

Copperton Concentrator
Kennecott Utah Copper Corp.
Magna, Salt Lake County, Utah
Mine ID No. 42-01996

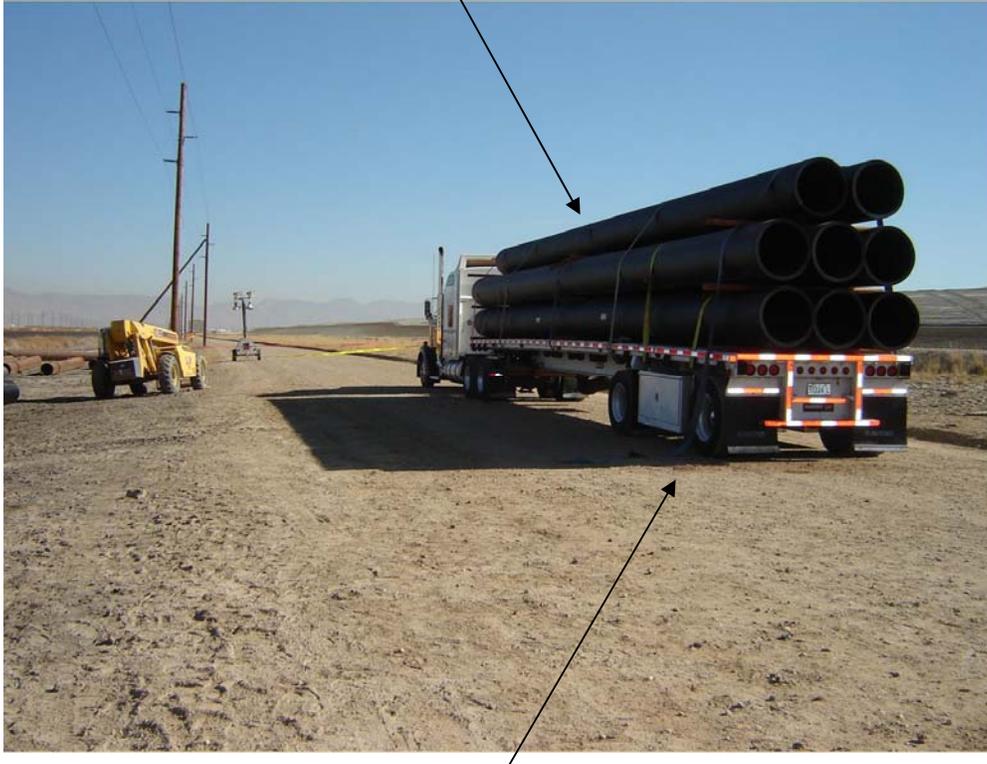
William L. Kay, delivery truck driver, age 81, was fatally injured on October 29, 2008. Kay was unfastening a load of pipe from a flatbed trailer when one 50-foot section of pipe rolled off and struck him. He was preparing to unload nine sections of pipe from the trailer.

Initial position of pipe

Victim location

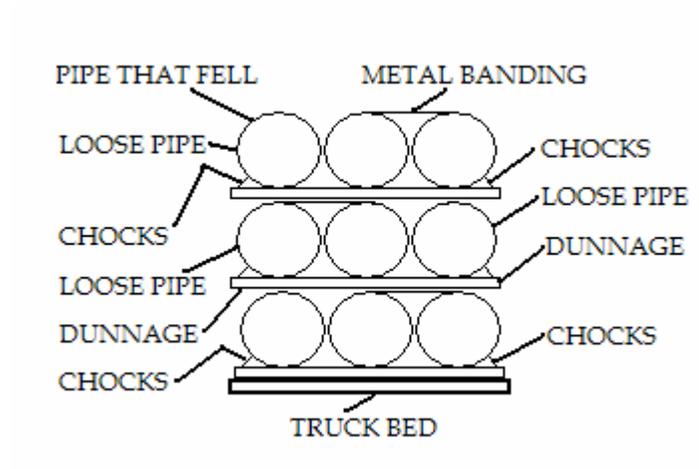
Typical pipe configuration on trailer

A typical trailer load of pipe consisted of nine sections arranged in three rows of three sections each. Two pipe sections in each row were banded together by the manufacturer. Three 2-¼ inch by 3-inch wooden timbers, referred to as dunnage, were placed between each row of pipe to provide stabilization. Chock blocks were typically provided to prevent the sections of pipe from rolling.

However, none of the wooden timbers on the trailer involved in the accident were provided with chock blocks. The load of pipe was secured to the trailer with several nylon ratchet-type straps each rated for 12,000 pounds of weight.

Note: No chocks were provided on the load of pipe involved in this accident

Corrective Action: Contractor management should establish policies and controls to ensure that pipe can be unloaded from trucks in a manner that does not create a hazard to persons.
