REPORT OF INVESTIGATION

**Fatal Powered Haulage Accident
January 2, 2010**

**Bull Mountains Mine No. 1
Signal Peak Energy LLC
Roundup, Musselshell County, Montana
MSHA I.D. No. 24-01950**

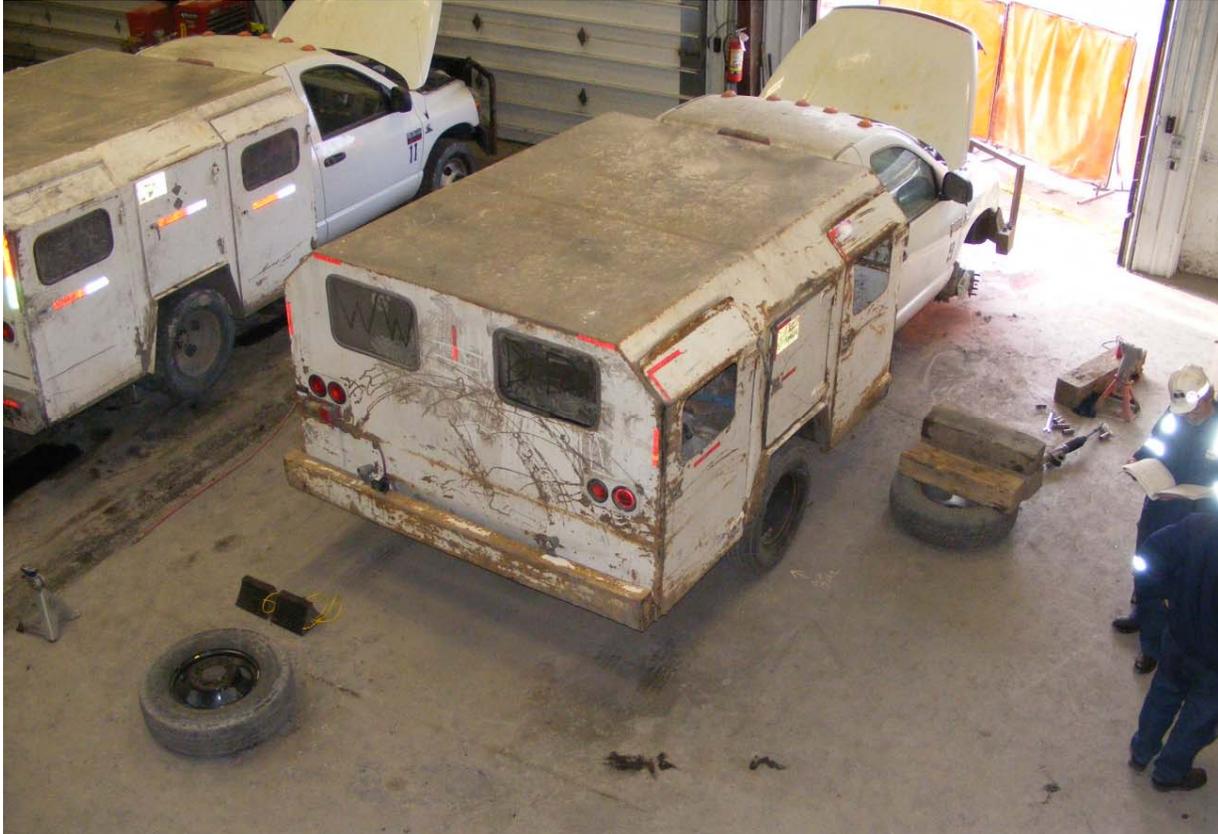
VIEW OF ACCIDENT SCENE

TRUCK WITH FABRICATED MANTRIP COMPARTMENT

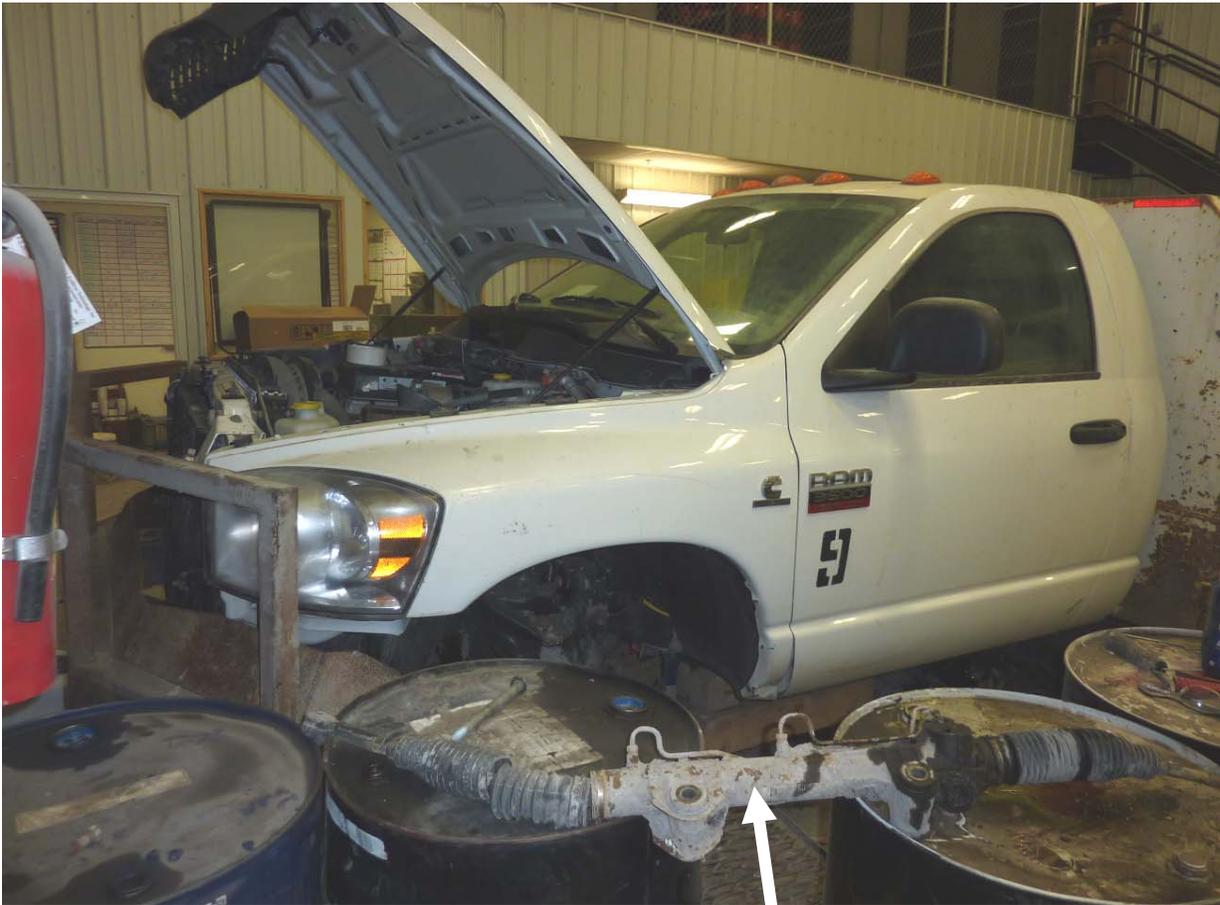
View of Truck and Power Steering Unit

POWER STEERING UNIT TAKEN OFF TRUCK

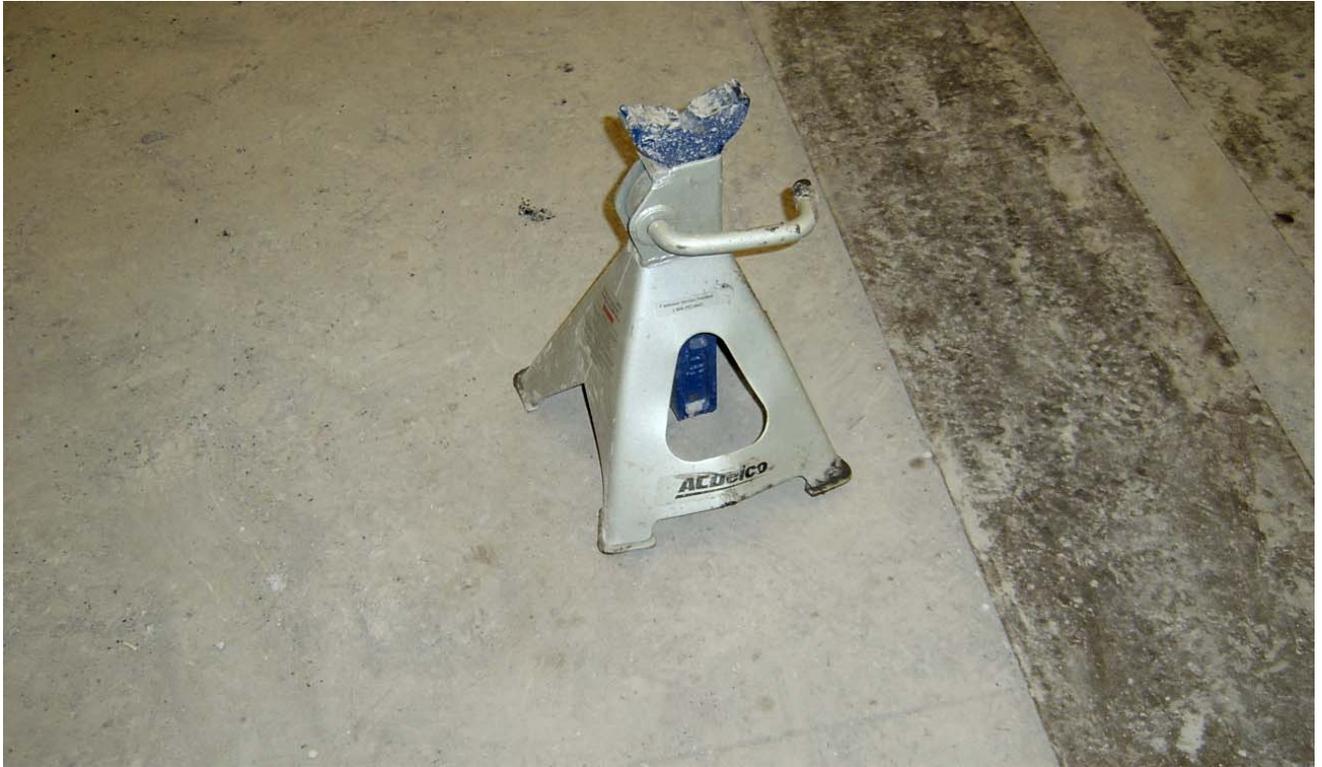
View of AC Delco Jack Stand

When the accident occurred, the front wheels had been removed from the truck and the front end was supported with two 6-ton AC Delco jack stands. At the end of dayshift, the mechanics left the front of the truck up on the two jack stands and had placed a heavy duty floor jack under the front bumper. The floor jack was not in place at the time of the accident. The two 6-ton AC Delco jack stands were considered adequate to support the truck in an elevated position, as long as the engine and drive wheels were not engaged.

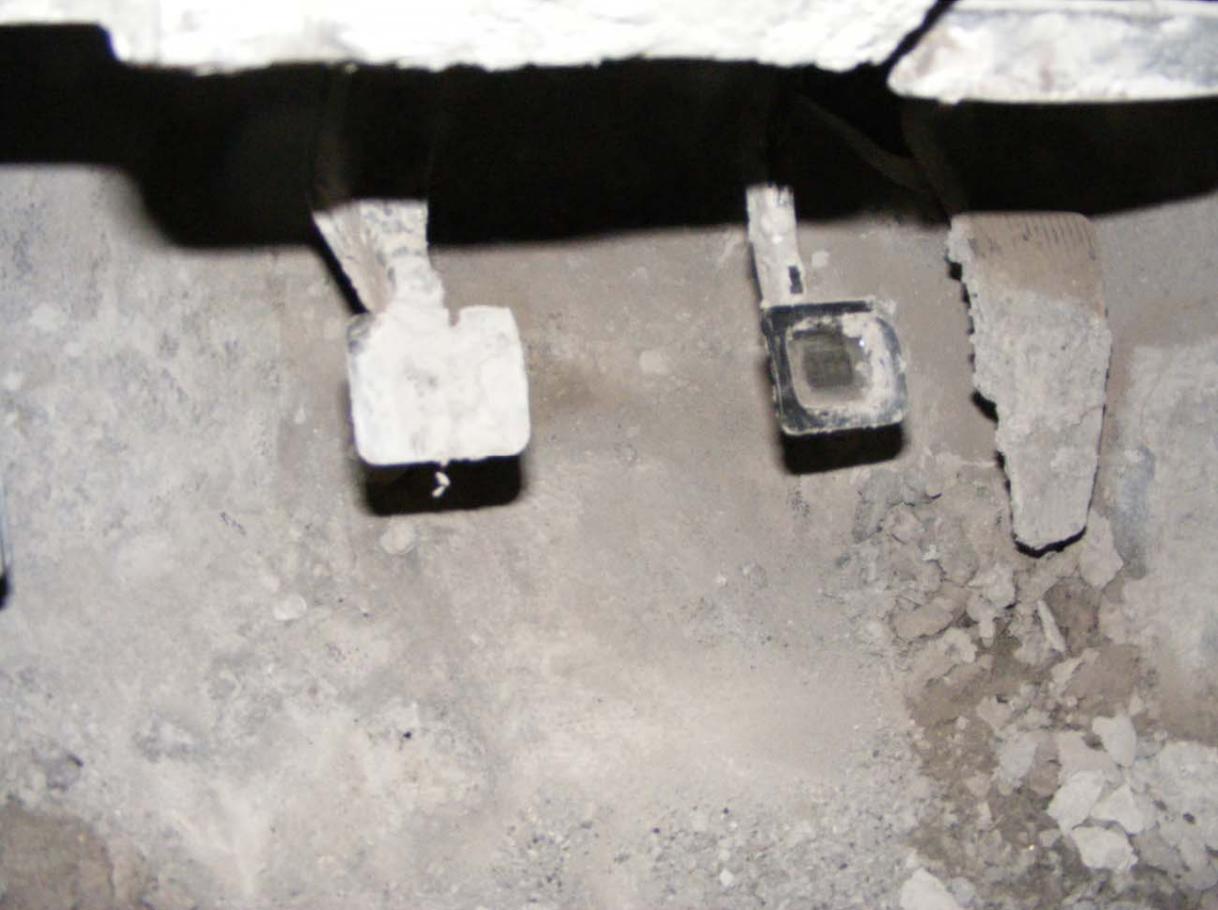
View of Clutch Pedal (left) and Brake Pedal (right)

The clutch pedal was examined during the investigation and the rubber friction pad/anti-slip cover for the top of the clutch pedal was missing, exposing the metal of the clutch pedal. The pedal had mud on it when it was examined, indicating that the cover was missing prior to the accident. The rubber friction pad/anti-slip cover for the top of the brake pedal was not on the pedal, but was found on the floor of the truck. It appeared that this cover was dislodged by Demers when he depressed the brake pedal with force after the truck started to lurch forward. The brake pedal was clean, indicating that the cover had been in place prior to the accident. See Appendix D for a picture of the clutch and brake pedals. Demers was wearing leather boots with rubber soles. He had worked in the wash bay earlier in the shift, washing mud off vehicles, but could not say whether his boots were wet/muddy at the time of the accident. He did state that “you are always wet and muddy when working at the mine.”

Root Cause: Management did not maintain the truck in safe condition in that the rubber friction pad/anti-slip cover for the top of the clutch pedal was missing. This unsafe condition contributed to the assistant’s foot slipping off the depressed clutch pedal, causing the accident.

Corrective Action: The rubber friction pad/anti-slip cover for the clutch pedal was replaced and training was provided to equipment operators to check for such safety defects during pre-operational inspections.
