REPORT OF INVESTIGATION

FATAL MACHINERY ACCIDENT

June 24, 2010

Leeco Incorporated  
#68  
Jeff, Perry County, Kentucky  
I.D. No. 15-17497

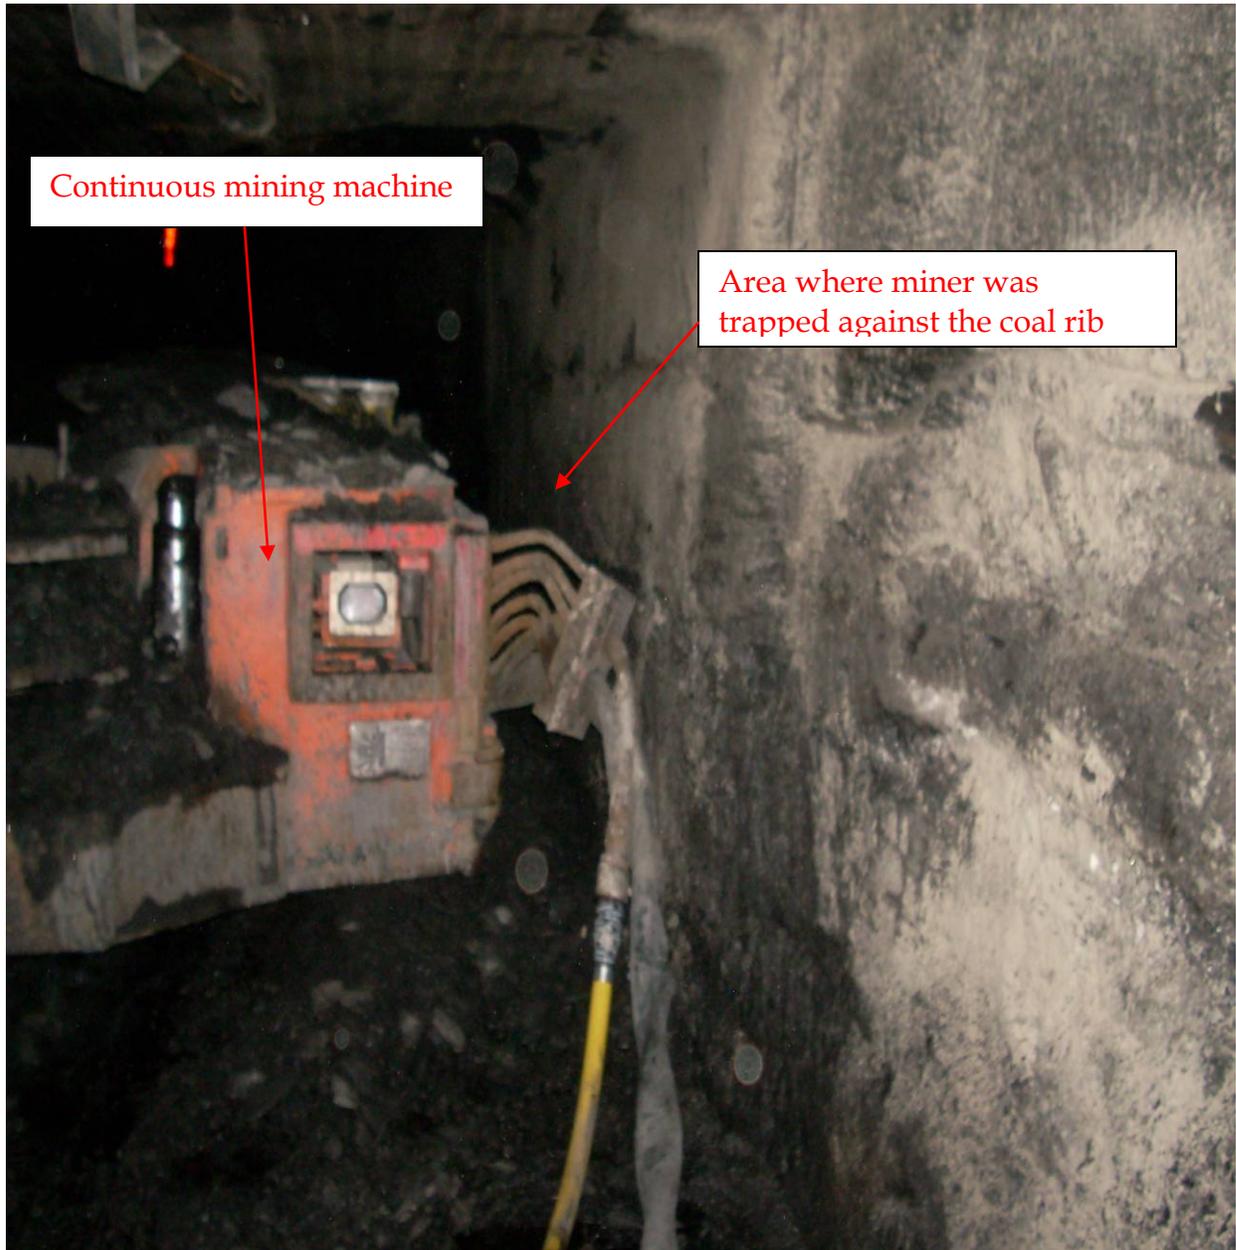
## PHOTOGRAPH OF ACCIDENT SCENE

At approximately 1:15 p.m. on Thursday, June 24, 2010, a 29 year old miner with twelve years mining experience was fatally injured when he became trapped between the continuous mining machine he was operating and the coal rib. The victim was tramming the mining machine by remote control along the right rib line to clean up the loose coal on the mine floor. While he was turning the front of the mining machine to the left, he became caught between the mining machine and the coal rib.

The investigation found that at the time of the accident, Bobby Smith Jr. (victim) was positioned in the "Red Zone" along the right side rear of the continuous mining machine, adjacent to the machine's cable stand-off anchor. He was making the final clean-up run along the right rib line when he turned the front of the continuous mining machine to the left, pinning himself between the machine and the right coal rib, causing fatal crushing injuries. There were no eyewitnesses to the accident. The mine operator failed to ensure that the continuous mining machine operator remained in a safe location, away from the machine, and away from pinch points created by either the continuous mining machine and/or haulage equipment.

**Corrective Actions:** Management developed and trained all miners on an Action Plan implemented as company policy that addresses "Red Zone Hazards," "Safe Work Practices," and "Panic Switches," prior to resuming normal mining operations. The Action Plan requires: 1) training for all miners on proper positioning out of harm's way when cutting coal or tramming the continuous mining machine; 2) that a Red/Danger Zone card, with danger zone precautions be attached to the continuous mining machine remote boxes; 3) reinforcement of training during future safety meetings and monitoring of compliance; 4) The Roof Control Plan has been revised to include enhanced precautions for the "Red/Danger Zones;" 5) A proximity system (Matric) has been installed by Joy Manufacturing on a continuous mining machine that was put in operation in January, 2011. The requirements for this system have been incorporated into the Roof Control Plan. These revisions have been included in the "Precautions for Remote Control Operation of Continuous Mining Machines," for the 014 section (See Appendix E). Mine management has proposed, and MSHA has accepted the proposal, that all new or rebuilt continuous mining machines put into production in this mine be equipped with proximity systems, designed to prevent miners from being injured by being caught in pinch points or being struck by the continuous mining machine.
