REPORT OF INVESTIGATION

**Surface Nonmetal Mine
(Fuller's Earth)**

**Powered Haulage Accident
October 20, 2010**

**Oil-Dri Corporation of Georgia
Simpson Mine
Ochlocknee, Thomas County, Georgia
Mine I.D. 09-00114**

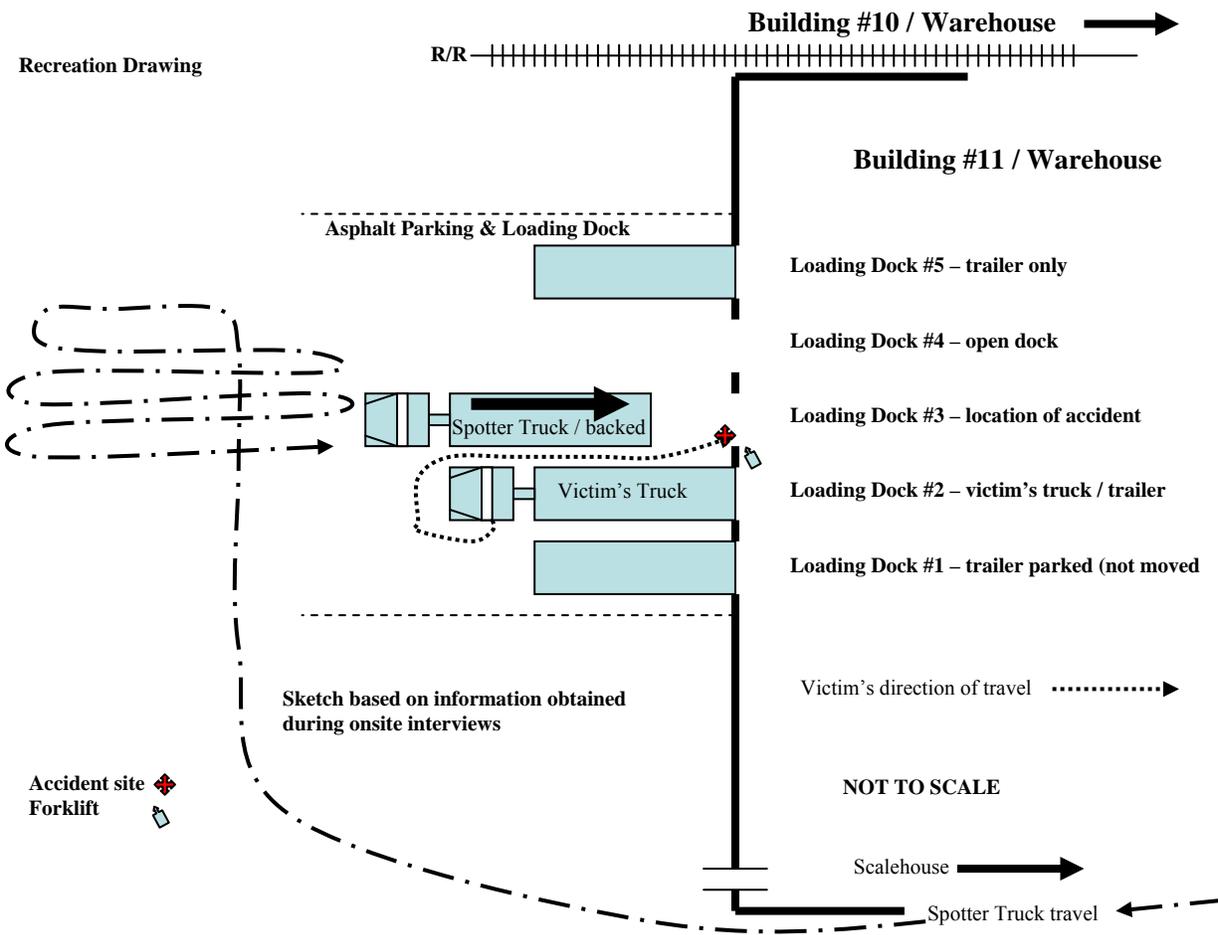
Sketch of Accident Area Building 11 - Loading Dock

The loading dock has five open loading bays where forklifts loaded the trailers. The bays are numbered from right to left, facing the warehouse. The openings are 8 ½ feet wide by 9 feet high with a 4-foot spacing between each bay. Two bumper blocks are mounted against the outside wall for the trailers to back against. The openings are equipped with overhead sliding doors which were not operational. There is a 4-foot drop from the floor of the warehouse to the ground where the trailers were parked.

The outside area of the loading dock is approximately 60 feet wide and paved. The area was flat, and sloped slightly toward the building. This area was illuminated by three lights located on the north end of the building. One light was mounted on the left side of bay #5, one light was mounted approximately 15 feet to the right of bay #1, and the other light was mounted approximately 63 feet to the right of bay #1. The three lights ranged from 14 ½ to 17 ½ feet high. The light mounted 15 feet to the right of bay #1 was approximately 17 ½ feet high and, was the

only light that functioned. This light was partially blocked by the approximately 13 feet high trailer parked in bay #1. Less than one foot candle of illumination was being projected onto the loading dock from the one operational light.

The order was terminated on January 4, 2011. Four (4) new lights were installed outside the loading dock bays which increased the foot candles from less than 1 to over 28 foot candles.
