REPORT OF INVESTIGATION

Surface Coal Mine

Fatal Machinery Accident
May 14, 2011

Guyan
Apogee Coal Company LLC
Rum Creek Road
Yolyn , Logan County, West Virginia
I.D. No. 46-08939

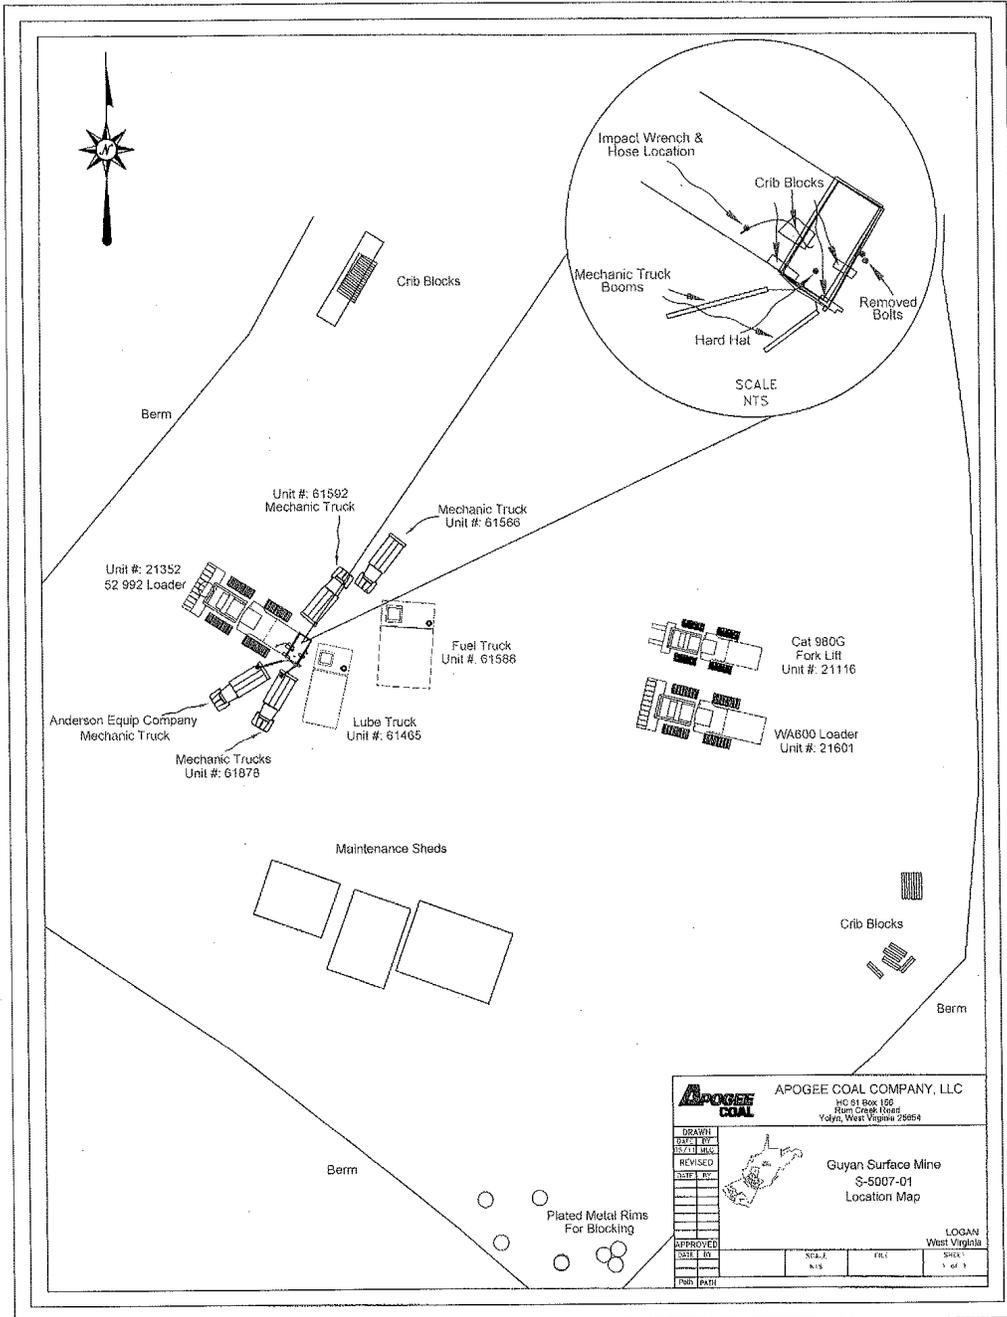
Sketch of the Accident

The service manual specifies that 16 bolts (eight on each side) connect the counter weight to the machine. Fourteen bolts were discovered in two separate piles beneath the counter weight after the accident occurred. Seven bolts were found in a pile beneath the left side of the counter weight. Seven bolts were discovered in a similar manner beneath the right side of the counter weight. The final and eighth bolt from the left side was found broken with the head of the bolt and approximately two inches of thread in the impact socket used to remove the bolt. The frame of the machine contained the rest of the broken bolt. The remaining bolt that was holding the counter weight was found broken with the

The accident occurred because mounting bolts were removed from an 11,685 pound counter weight without installing proper blocking to assure that the counter weight was secured against motion. The employee was positioned directly below the counter weight while performing this task.

Corrective Action: Management has implemented a written procedure that requires verification that adequate blocking or securing material is in place prior to anyone working under machinery or removing large components.

Corrective Action: Management now requires mechanics performing tasks which are not performed on a regular or routine basis to refer to the manufacturer's service manuals or computer service guide for safe repair procedures before beginning the task.
