REPORT OF INVESTIGATION  
Underground Coal Mine

Fatal Handling Material Accident  
March 3, 2012

Parton Bros. Contracting, Inc.  
Timber Tree #9  
Cumberland, Harlan County, Kentucky  
I.D. No. 15-19051

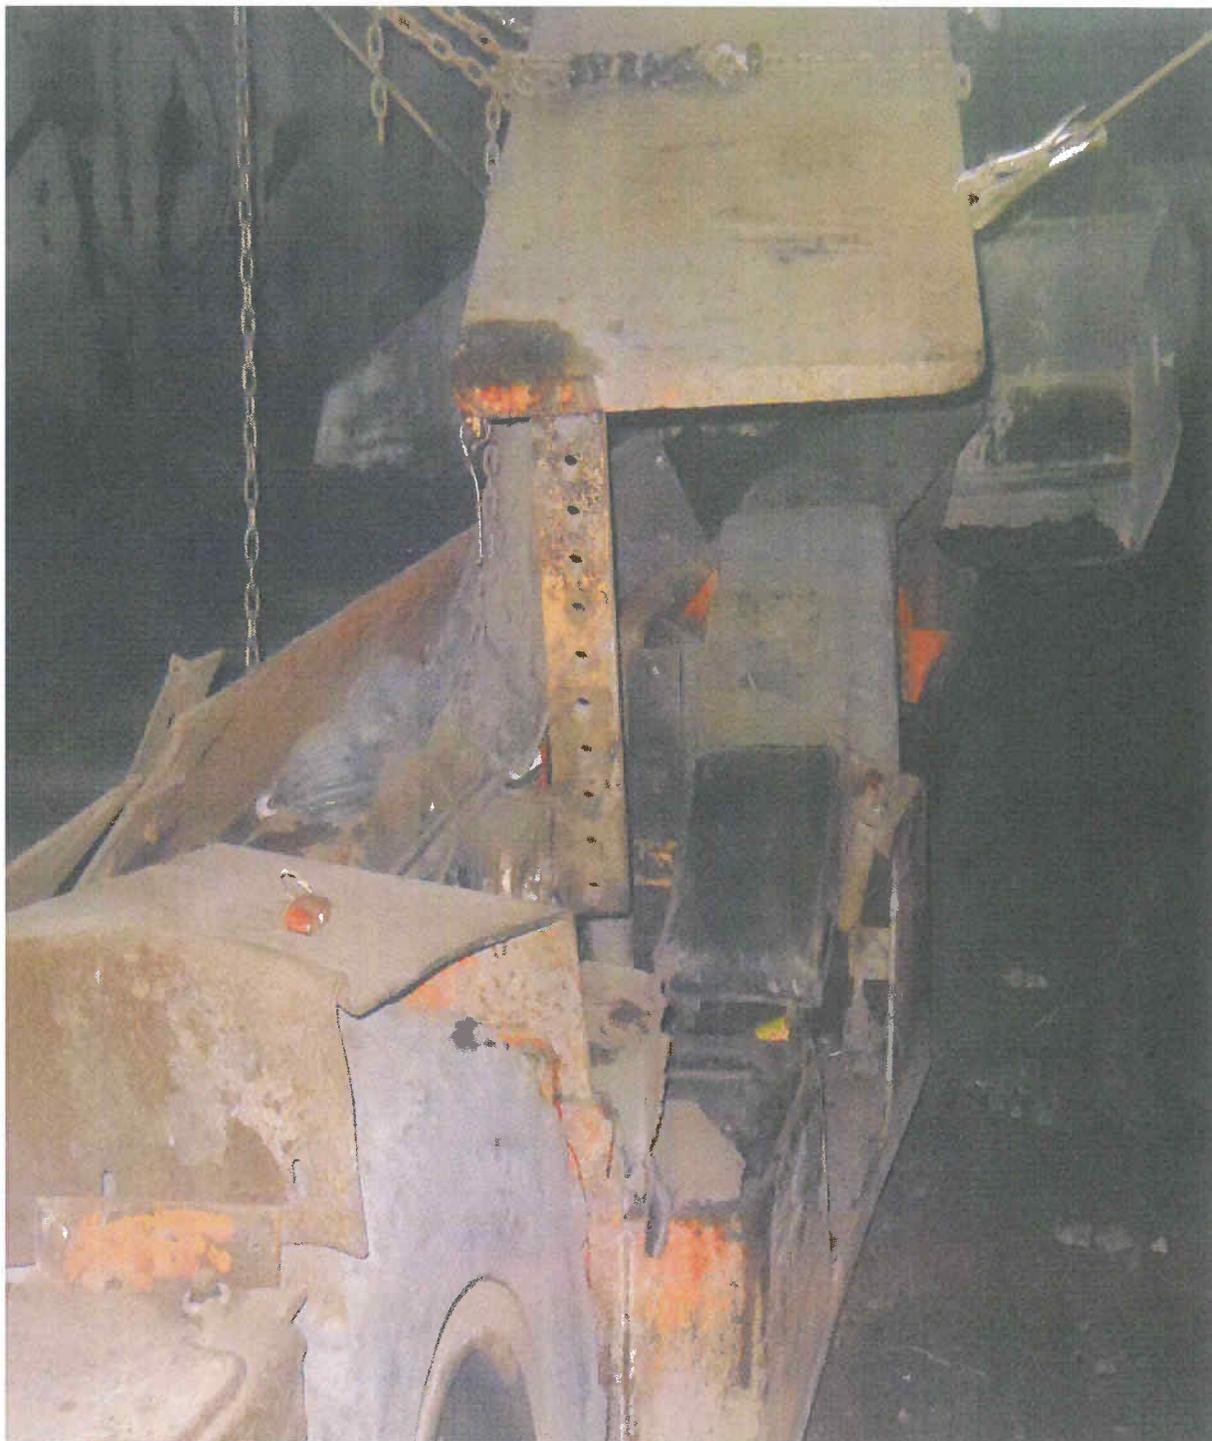
PHOTOGRAPH OF ACCIDENT SCENE POST VICTIM RECOVERY

- Bailey was found sitting in the shuttle car operator's compartment, facing in the direction of travel, when struck by the canopy.
- The canopy was wedged tight between the mine roof and the shuttle car, requiring the shuttle car to be pushed back approximately 10 inches to free the victim prior to recovery.

- The shuttle car was found energized, was not locked and tagged, and was not blocked against motion.
- The roof bolt plate used to support the chain and 2-ton come-along broke, indicating that excessive force had occurred, causing the roof bolt plate to spin and break. Testing conducted on a similar plate showed that approximately 3,000 pounds of force would have to be applied to a new plate in order for it to break. The weight of the canopy was 690 pounds.

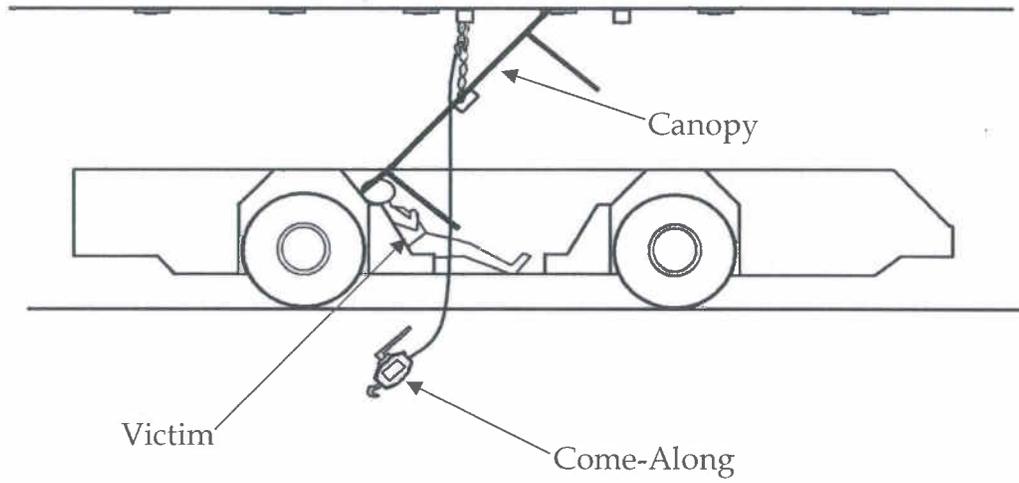
Drawing of the Accident Scene

The accident occurred in the intersection of the No. 3 entry (belt entry) on the 001 section, approximately 60 feet outby survey station number 483. This area was dry at the time of the accident and the mine height throughout the intersection ranges from 76, to 79 inches.
