REPORT OF INVESTIGATION

Underground Metal Mine  
(Gold)

Fatal Slip or Fall of Person Accident  
August 31, 2012

Exodus  
Newmont USA Limited  
Carlin, Eureka County, Nevada  
Mine I.D. No. 26-02661

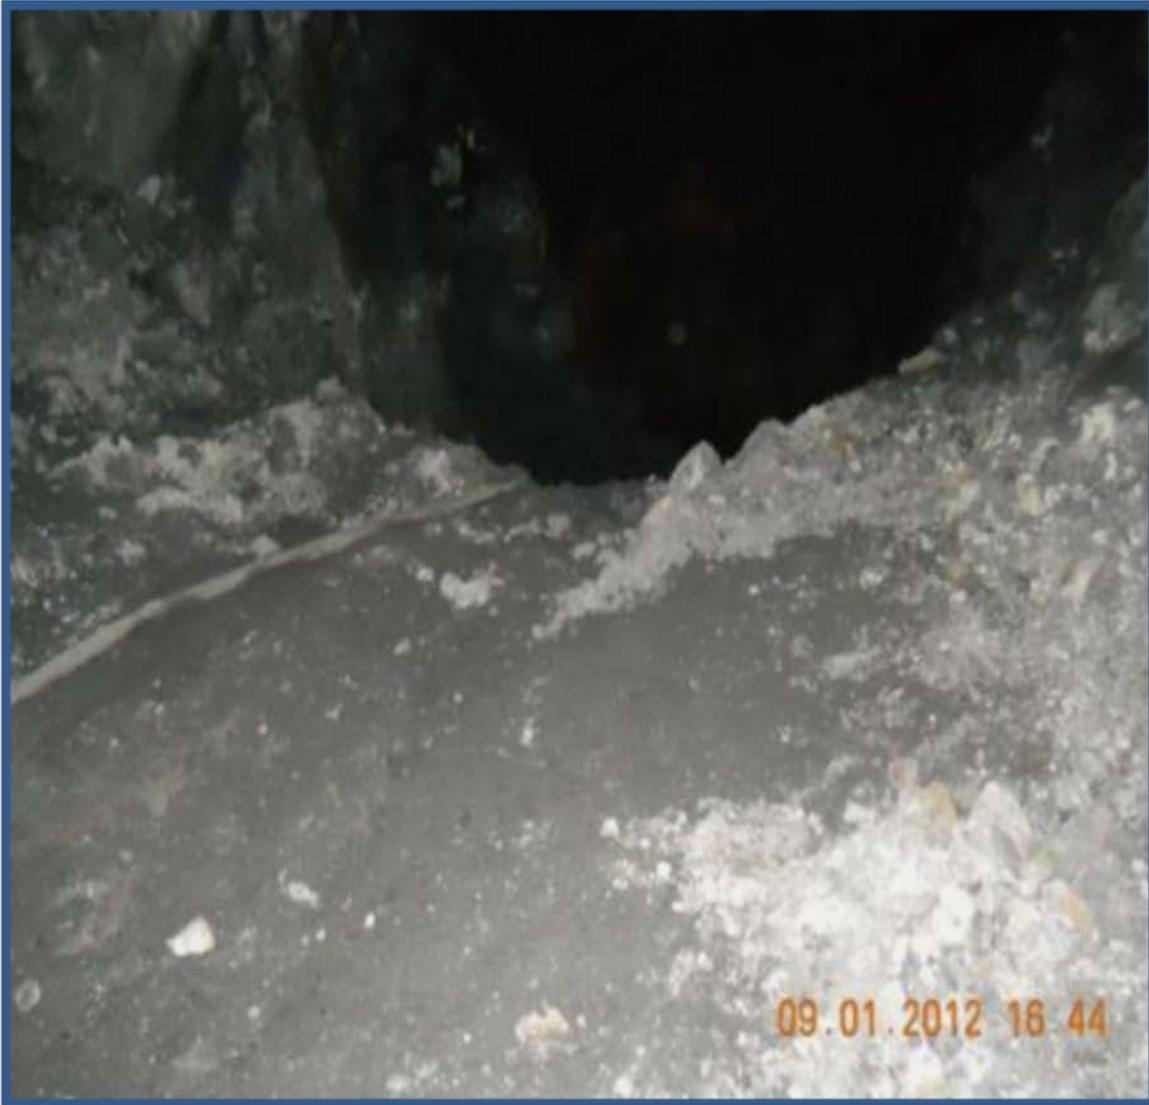
Photo taken from the right side of drift looking toward open hole.

Kranovich and Edson walked back into the 4500-315 stope to look for Campbell but did not find him. They noticed an open hole, 3 to 4 feet in diameter, had developed in the bridged material and found a 1-inch water hose laying over the edge of the open hole with water running in it. Keogh asked other miners in the area if they had seen Campbell but they had not seen him.

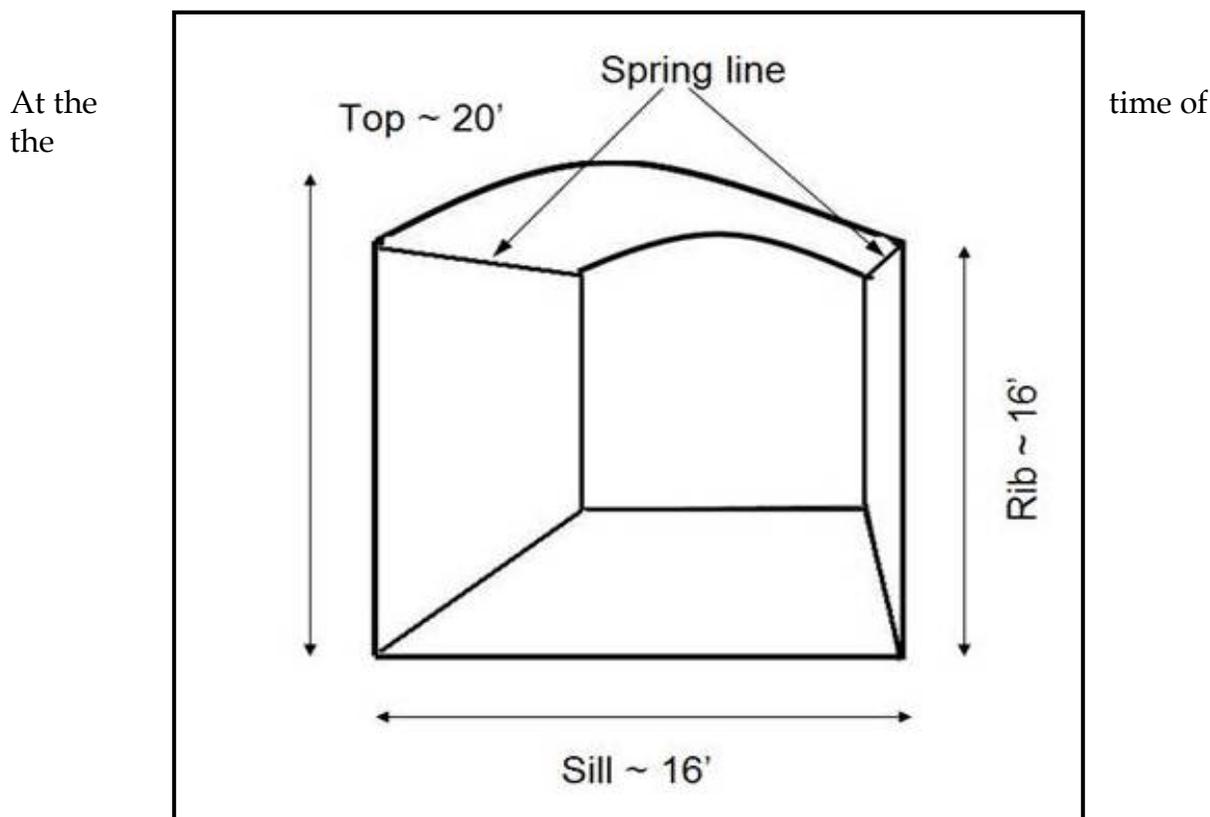
Figure 1. Cross sectional diagram of an ideal drift at Exodus

The specific location of the accident was the 315 drift on the 4500 level, the 4500-315 stope. Drift dimensions were 16 feet across the sill and 16 feet to the spring line as indicated in Figure 1. The back curved upward from the spring line to about 20 feet before curving down to the opposite side spring line. The overall length of the 4500-315 stope was approximately 300 feet.

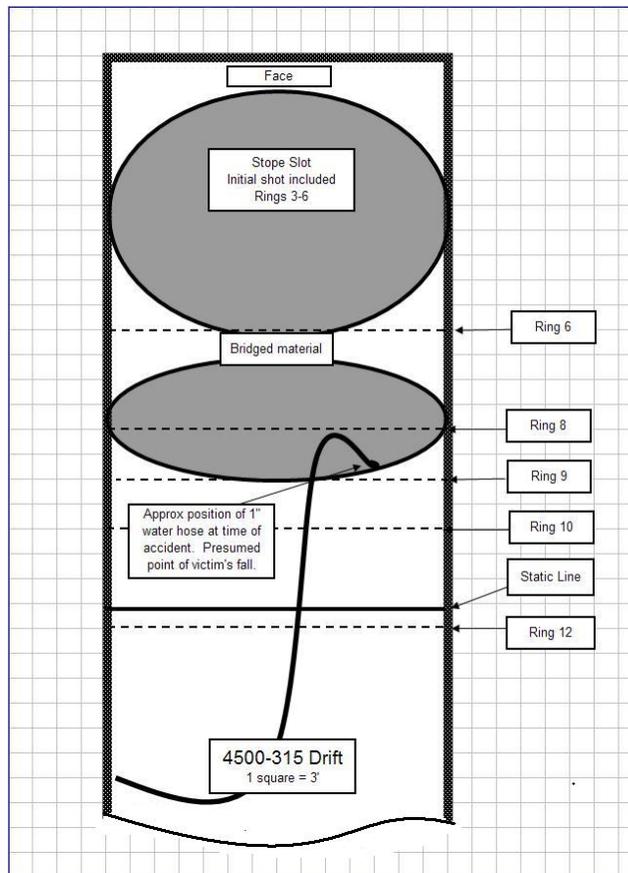
Figure 2. Sketch of drift 4500-315 at time of the investigation

investigation, the leading edge of the stope corresponded with Ring 9 as indicated in the diagram shown in Figure 2. This was consistent with the expected results of drilling and shooting Rings 7 and 8. The investigators noted marks on both the left and right ribs that corresponded with the location of Ring 9. An arrow was pointing to the face just inby those white lines.

As stated during interviews, a line is normally painted on the rib 10 feet from the assumed edge of the stope to warn miners that fall protection was needed beyond that point. The location of the 10 foot warning line from the expected new leading edge should have been close to Ring 11 not at Ring 9. The distance from Ring 9 to Ring 6, at the time of the shot, was 18 feet. The crest of the bridged material was about 16 feet from Ring 9. This distance was nearly the distance expected to Ring 6 which should have been the approximate leading edge when the holes were drilled for Rings 7 and 8. After the investigation began, a static line was attached to each rib across the drift about 2 feet inby the Ring 12 position or about 16 feet from the mark indicating Ring 9. The static line was installed at the request of the investigators for attaching fall protection.

**Corrective Action:** Management reviewed the standard operating procedures for working near stopes and made revisions to include specific instructions regarding the use of fall protection. A second person will be present when a miner is working near a stope. All of the stope crews were trained in these new procedures.

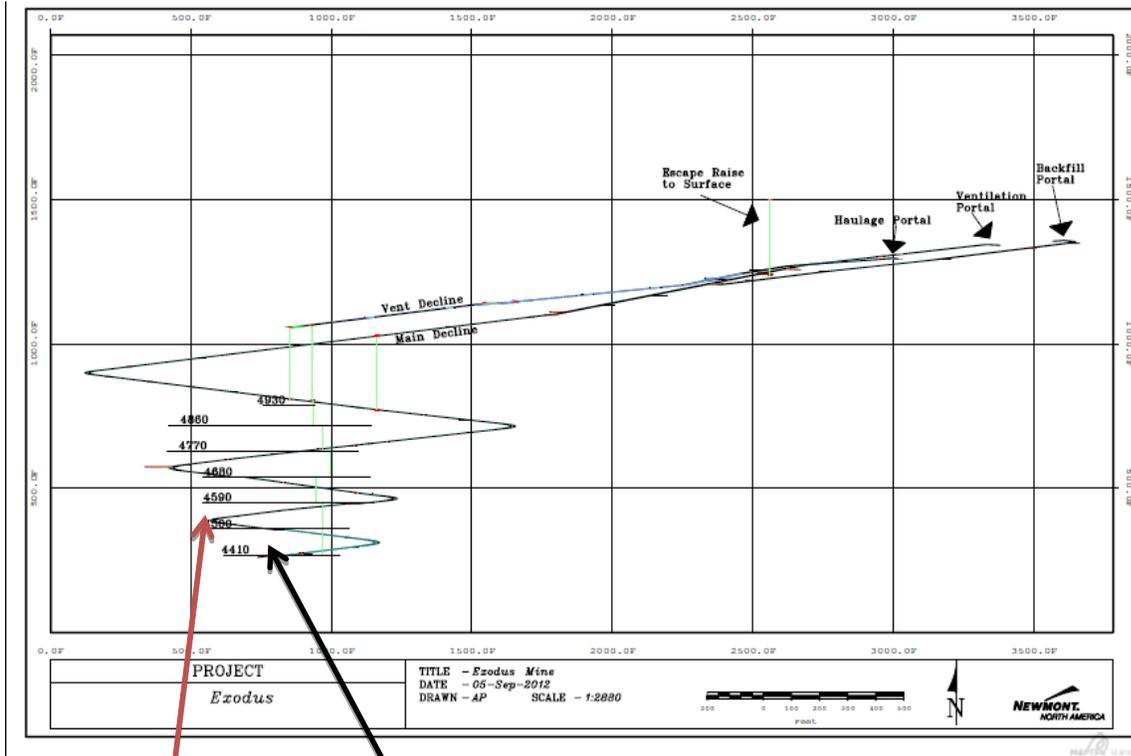
# Appendix B

During the process of preparing for a shot, Campbell fell approximately 90 feet from the drift he was working into the muck pile on the level below. During interviews, miners reported the top layer of material had remained in place after the previous shot. This infrequent post blast condition is referred to as 'being bridged over'. The bridged over material sometimes collapsed by its own weight. If that did not occur, remediation from additional blasting or other mechanical means was required. In this case, all but a narrow strip of bridged over material had fallen before the investigators arrived. A narrow band of strata remained in place at the approximate location of the leading edge of the previous stope hole shot.
