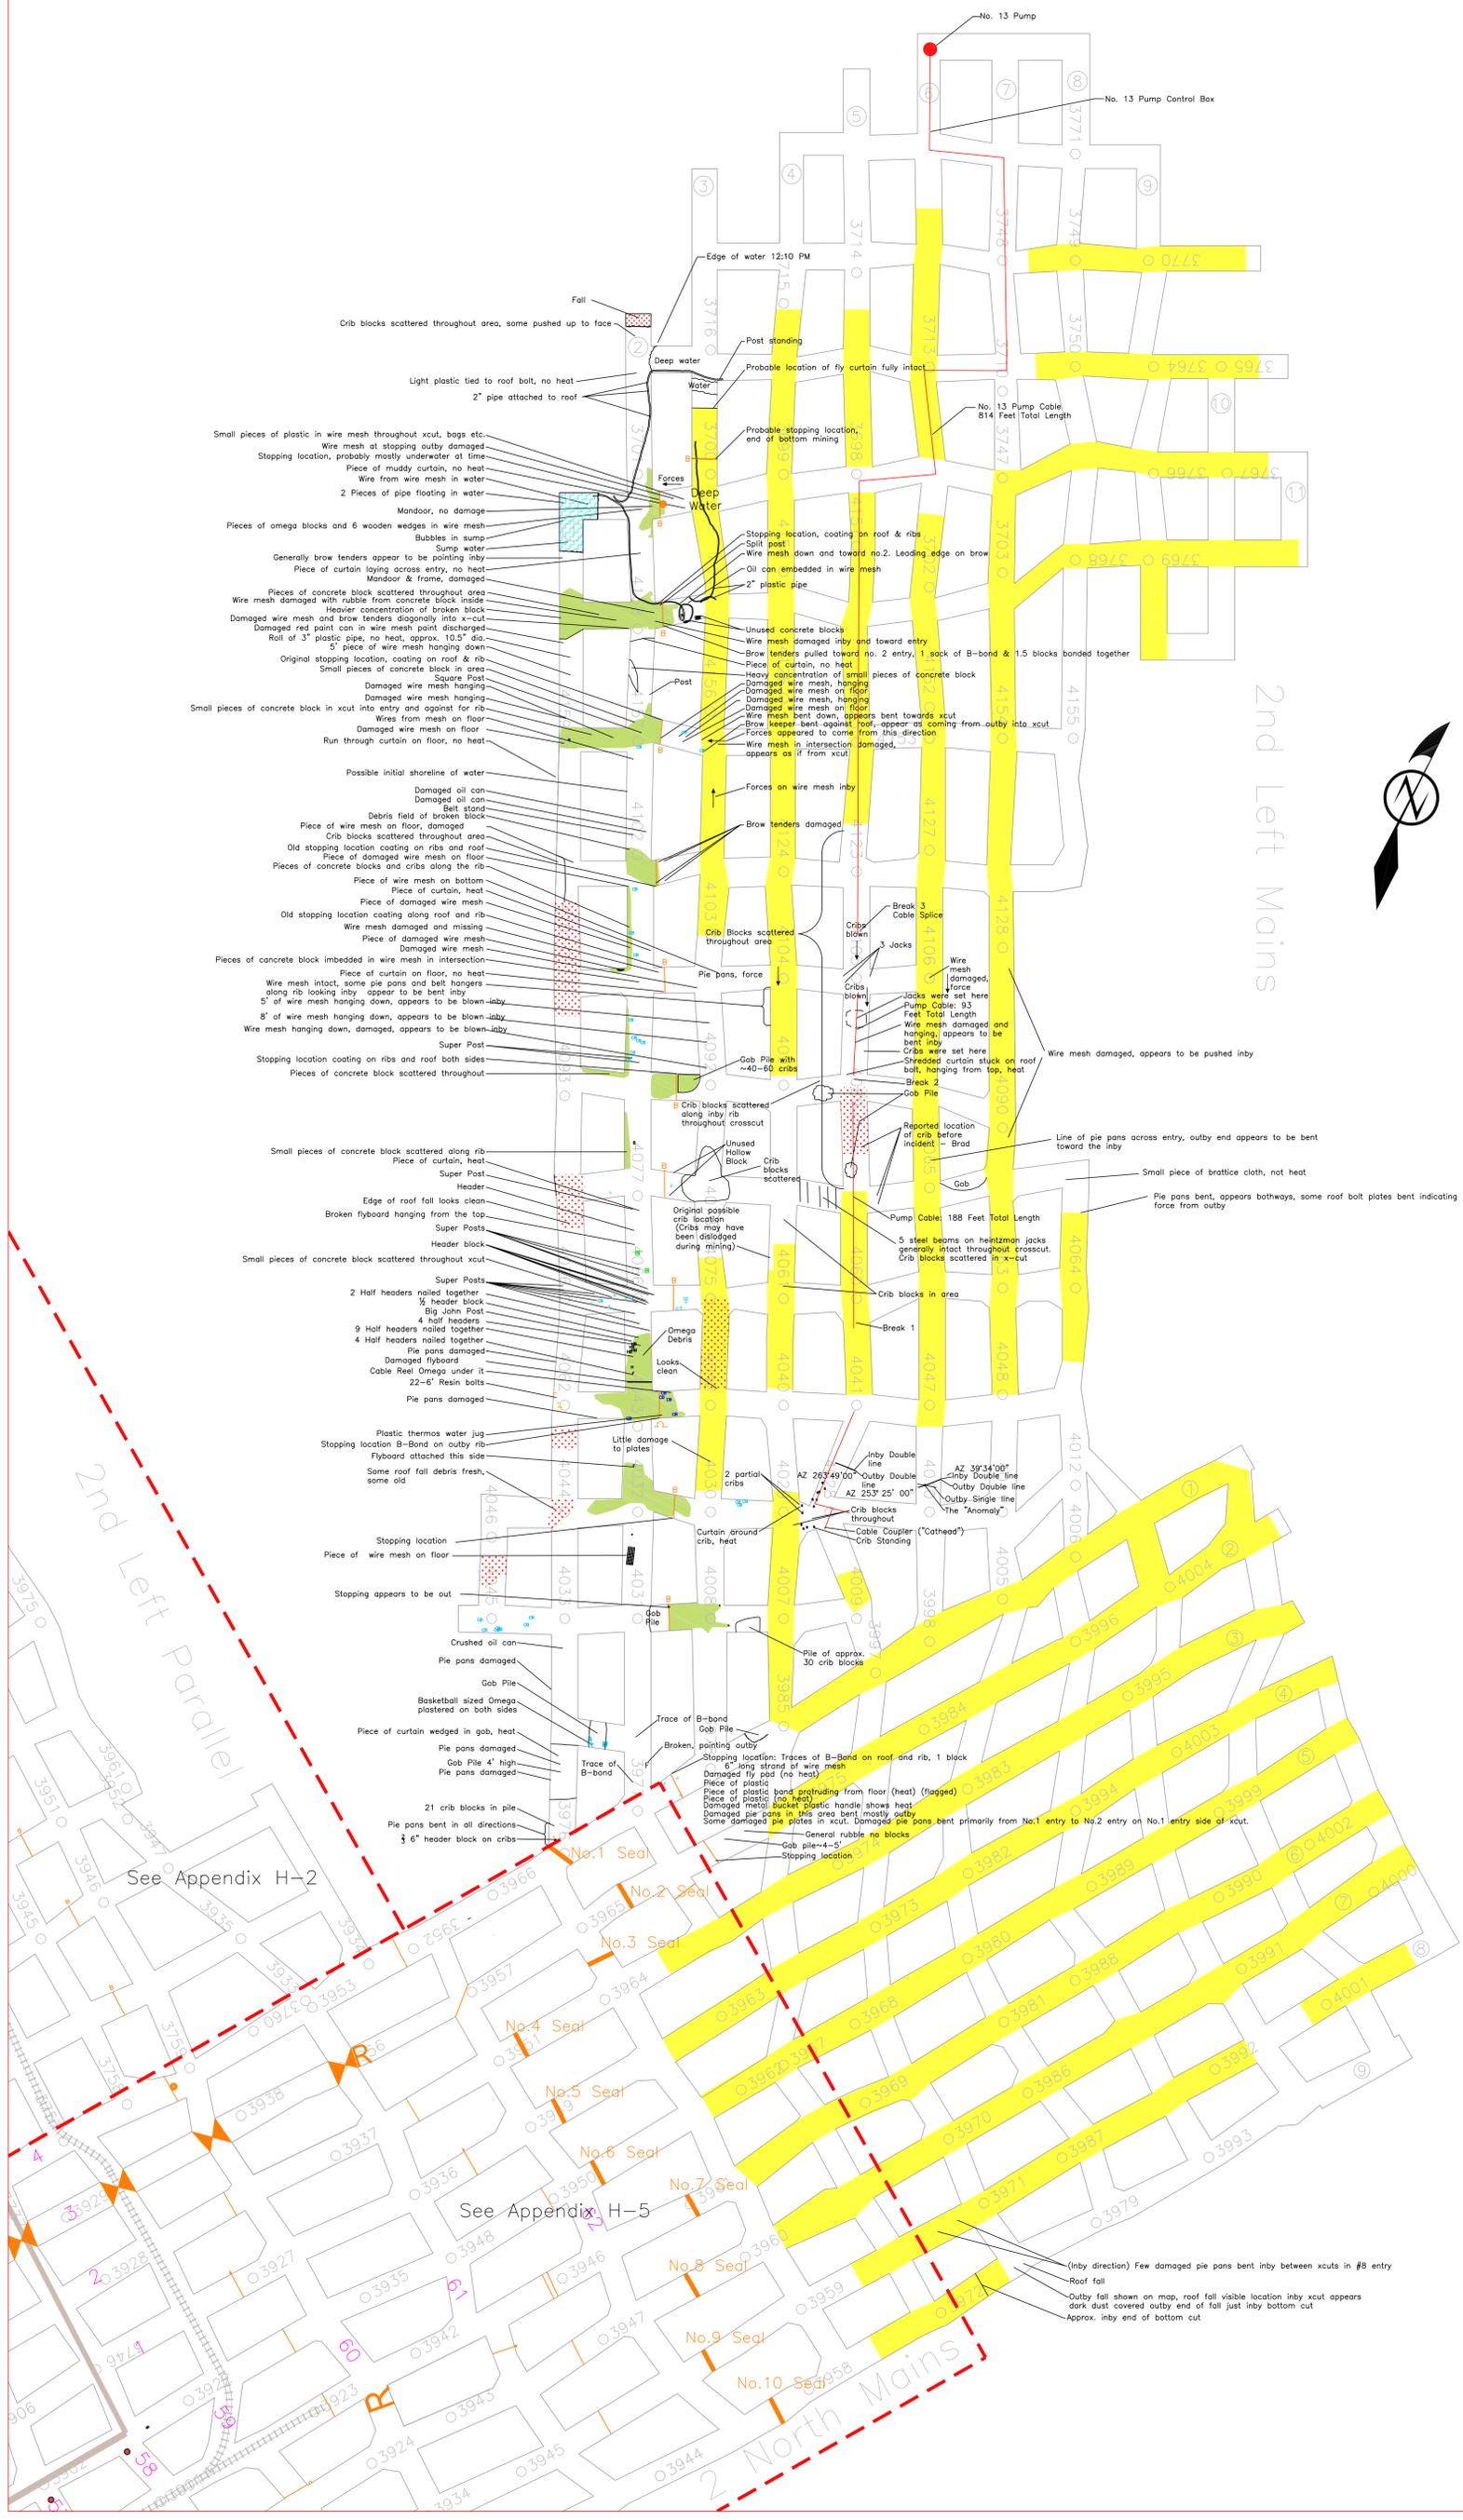
(Inby direction) Few damaged pie pans bent inby between xcuts in #8 entry
 Roof fall
 Outby fall shown on map, roof fall visible location inby xcut appears dark dust covered outby end of fall just inby bottom cut
 Approx. inby end of bottom cut
