REPORT OF INVESTIGATION

Underground Coal Mine
Fatal Fall of Roof Accident
June 23, 2009

Bailey Mine
Consol Pennsylvania Coal Company
Wind Ridge, Greene County, Pennsylvania
I.D. No. 36-07230

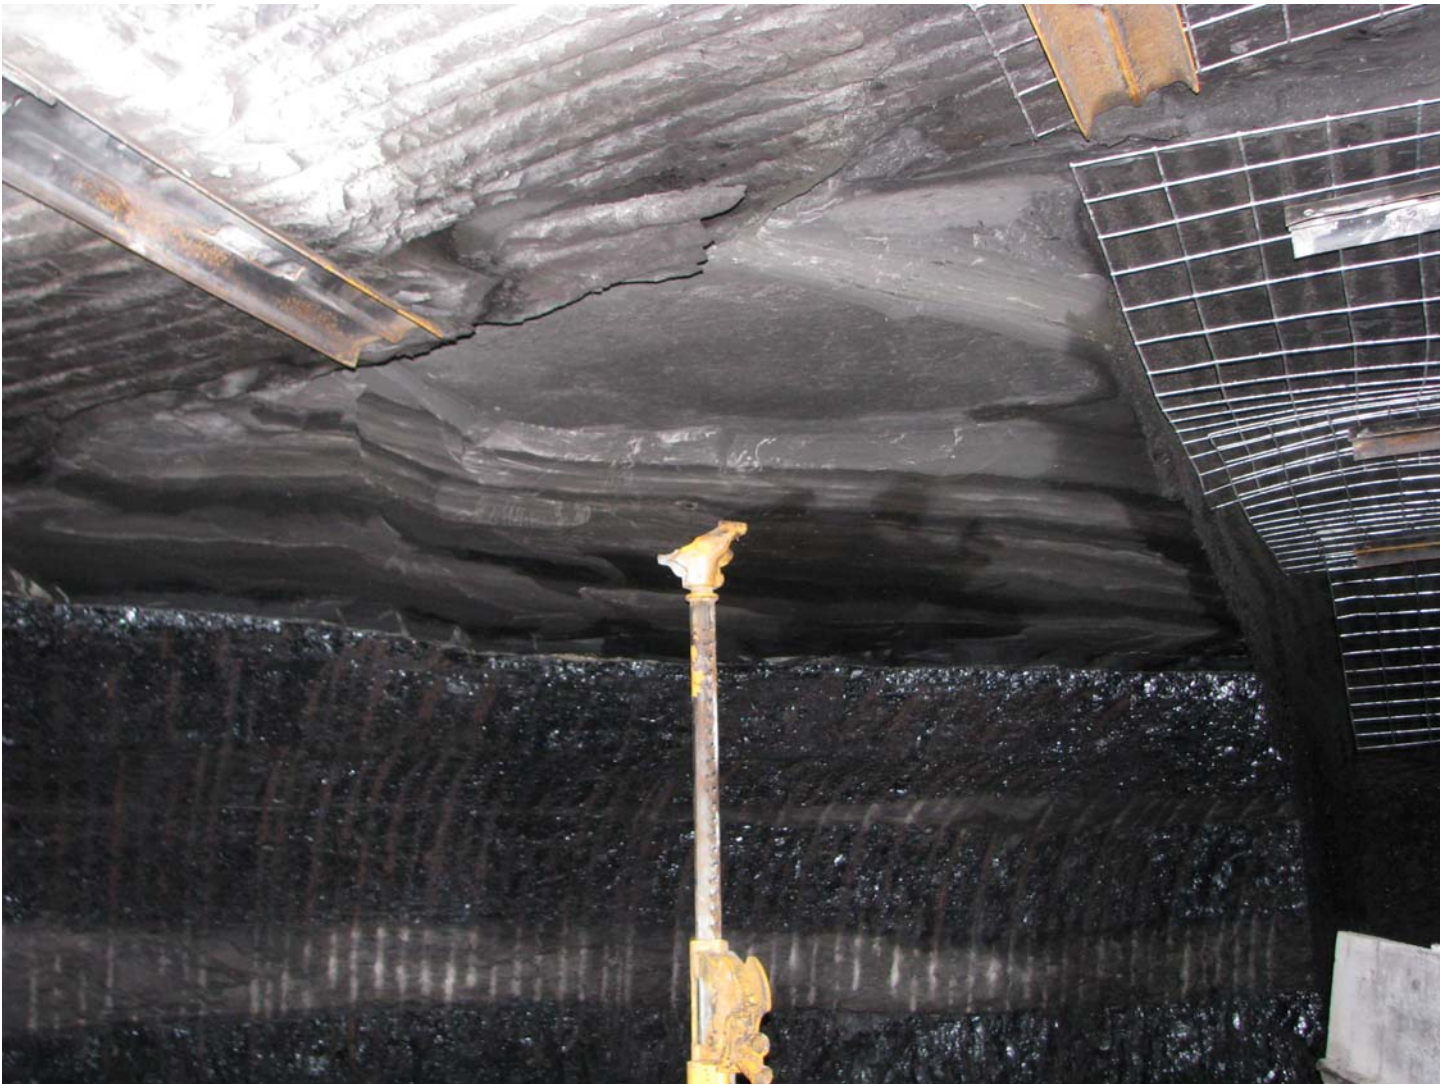
The roof jack was installed by the crew members after the accident to support the top while performing First Aid/CPR on the victim.

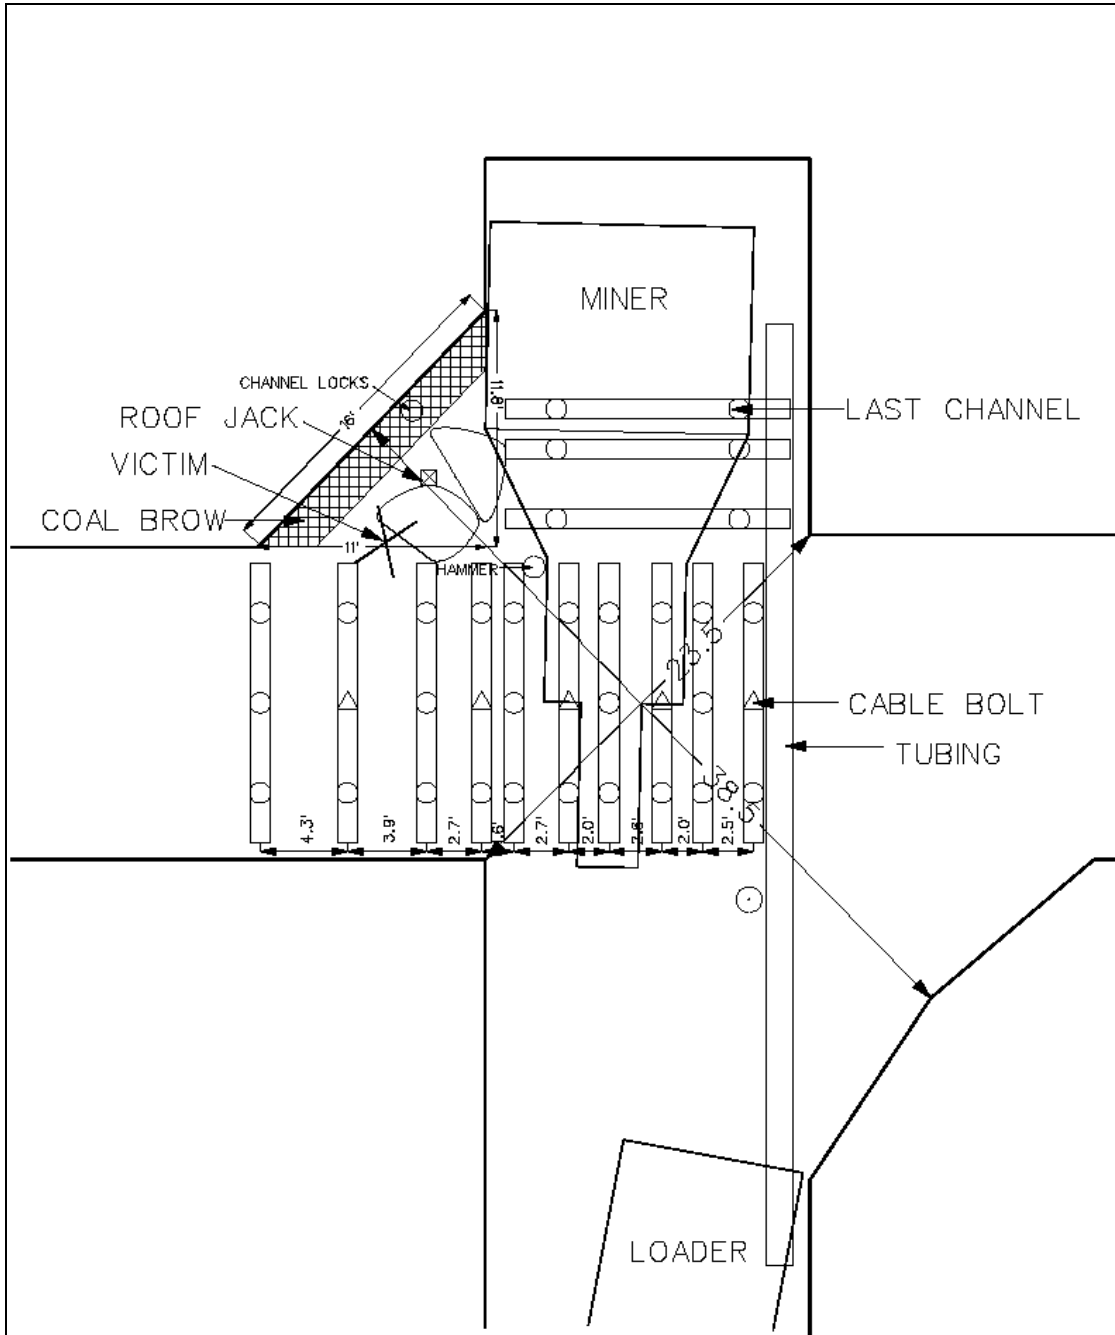
ACCIDENT SCENE

The mining height in the crosscut averaged 100 inches and entries and crosscuts averaged 16 feet in width. The left inby corner in the No. 2 entry at the No. 60 crosscut was triangular in shape. The corner measured approximately 11 feet by 11.8 feet by 16 feet. (See Drawings in Appendix D). Harteis and Farrell commented that the roof conditions in the No. 2 entry and the intersection at 60 crosscut were good. The crew had not detected any bad roof up to the time of the accident. A hammer, which is commonly used as a roof sounding device, was found lying on the mine floor, in the vicinity of the accident site.

The No. 2 entry was mined to intersect the Nos. 59 and 60 crosscuts. Once a crosscut is intersected and the area is bolted up to the previously installed roof supports, the corners are cut. The roof above the outby corners are bolted from the continuous mining machine as the corners are mined. The left inby corner is cut, head on, from the No. 2 entry and is not bolted from the continuous mining machine. In order to prevent the previously installed roof supports from being cut out while mining the corner, the head of the continuous mining machine is lowered away from the mine roof. This leaves a brow of rock and/or roof coal. (See Drawings in Appendix D)

Prior to mining into the No. 60 crosscut, the intersection was center-bolted with 8 foot combination bolts and 16 foot cable bolts. The cable bolts are a non-tension resin bolt system. The cable bolts were installed in every other channel across the intersection area. (See Drawings in Appendix D)
