**Internal Review of MSHA's
Actions at the Upper Big Branch Mine-South
Performance Coal Company
Montcoal, Raleigh County, West Virginia**

U.S. Department of Labor
Mine Safety and Health Administration
Program Evaluation and Information Resources

March 6, 2012

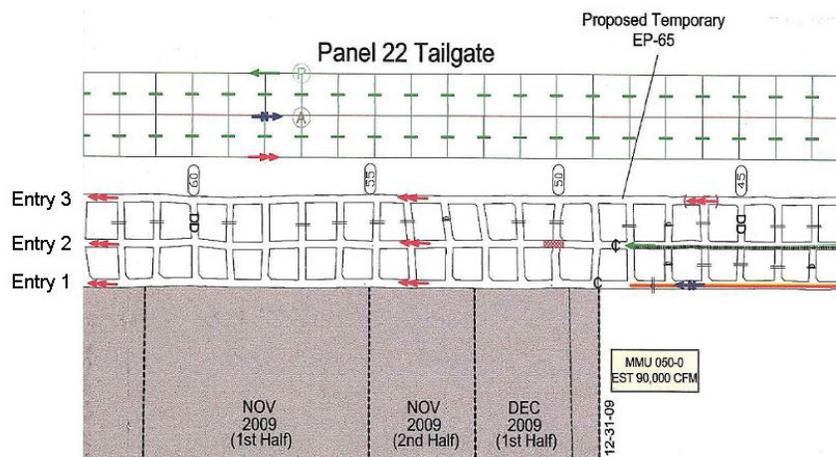
In the ventilation plan supplement approved January 22, 2010, a temporary evaluation point (EP-65) was added (See Figure 18) to account for the return air split from Headgate #22 section which entered the worked out area. The Operator specified that the EP would move outby with the 1 North Longwall face until it reached the regulator at crosscut 31. Once the longwall face reached crosscut 31, the EP would become permanently established at the regulator installed in this crosscut. This evaluation point was critical in determining the effectiveness of ventilation on the headgate side of the worked out area. However, there was no record of an air reading being taken at this EP by either MSHA inspectors or UBB examiners.

Figure 18 - Portion of ventilation plan supplement approved January 22, 2010, showing EP-65
