Summary of Some Selected Underground Coal Mine Face Machinery Fatalities—1973

Informational Report 1029

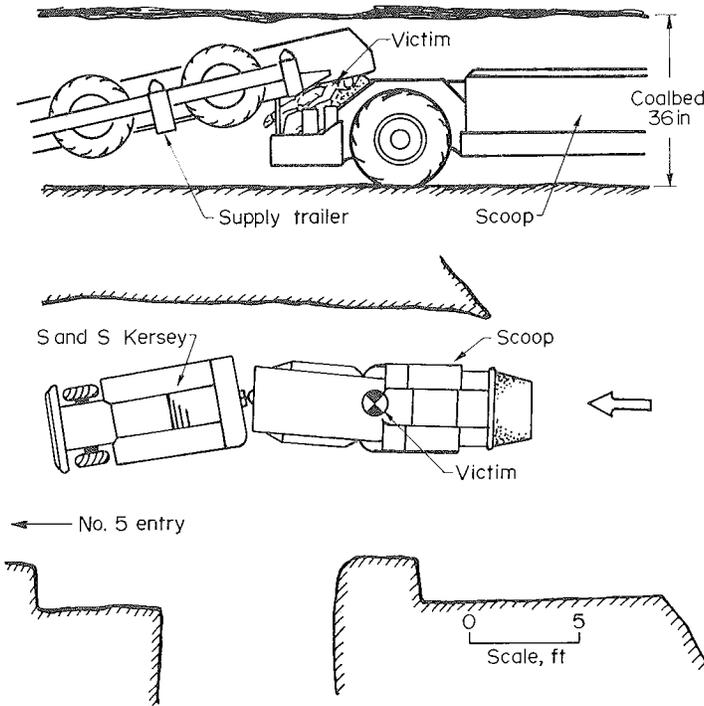
FIGURE 1. - Pushing or pulling equipment with other equipment.

Figure 1 shows a battery-tractor operator (age 51 with a total of 28 years' mining experience, 8 years in his present job) crushed between a battery-scoop and supply trailer attached to a battery-tractor.

CAUSE OF ACCIDENT: Pushing disabled tractor-trailer with scoop.

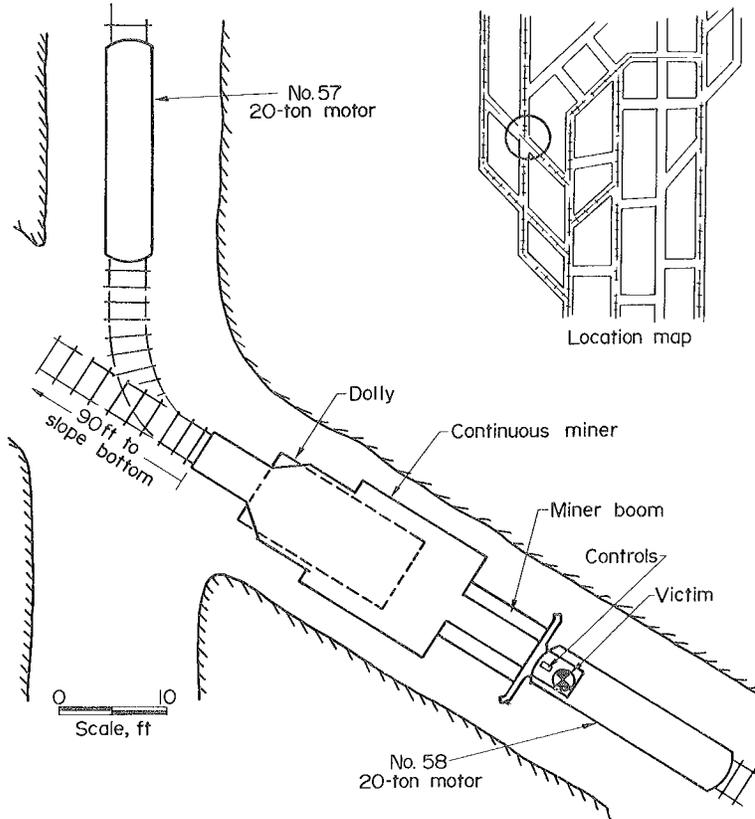
Figure 2 shows a setup man (age 30) caught between the deck of a 20-ton motor and the discharge conveyor of a continuous miner. He had 21 months' mining experience, 6 months of which were in his present job.

TYPE OF ACCIDENT: Caught between the deck of a 20-ton motor and the discharge conveyor of continuous miner.
 CAUSE OF ACCIDENT: Pushing continuous miner with 20-ton motor without a mine car or another motor between the two units.

pulled the continuous miner to the last switch-out track and uncoupled. The first 20-ton motor that switched out was positioned at the boom end of the continuous miner with the operator's deck adjacent to the boom. In this manner, the motorman (victim) attempted to push the continuous miner to the slope bottom. The result is shown in the sketch.

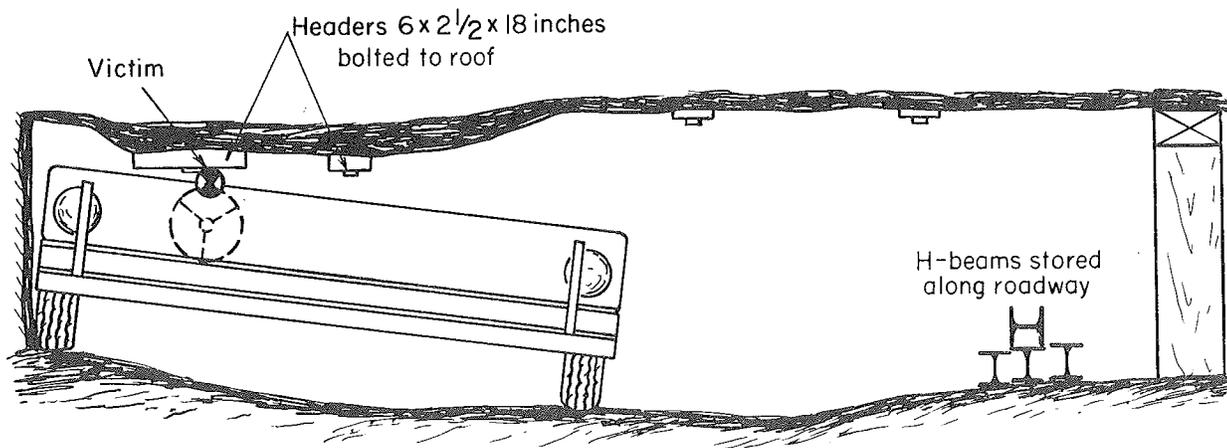
Figure 3 shows a continuous miner operator (age 40), who also was an incidental battery-tractor operator, crushed between a roof header block and steering wheel of a battery tractor. The victim had a total of 28 years' mining experience, 8 years on his present job. This accident occurred near the end of the shift in a low clearance area while a mantrip skid was being repositioned. The section crew was getting ready to return to the surface. The victim was pushing the chain-coupled skid from the operator's end of the tractor when the accident occurred. There were no witnesses to this accident.

| <u>DATE</u> | <u>OCCUPATION</u> | <u>EXPERIENCE</u> | | <u>EQUIPMENT INVOLVED / AGENCY</u> |
|---|---|---|---|---|
| 9/15/73 | Continuous miner operator, Age 49 | 28 years | 8 years | Battery tractor/Header block Inadequated clearance |

CAUSE OF ACCIDENT : Reversing tractor with coupled mantrip skid in low clearance area.
Victim was an incidental tractor operator.

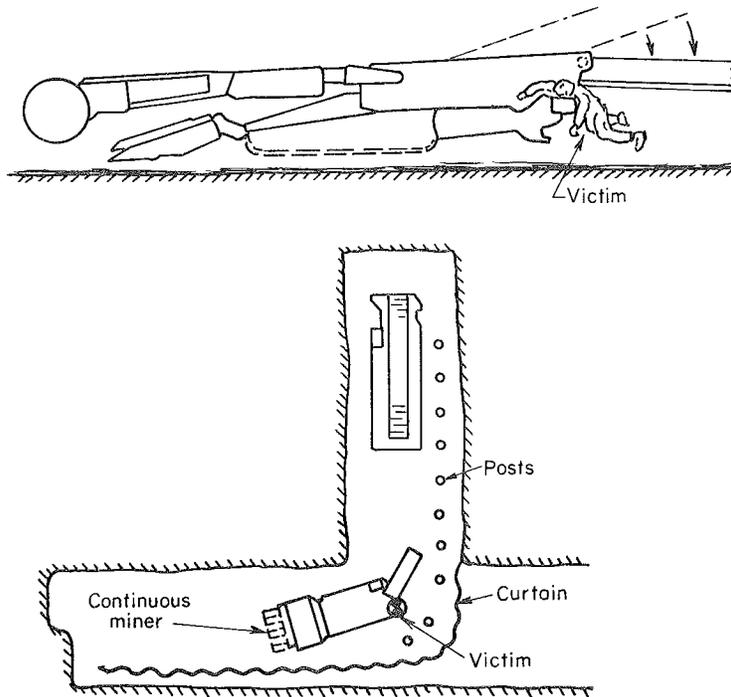
Figure 4 shows a mechanic crushed between the discharge conveyor and bumper of a continuous miner. He had a total of 20 years' mining experience, 1-1/2 months in his present job. While performing a routine task, the victim had

positioned himself in an unsafe position by attempting to repair a hydraulic hose fitting under the unblocked elevated discharge conveyor. Hydraulic pressure to the elevating jack of the discharge conveyor was lost while the victim was making these repairs. It was conjectured by the investigating committee that the victim, while attempting to tighten the hydraulic hose fitting, inadvertently disconnected the hose fitting which relieved the pressure from the hydraulic system and permitted the boom to fall.

CAUSE OF ACCIDENT: Hydraulic pressure to elevating jack or discharge conveyor was lost while victim was making repairs under unblocked discharge conveyor.

1. As specified in Section 75.1726(b), no work shall be performed under machinery or equipment that has been raised until such machinery or equipment has been securely blocked in position.

2. As specified in Section 75.1725(c), repairs or maintenance shall not be performed on machinery until the power is off and the machinery is blocked against motion, except where machinery motion is necessary to make adjustments.

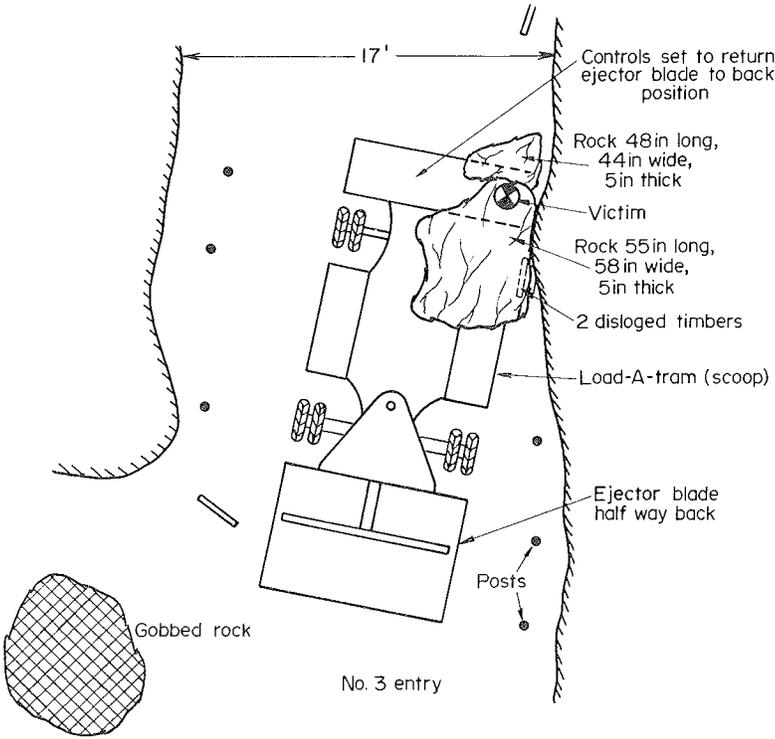
Figure 5 shows the accident scene involving a scoop operator who was crushed between the scoop and a fall of roof. He had a total of 33 years' mining experience of which 2-1/2 years were in his present job. He was assigned the tasks of loading, hauling, and dumping in a cleanup operation of an old entry. After unloading the bucket of material near the mouth of the crosscut, the victim placed the control lever for the ejector blade in the retracting position, and was apparently facing the bucket end of the scoop as he backed into and dislodged three props along the right rib of No. 3 entry. In doing so, the rock fell onto the victim.

TYPE OF ACCIDENT: Crushed between scoop and fall of roof.
 CAUSE OF ACCIDENT: Trimming scoop in reverse-dislodging props which caused roof rock to fall onto victim.

1. As specified in Section 75.1403-10(j), Subpart O, Title 30, Code of Federal Regulations, operators of self-propelled equipment should face in the direction of travel.
2. As specified in Section 75.1403-10(h), a total of at least 36 inches of unobstructed side clearance (both sides combined) should be provided for all rubber-tired haulage equipment where such equipment is used.

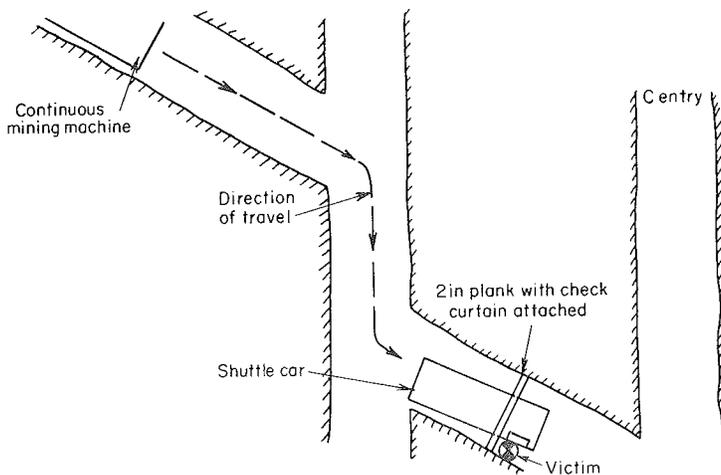
FIGURE 7. - Tramming self-propelled equipment through check curtains.

CAUSE OF ACCIDENT: Tramming through check curtain in a low clearance area. The victim was an incidental shuttle car operator.

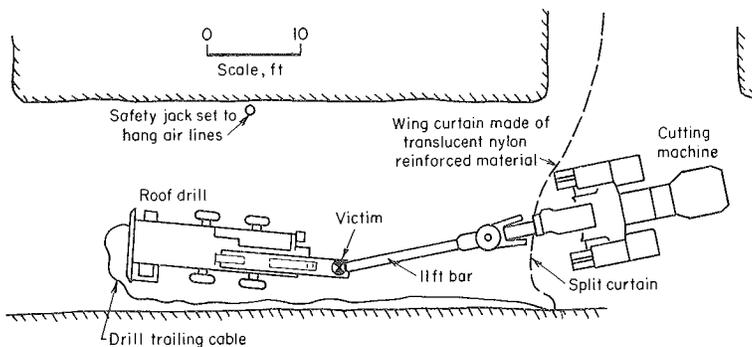
CAUSE OF ACCIDENT: Parking in proximity of check curtain. Passing through check curtain with bar leading.

4. To lessen the possibility of the check curtain snagging control levers and/or loose material on self-propelled face equipment, a minimum of three (3) vertical slits at each crossing point be maintained in each check-curtain installation.

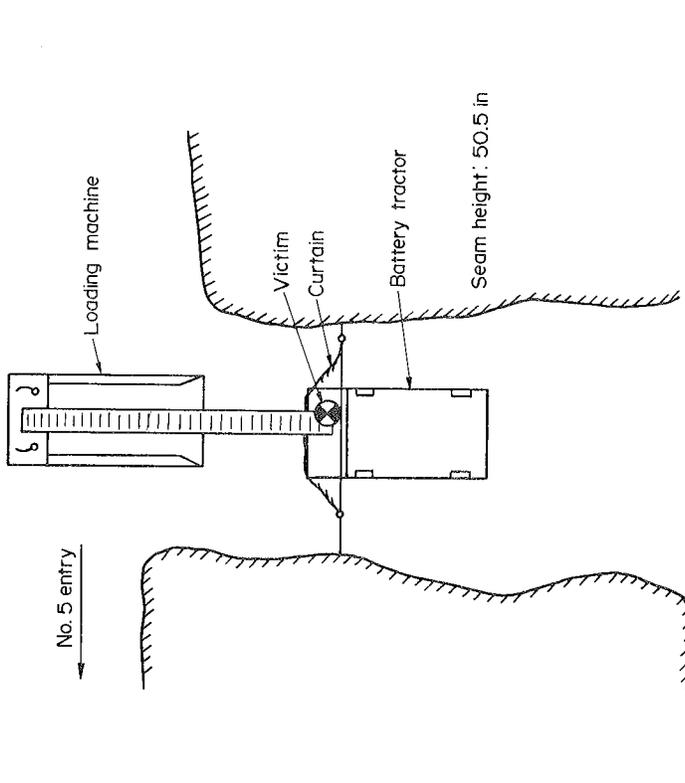
FIGURE 9. - Trimming self-propelled equipment through check curtains.

TYPE OF ACCIDENT: Crushed between the discharge conveyor of a parked loading machine and a battery-tractor he was operating.
 CAUSE OF ACCIDENT: Parking the loading machine adjacent to a check curtain and passing through same.

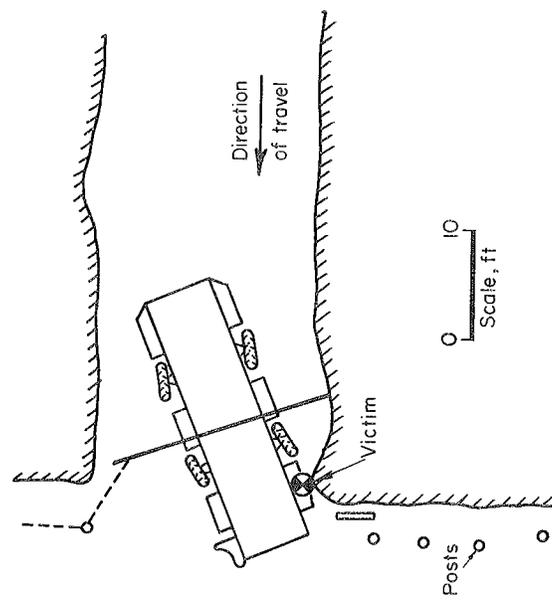
FIGURE 10. - Trimming self-propelled equipment through check curtains.

TYPE OF ACCIDENT: Crushed between shuttle car and coal rib.
 CAUSE OF ACCIDENT: Restriction at entrance to crosscut, improper installation of check curtain.

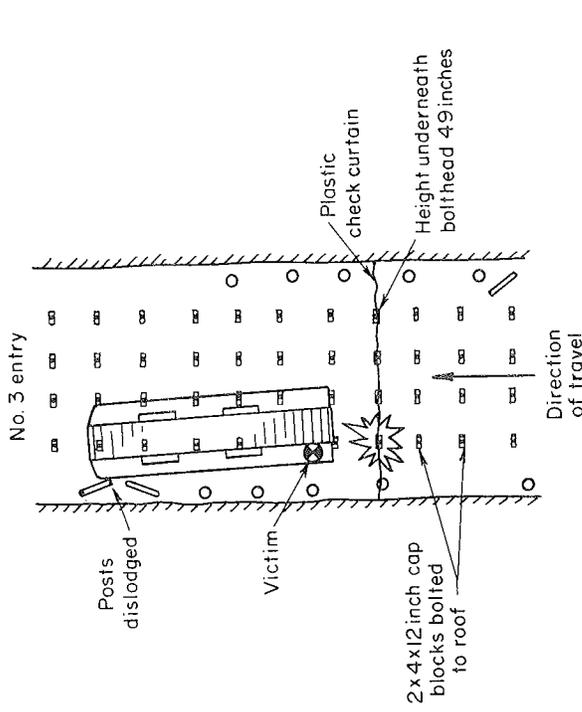
FIGURE 12. - Trimming self-propelled equipment through check curtains.

CAUSE OF ACCIDENT: Head clearance decreased by cap blocks obscured by check curtains.

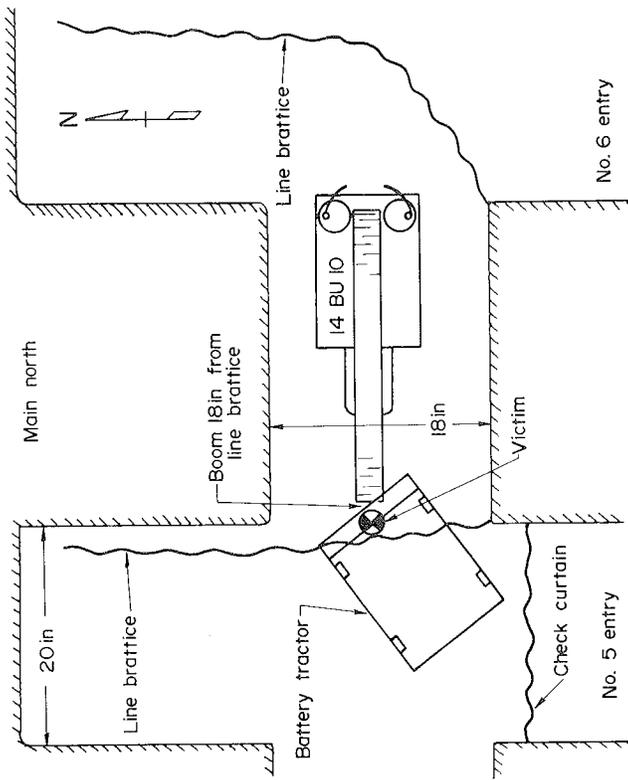
FIGURE 11. - Trimming self-propelled equipment through check curtains.

CAUSE OF ACCIDENT: Parking loading machine adjacent to check curtain.

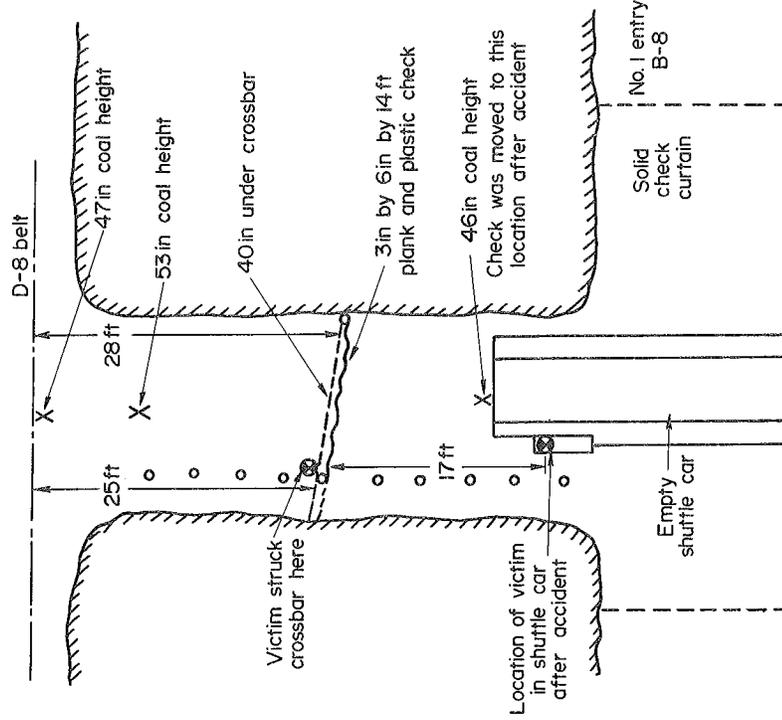
FIGURE 14. - Trammimg self-propelled equipment through check curtains.

TYPE OF ACCIDENT: Caught between crossbar bolted to roof and shuttle car he was operating.

CAUSE OF ACCIDENT: Head clearance decreased by crossbar obscured by check curtain.

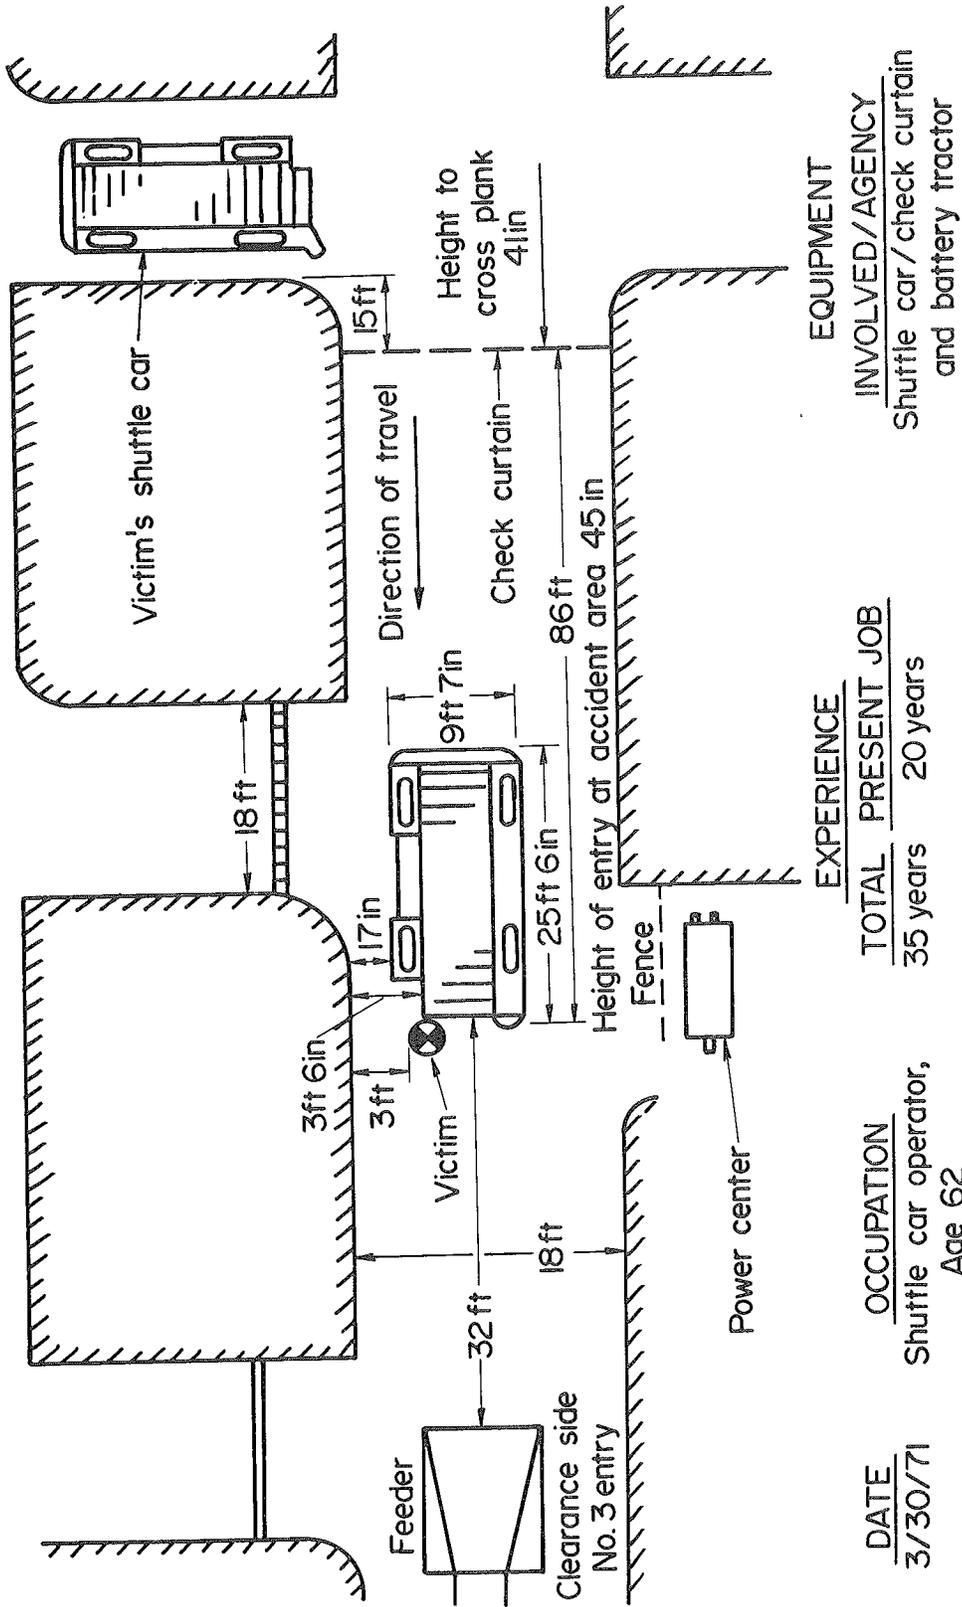
FIGURE 15. - Tramping self-propelled equipment through check curtains.

TYPE OF ACCIDENT: Victim was run over by a shuttle car in vicinity of check curtain.
 CAUSE OF ACCIDENT: Check curtain obstructing visibility of shuttle car operator - tramping through check curtain - location of victim while walking in entry.

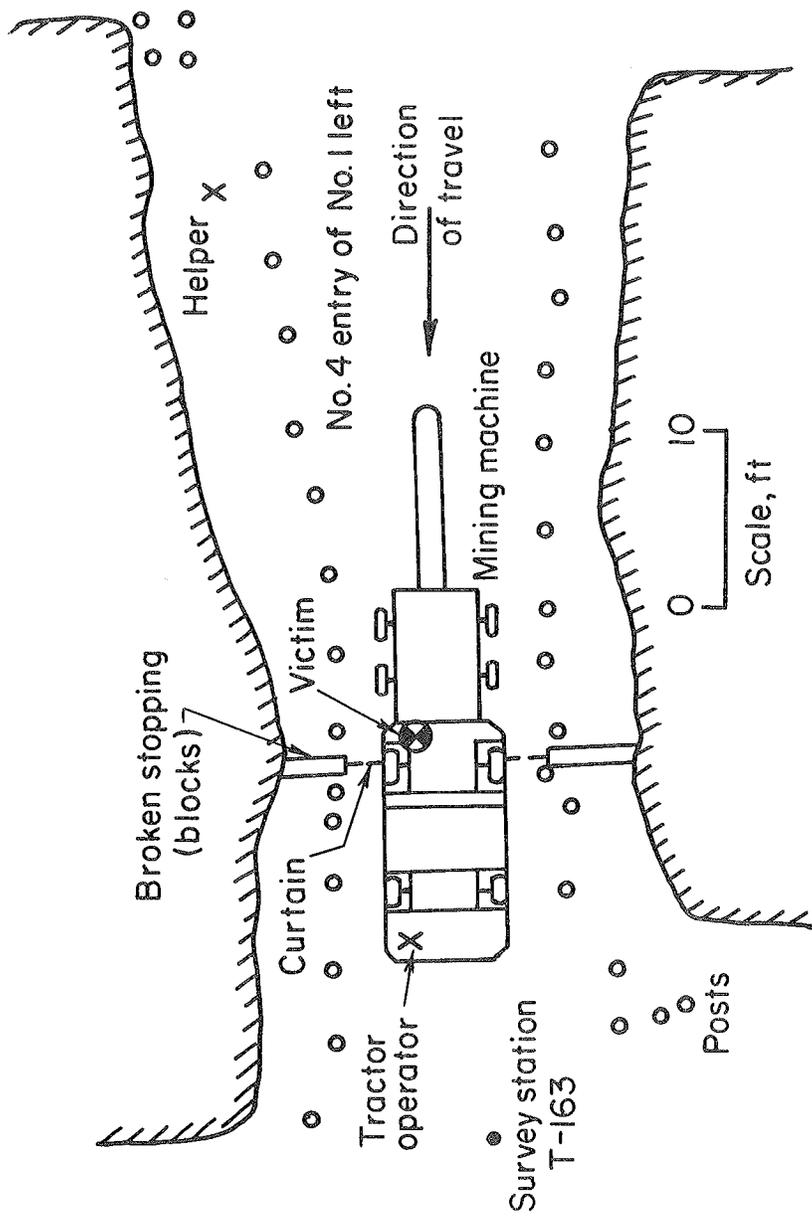
FIGURE 16. - Trimming self-propelled equipment through check curtains.

TYPE OF ACCIDENT :Crushed between tractor and cutting machine he was operating.
CAUSE OF ACCIDENT :Collision between two units of self-propelled equipment passing through check curtain.

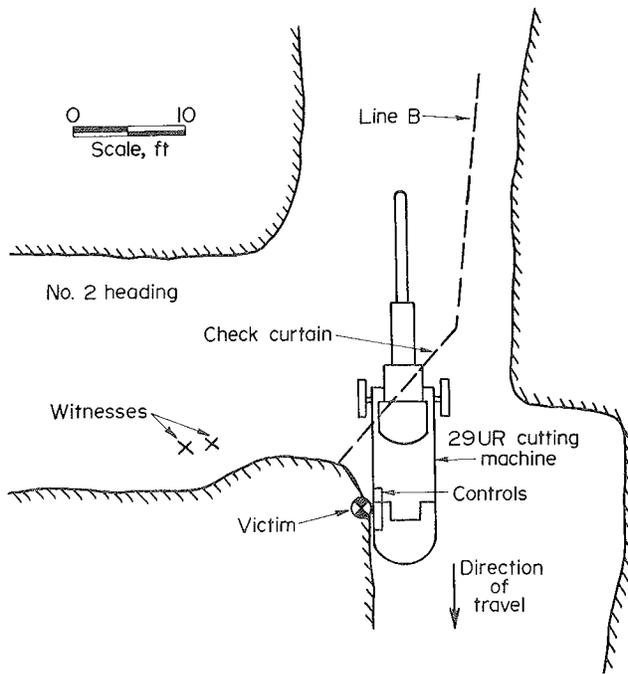
CAUSE OF ACCIDENT: Tramming cutting machine into coal rib through check curtain in "high tram".

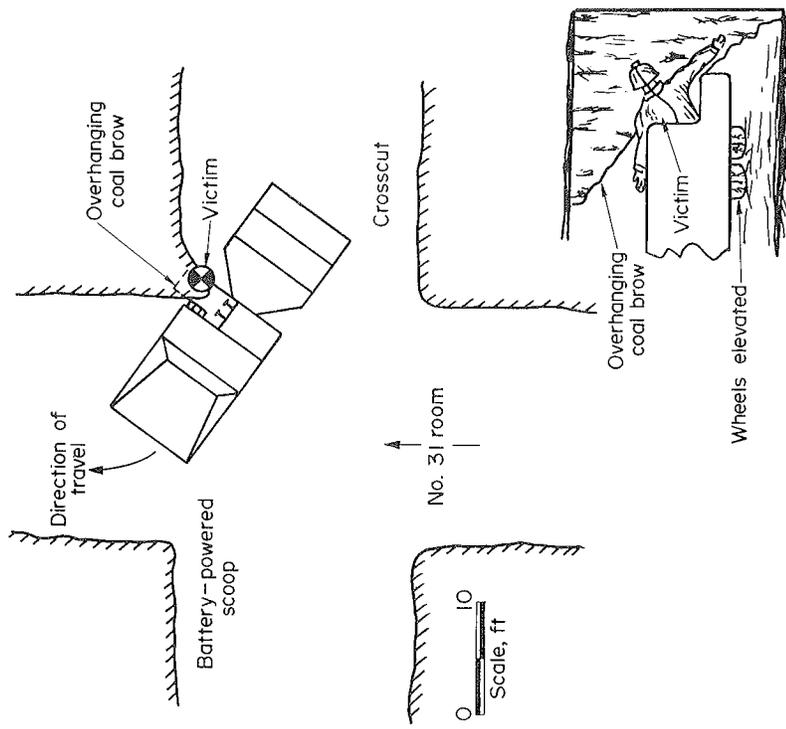
FIGURE 18. - Overhanging brows or rib rolls.

Figure 18 shows a fatal accident involving a scoop and an overhanging coal brow. The scoop operator (victim) had a total of 6 years' mining experience of which 3 years were in his present job. While in the act of tramming to the face, the victim was crushed between his scoop and the overhanging coal brow. The investigative report revealed substandard conditions existed in the immediate working face area. Specifically, it was noted that poor mining practices prevailed in the face cycle of cutting, drilling, blasting, and loading.

TYPE OF ACCIDENT: Crushed between the frame of the scoop and overhanging brow.

CAUSE OF ACCIDENT: Trimming into overhanging brow.

1. All coal miners must be trained and instructed in the proper methods of testing roof, face, and ribs. Face workers and other employees whose work exposes them to hazards or falls of roof and coal shall thoroughly test the roof, face, and ribs, before starting to work or before starting a machine, and frequently thereafter.

- c. Cutting width of the working face cut shall not exceed 12 inches to either side of the rib drill holes.
3. In the event an overhanging face or rib brow is produced by poor mining practices, the unsafe condition shall be corrected by "squaring up" the face or rib. This may be done by pick scaling, bar wedging, or trimming with the cutter bar.

4. Advancement for the next face cut shall not be permitted until the unsafe conditions of overhanging face or rib brows have been corrected.
5. Roof area exposed by the removal of the face or rib overhang shall be supported according to the requirements of each mine-roof support plan.

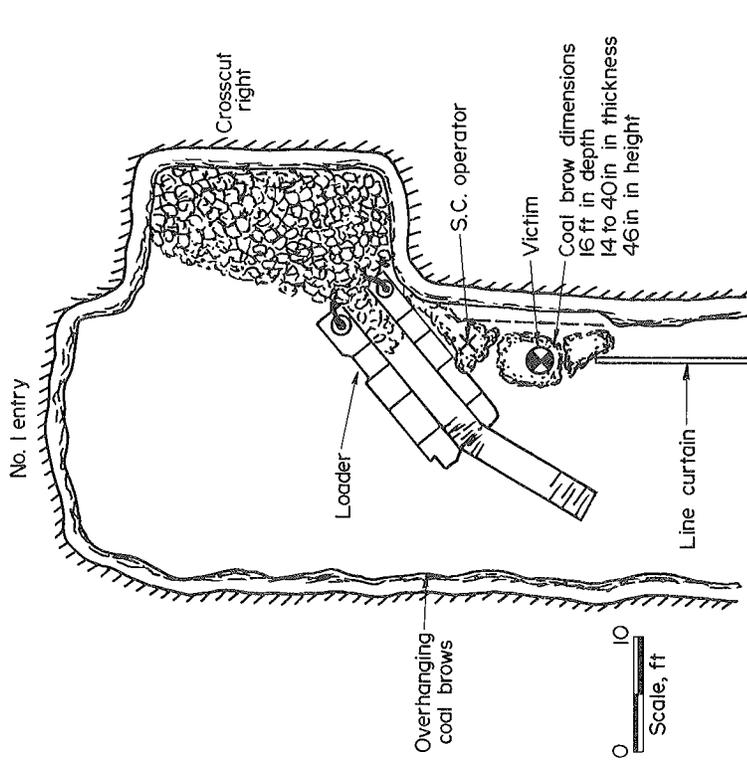
Figure 19 shows a rib coal brow which separated from the rib and rolled onto the loader operator (victim) who was standing beside the loader giving instructions to his shuttle car operator, who was learning to operate the loader. A loader operator instructing his helper is a common practice throughout the mining industry and technically had little or nothing to do with contributing to the cause of this accident. However, figure 19 shows that the selection of the crosscut for giving instructions was somewhat precarious. Other learning-type accidents have resulted in the operator or his helper getting pinned between the loader and rib or crushed between the discharge conveyor and rib.

Again this investigative report revealed substandard practices in the face preparation of coal which contributed to the cause of this accident. The side or width limits of the machine cuts were not compatible with the drill holes for blasting. The machine undercuts ranged from 36 to 66 inches outside the drill holes, a very unacceptable coal-mining practice.

TYPE OF ACCIDENT: Coal brow rolled onto loader operator instructor.

CAUSE OF ACCIDENT: Coal brow conditions created by unsatisfactory coal preparation techniques. The side limits of the machine cuts were not compatible to the drill hole for blasting. The machine undercuts ranged from 36 to 66 inches outby the blast holes.

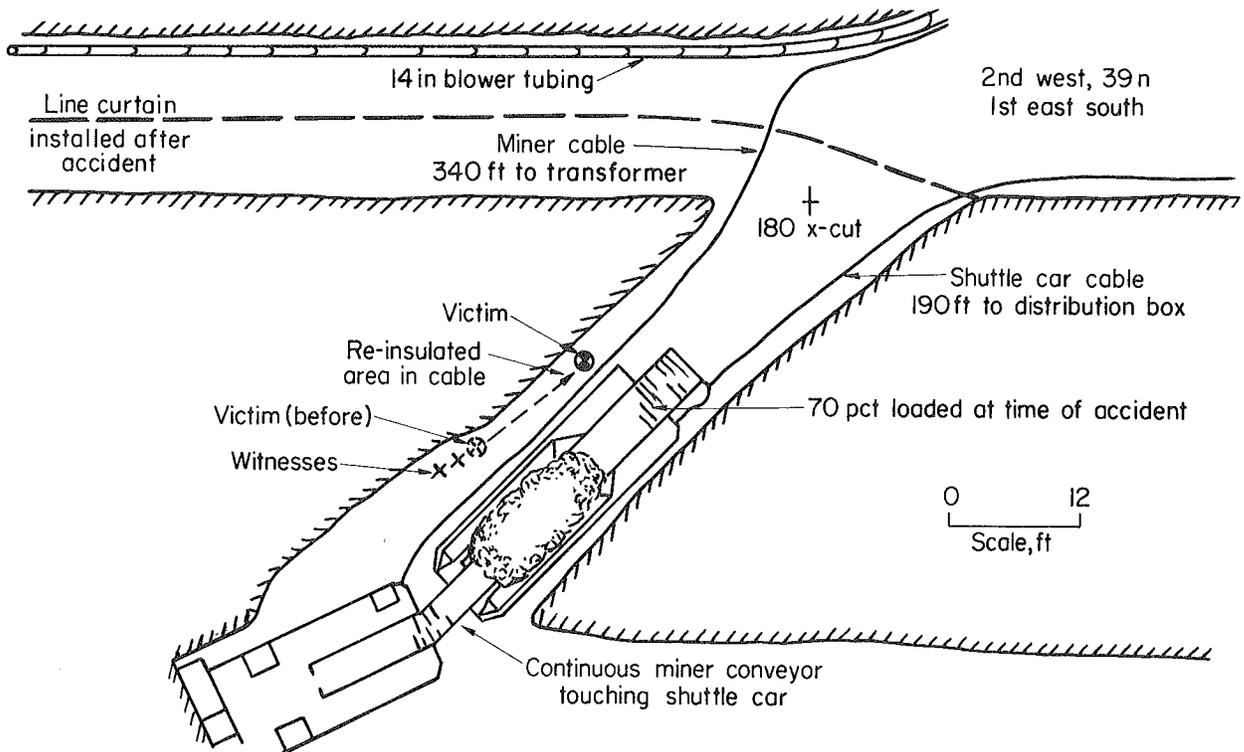
Figure 20 shows how a continuous miner operator was electrocuted while attempting to shut the conveyor motor off on a shuttle car. The victim had a total of 3 years' mining experience including 9 months in his present job. According to the investigative report a shuttle car in operation for over 2 hours was almost loaded when the circuit breaker opened at the load center after which the shuttle car operator went to reset the breaker. It was evident that he had left the electrical control for the chain conveyor in the "on" position because as soon as the circuit breaker was reset, the chain conveyor started to spill coal onto the bottom. Seeing this, he rushed to shut the chain-conveyor motor off on the shuttle car coming in contact with the energized frame of the shuttle car thereby sustaining the fatal electrical shock.

The investigative report also pointed out that the trailing cable of the shuttle car had strands of phase and ground wires making intermittent contact

CAUSE OF ACCIDENT: Victim contacted energized frame of shuttle car. Trailing cable had strands of phase and ground wires making intermittent contact.

at a damaged spot and that the previous shift had similar electrical trouble with the shuttle car.

1. All electrical equipment not functioning in a safe manner shall be placed out of service until corrected according to Section 75.512.
2. All equipment operators prior to leaving the operator's position shall deenergize the equipment and make certain that the brakes are set and all control levers are in the neutral or off position.
3. Trailing cables shall be inspected prior to each production shift for bare conductors, cuts, abrasions, defective splices and more than one temporary splice.
4. Protective gloves shall be worn when handling trailing cables.

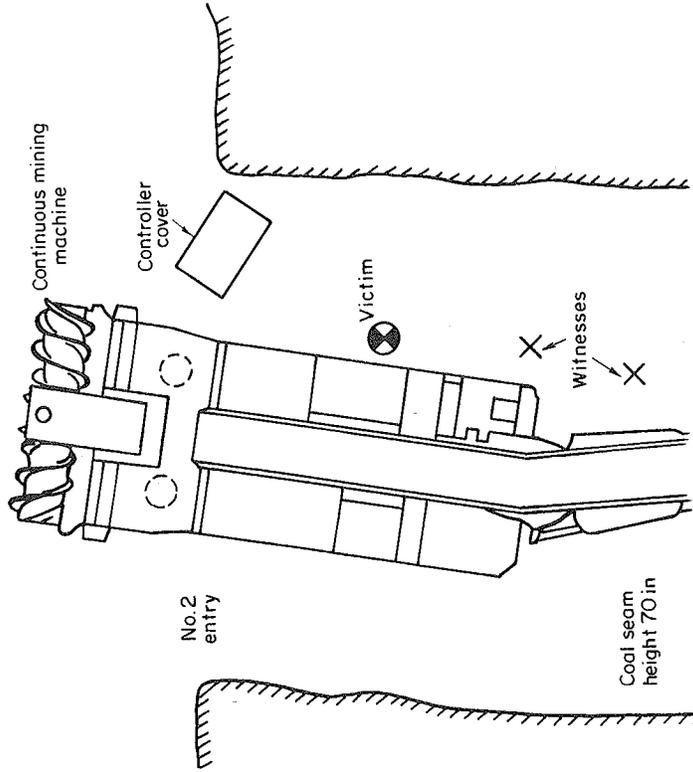
FIGURE 22. - Electrical shock.

Figure 22 shows how a qualified electrician (age 38, with 11 years' mining experience) was electrocuted when he came in direct contact with energized circuitry on a continuous miner. The continuous miner was down for electrical repairs and the victim was in the process of troubleshooting when the accident occurred. In brief, in the final stage of the troubleshooting, the victim

TYPE OF ACCIDENT: Electrical shock
 CAUSE OF ACCIDENT: Direct contact with energized circuitry on a continuous miner, victim was trouble shooting when the accident occurred.

with the main control-panel cover removed was ground-fault checking with a voltohmmeter when he contacted energized wires. The voltohmmeter was found on the continuous-mining machine in the ohms (RX1) position indicating that the victim may have been attempting to localize a ground-fault or a short-circuit with the machine energized. There were three witnesses to the accident, the section forman and two roof bolters.

5. All electrical-powered equipment shall be deenergized and locked out when making electrical repairs to the machine, except when testing or troubleshooting procedures require that the equipment be energized.

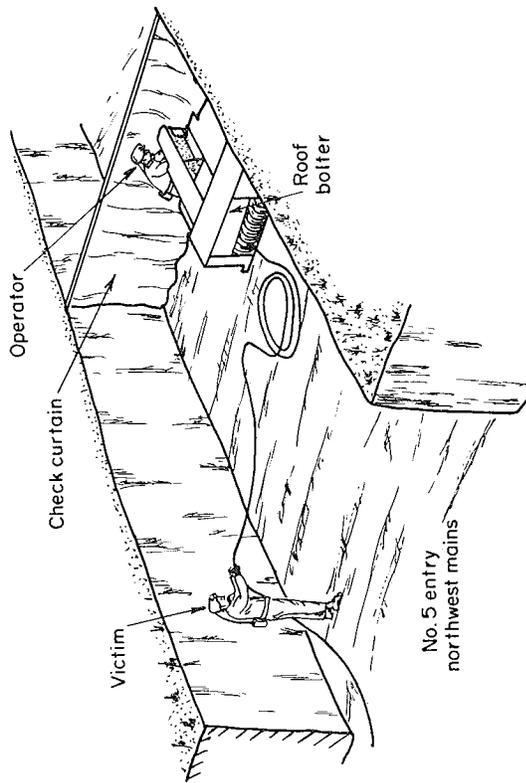
In brief, the foreman was pulling up cable slack to assist a roof-bolting machine operator in tramming his machine out of a working place. Pulling cable with unprotected hands is a common occurrence and this resulting accident is a typical example of an unsafe act catching up with its performer.

TYPE OF ACCIDENT: Electrical shock
 CAUSE OF ACCIDENT: Hands came in contact with a bared spot in the trailing cable. Victim was assisting roof bolter in tramping out of the working face.

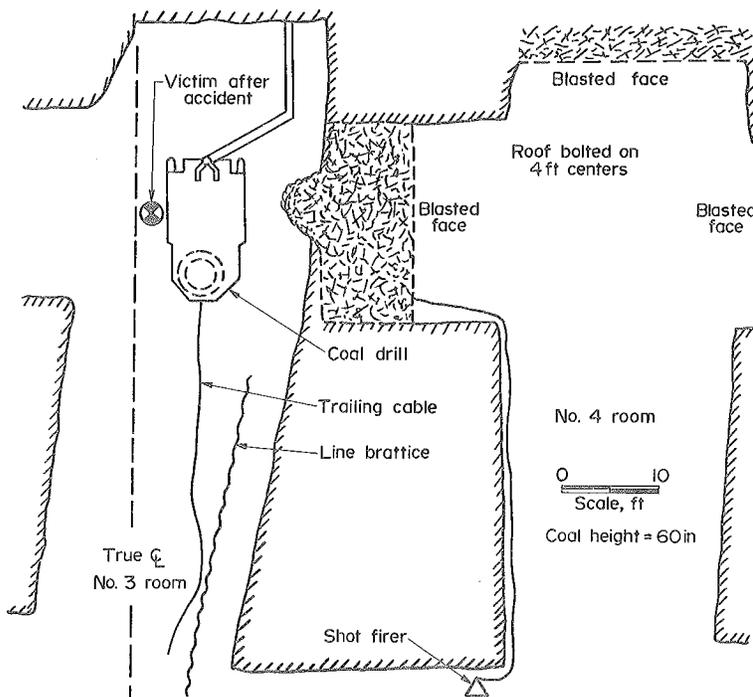
Figure 23 shows how a coal drill operator (victim) received a fatal blast of coal rib while drilling in an entry adjacent to a blasting operation in a crosscut. The victim, age 48, had 26 years' mining experience, the last 2 years as a coal drill operator. The working section was mined with conventional coal-mining equipment. To be properly mined the coal required undercutting, drilling, and blasting

TYPE OF ACCIDENT: Rib blast. Unsafe position of victim.
 CAUSE OF ACCIDENT: Victim received a fatal blast of coal rib while drilling in entry adjacent to blasting operation in crosscut.

prior to being loaded mechanically. As shown in the sketch, several unsafe conditions and/or unsafe mining practices were in evidence which contributed to the cause of this accident. Specifically--

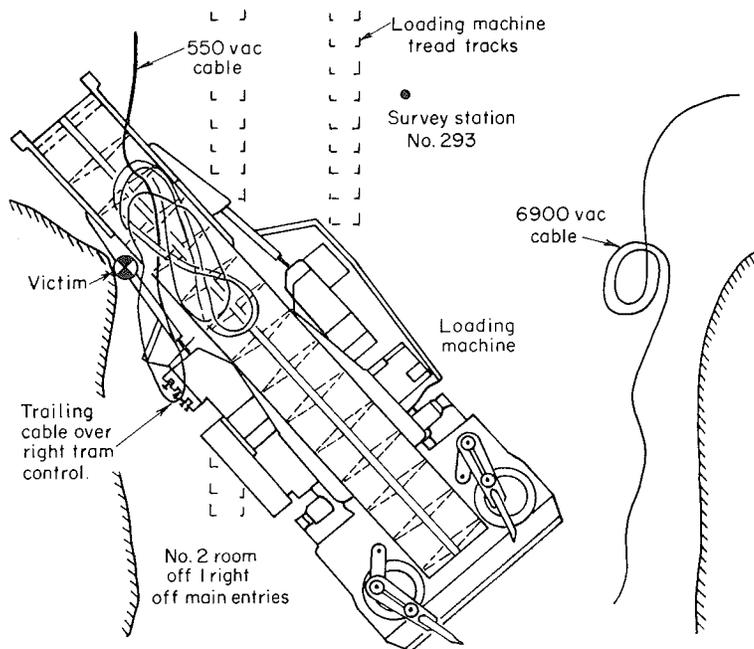
Figure 24 shows how a roof bolter (age 34, with 7-1/2 years' mining experience) was struck by and caught between a loader-

discharge conveyor and rib. The victim was an extra loading machine operator who was in the process of tramming when he was cautioned to stop for lack of cable slack. Heeding the warning, the operator stopped tramming and with the loading machine energized proceeded to remove extra cable from the discharge conveyor. In doing this, the trailing cable snagged a tram lever causing the machine to move toward the rib.

TYPE OF ACCIDENT: Caught between discharge conveyor and rib.
 CAUSE OF ACCIDENT: Victim, an extra operator, while pulling stacked trailing cable off energized loading machine activated the tram lever with the snagged trailing cable causing the machine to move toward the rib.

1. All equipment operators prior to leaving the operator's position shall deenergize the equipment and make certain that the brakes are set and all control levers are in the neutral or off position.

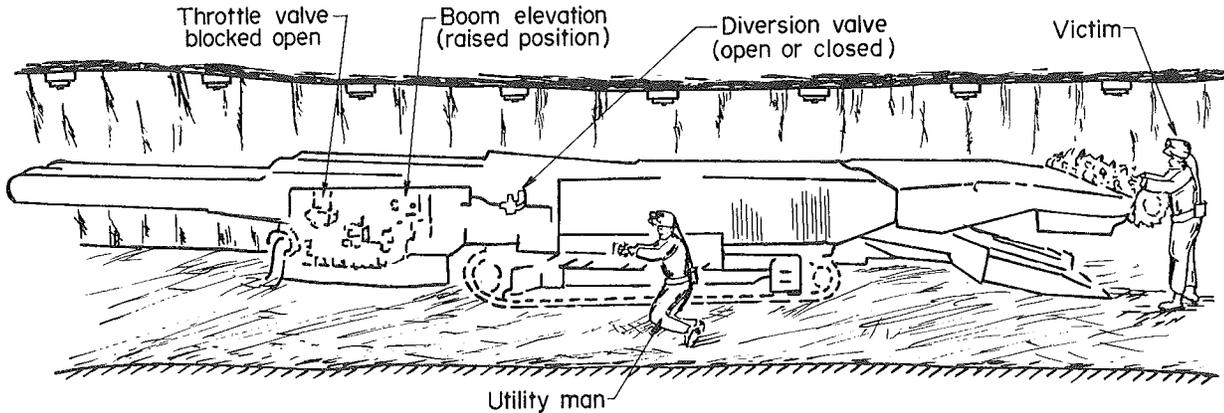
FIGURE 25. - Changing bits on energized equipment.

TYPE OF ACCIDENT: Crushed between the ripper head of the continuous miner and the mine roof.
 CAUSE OF ACCIDENT: Changing bits on energized continuous miner. Utility man was lubricating CM utilizing integral hydraulic pumping system when the hydraulic pressure to the elevating jacks of the ripper head became activated.

1. Prior to changing bits the machine shall be deenergized according to the provisions of Section 75.1725(c).

2. All persons must be in the clear and in a safe zone prior to the starting of any machinery.

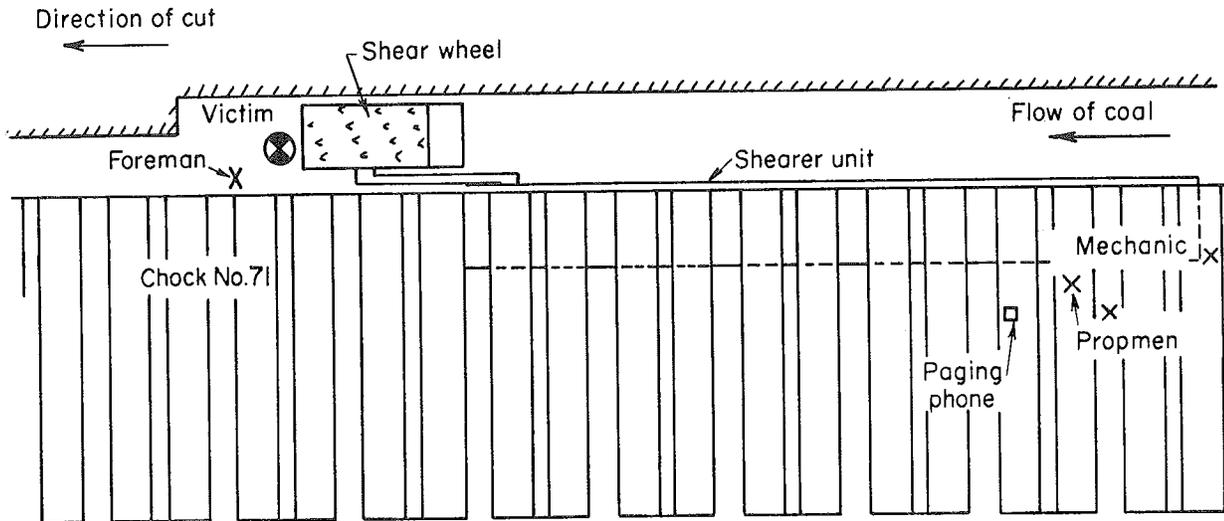
FIGURE 26. - Changing bits on energized equipment.

TYPE OF ACCIDENT: Crushed by shearer wheel
 CAUSE OF ACCIDENT: Changing bits with the shearer energized. The shearing machine was inadvertently energized by another crew member.

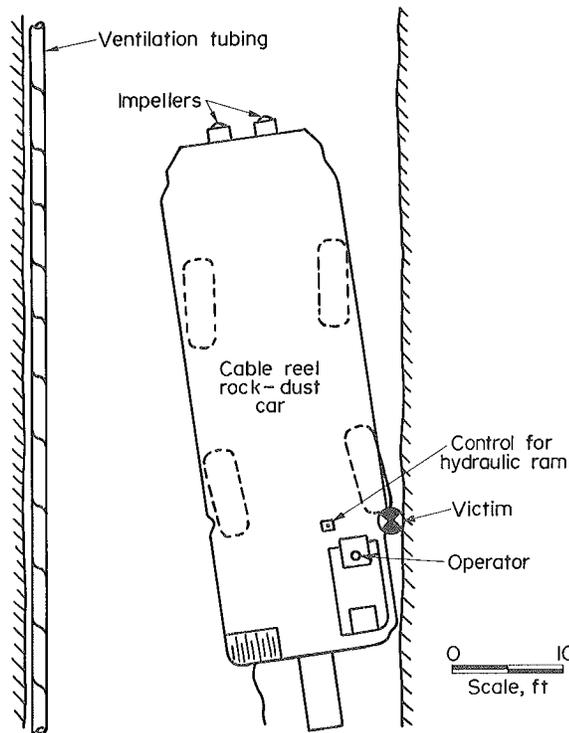
FIGURE 27. - Unsafe position near moving equipment.

In figure 27 we see how a section foreman (age 45, with a total of 26 years' mining experience) was caught between a self-propelled rock-dust car and rib. The victim was in the process of giving a roof bolter specific instructions in rock dusting when the accident occurred. Specifically, the roof bolter had just completed roof bolting the face of No. 4 entry when he was instructed to switch out the roof-bolting machine and to get the rock-dust car to rock dust the No. 4 entry. The roof bolter parked the roof-bolting machine and returned to the face of No. 4 entry with the rock-dust car. The foreman (victim) from his position between the rock-dust car and rib instructed the roof bolter to start the car and rock-dust distributor and

CAUSE OF ACCIDENT: Trimming rock-dust car before the section foreman could get in the clear.

1. Operators of self-propelled mobile equipment shall not tram such equipment until all persons in close proximity are in a safe location. An alarm shall be sounded before tramping.
2. It is recommended that panic bars be installed on all self-propelled mobile equipment.
