MINE SAFETY AND HEALTH ADMINISTRATION

ANALYSIS OF FAILURE TO BLOCK OR SECURE
MINING EQUIPMENT IN A RAISED POSITION,
COAL MINING 1973-1980

Harvey Padgett
Mine Safety Specialist^{1/}

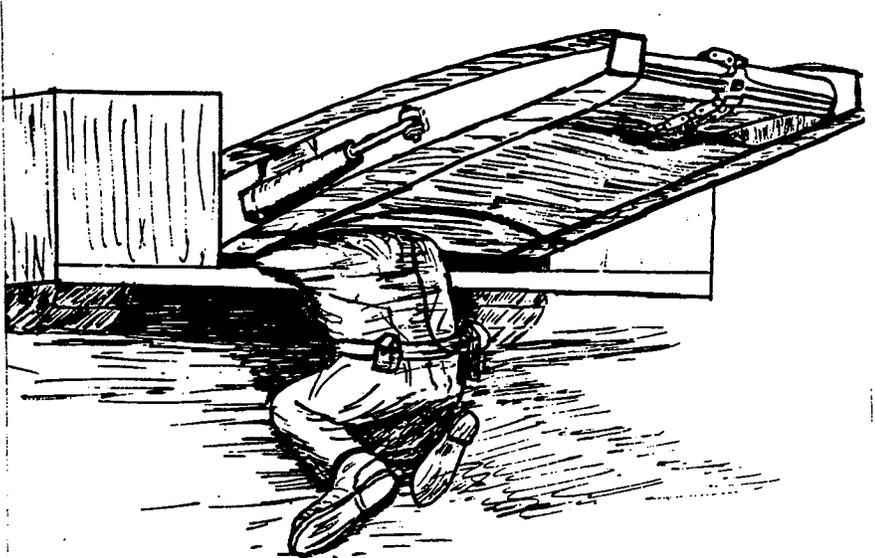
January 29, 1973

While repairing a hydraulic leak on a continuous mining machine, a mechanic positioned himself between the raised unblocked conveyor tail boom and the bumper. The hose ruptured, permitting the boom to fall, crushing the victim.
(underground)

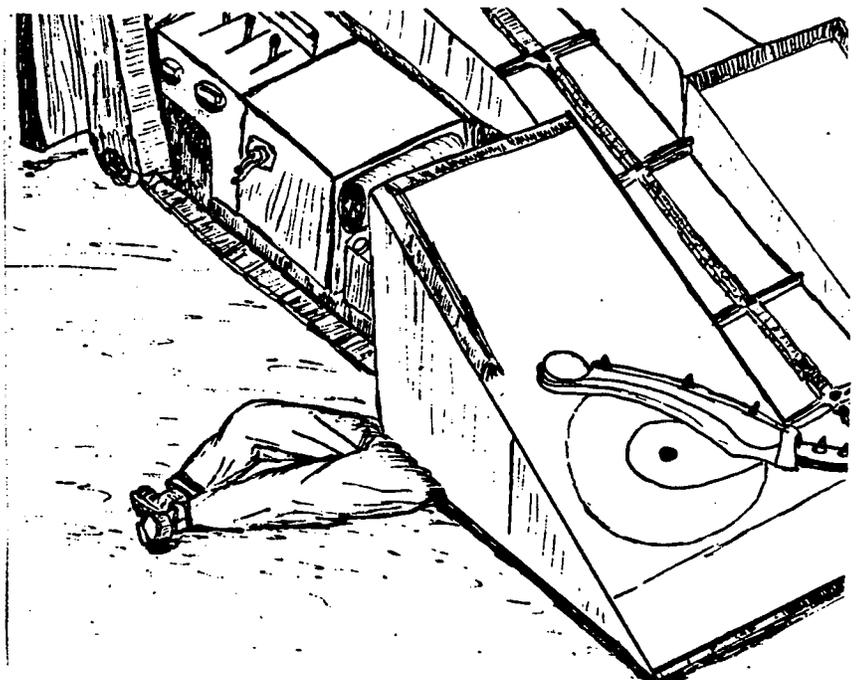
November 30, 1973

An employee positioned himself under a raised unblocked head of a loading machine to remove the drain plug in a loading arm pot. Another employee accidentally hit the loader head control lever causing the head to fall, crushing the victim.
(underground)

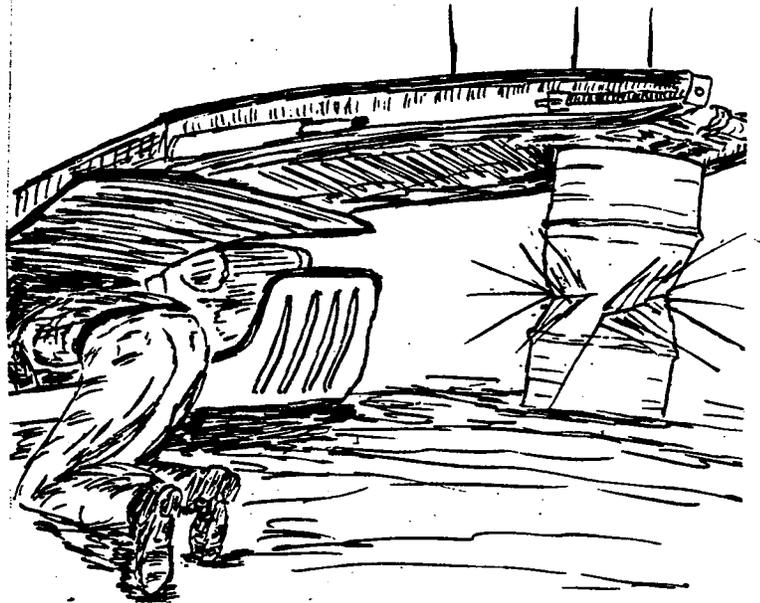
September 24, 1974

An employee positioned himself between a raised conveyor boom and the bumper of a loading machine to repair the hydraulic system. The boom was improperly blocked with a 55-gallon drum. The boom fell, crushing the drum and the victim. (underground)

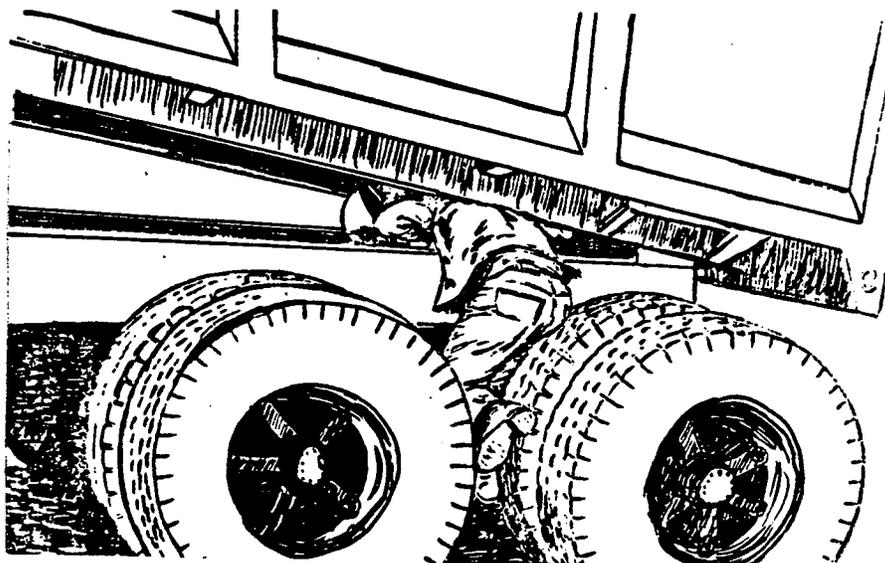
April 20, 1976

A truckdriver positioned himself between the raised unblocked truck bed and the frame to repair the universal joint between the tandem axles. The bed fell, crushing the victim. (surface)

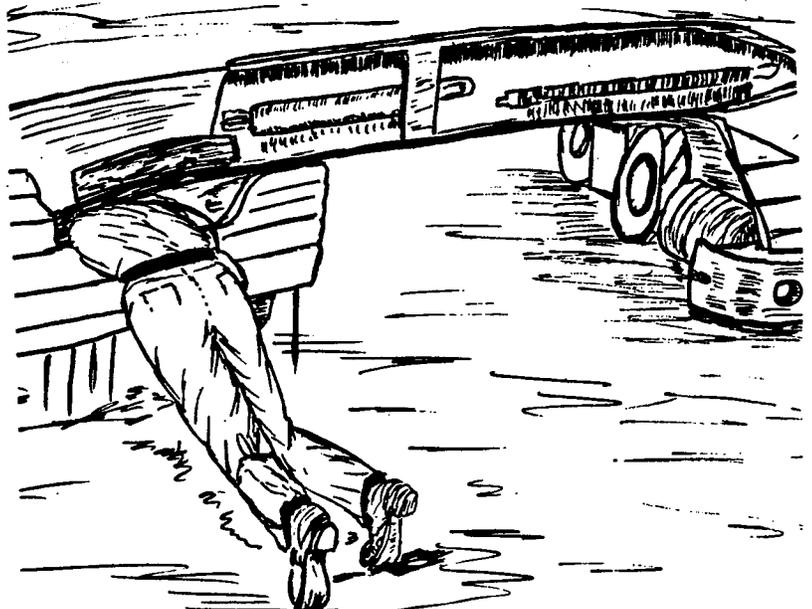
April 8, 1977

After blocking the loading machine conveyor boom on the side of a shuttle car, a repairman positioned himself between the boom and the bumper to repair a hydraulic fitting. The fitting broke, releasing the boom pressure; causing the bumper to come up, crushing the victim into the boom. (underground)

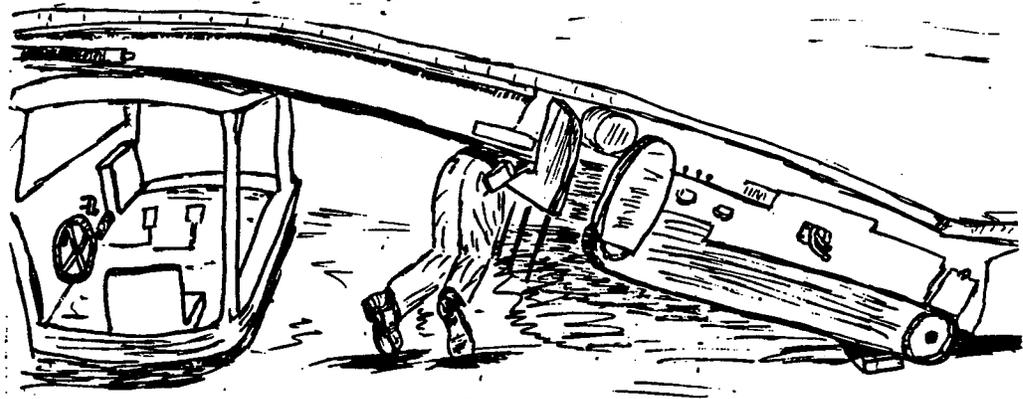
August 30, 1977

A loading machine was elevated on wooden blocks with the conveyor boom resting on another machine. A repairman was working between the boom and the bumper when the hydraulic pressure to the boom jacks was released. The rear frame moved upwards, crushing the victim. (underground)

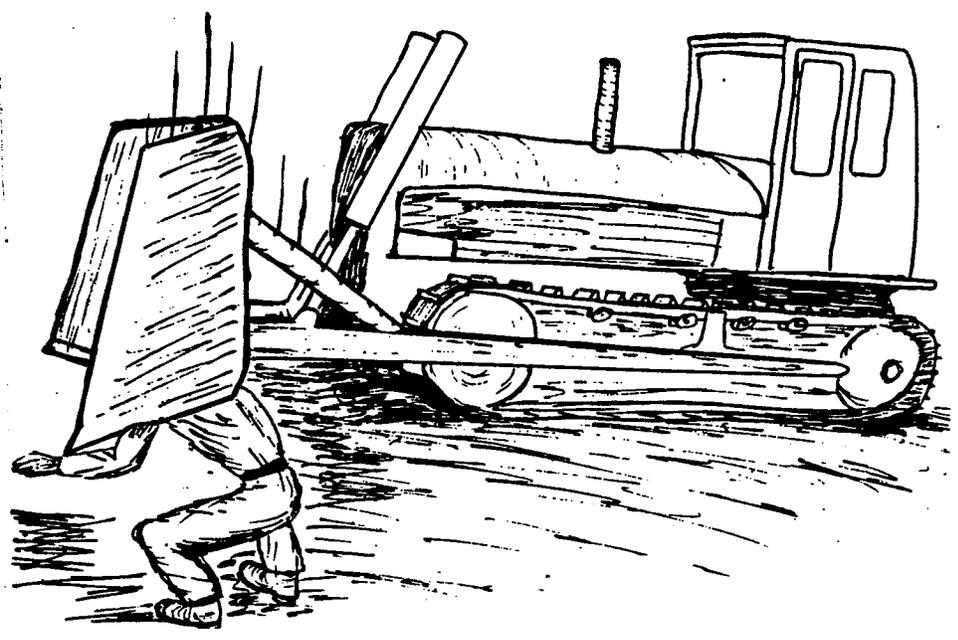
May 22, 1978

A mechanic positioned himself under a raised unblocked dozer blade to tighten the corner bit bolts on the blade. The dozer operator inadvertently hit the dozer blade control, causing the blade to fall, crushing the victim. (surface)

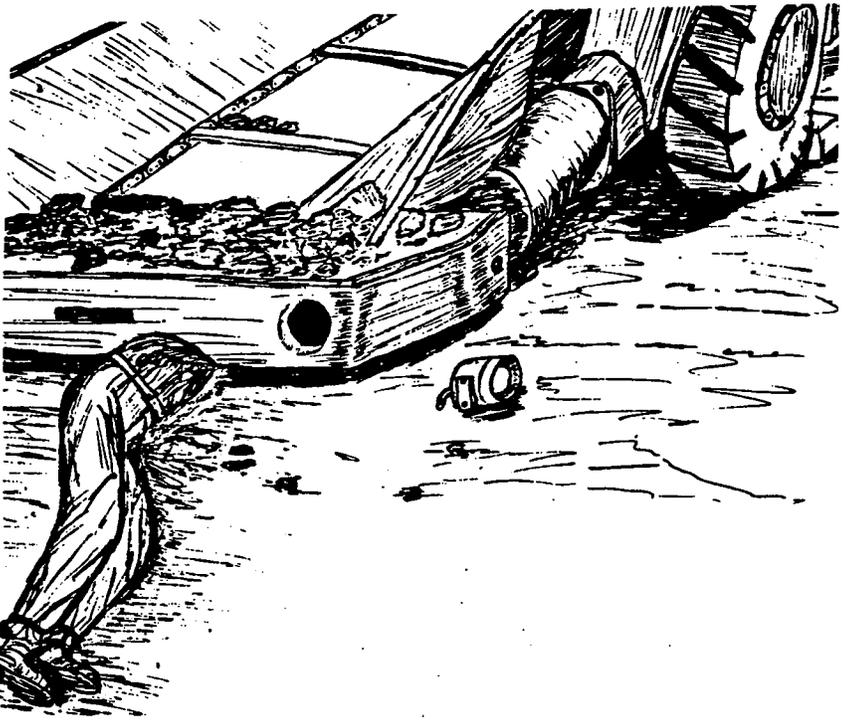
August 16, 1978

While under a raised continuous miner cutting head, a mechanic trainee was attempting to insert a cutting jack hinge pin when the material used to block the head dislodged. The cutting head fell, crushing the victim. (underground)

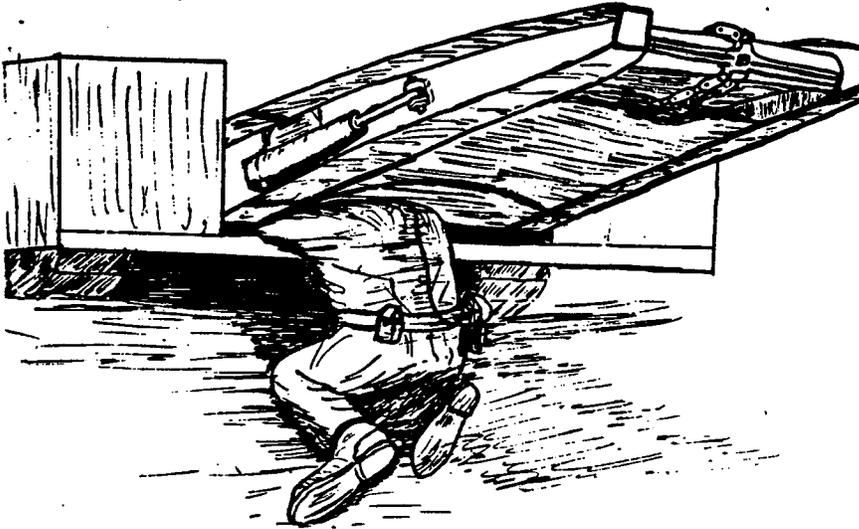
July 23, 1979

A repairman positioned himself under a raised continuous mining machine cutting head that was blocked with two vertical posts. The blocking material dislodged, causing the head to fall, crushing the victim. (underground)

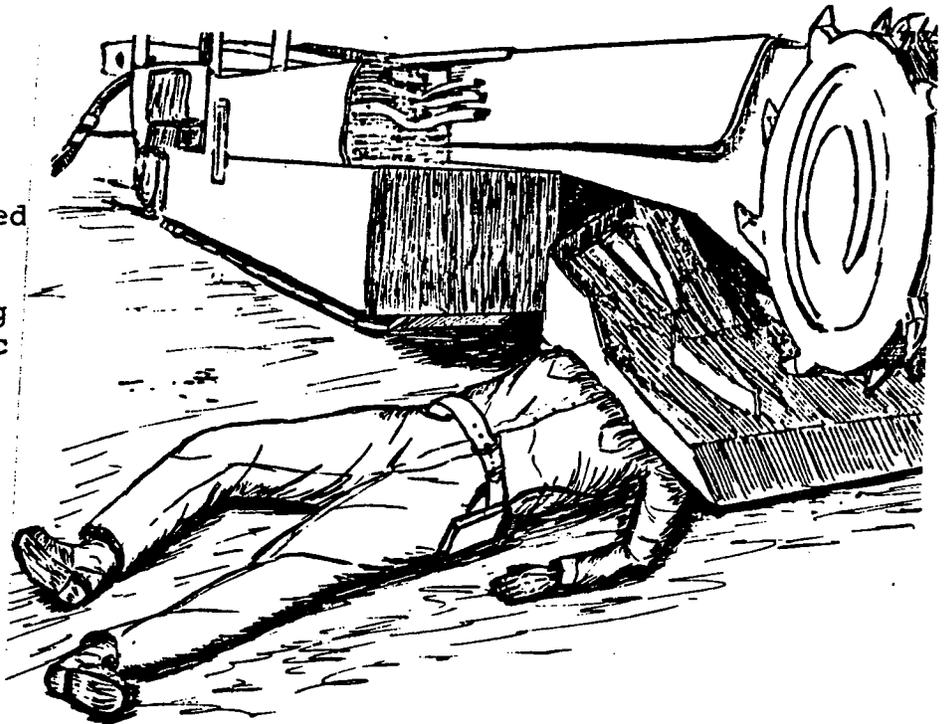
February 7, 1980

An electrician positioned himself under a raised unblocked continuous mining machine gathering head while the hydraulic system was being operated to keep the head elevated. A relief valve in the system opened, permitting the gathering head to fall, crushing the victim. (underground)

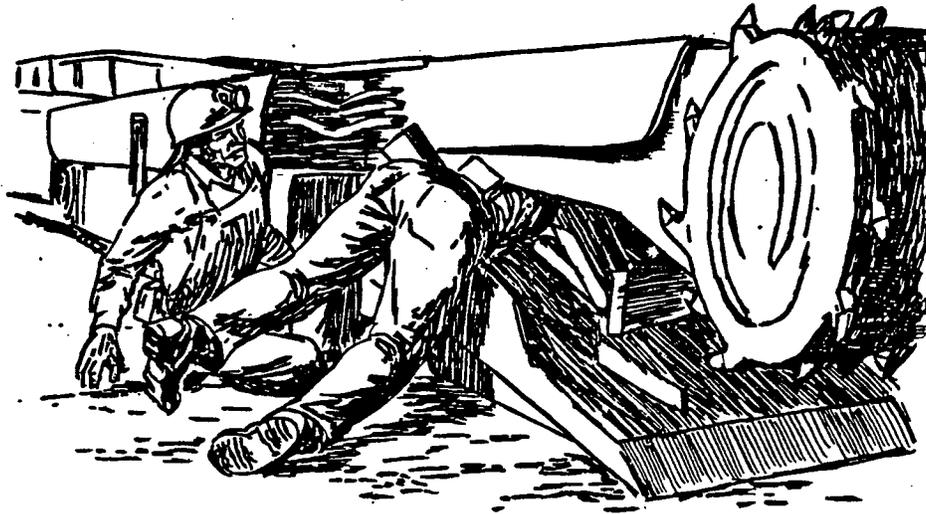
March 17, 1980

A maintenance foreman, looking for a hydraulic oil leak, positioned himself under a raised, unblocked continuous mining machine cutting head. Another employee uncoupled a hydraulic hose to the head, causing the head to fall, crushing the victim. (underground)

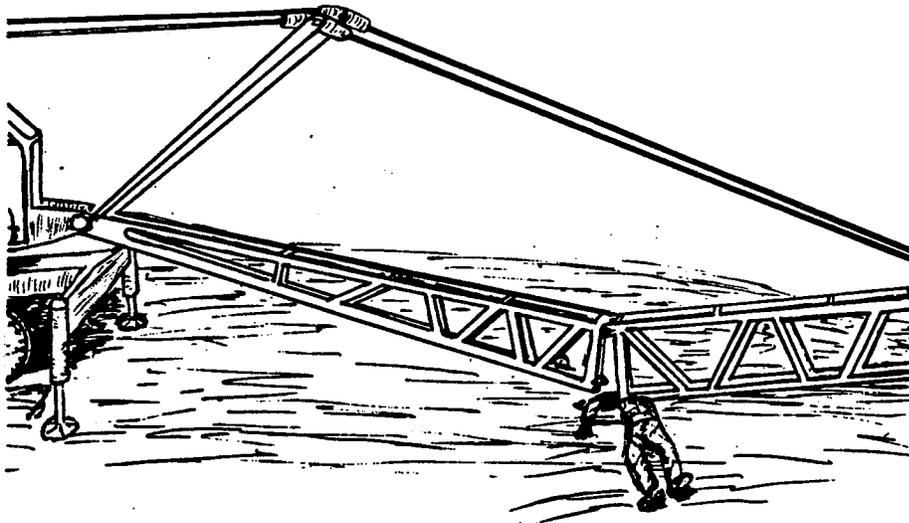
September 19, 1980

A welder crawled under a suspended, unblocked crane boom to remove the second lower hinge pin so the boom could be lengthened. The pin came out, permitting the sections to part, crushing the victim under the boom. (surface)
