Near Miss

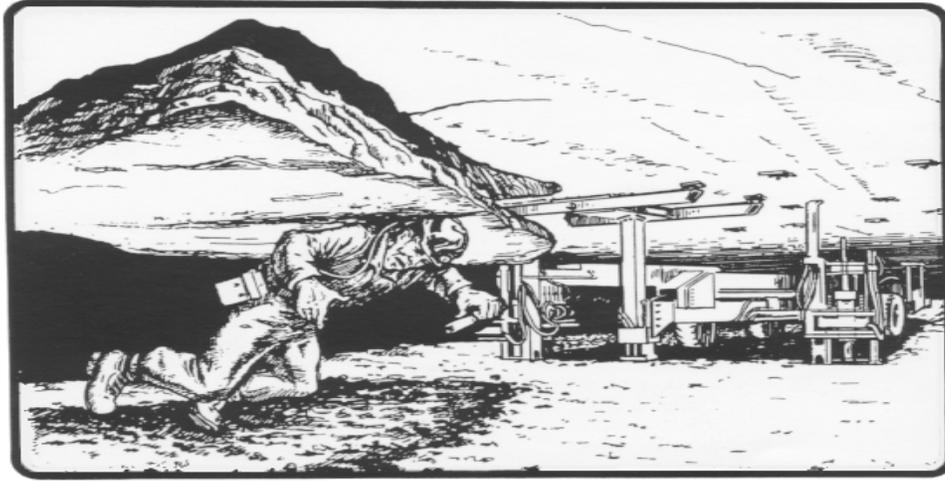
October 5, 2011 a miner was seriously injured while attempting to bolt the first cut of a right crosscut. The roof bolting machine was brought through the last open crosscut after bolting the right cut through from No. 5 to No. 6 entry. The Fletcher double head bolter was positioned with the ATRS toward the outby corner preparing to install the corner bolts. The ATRS was placed under an overhanging brow on the corner shear, and was not in solid contact with the mine roof when the accident occurred. The right side operator was preparing to install the first corner bolt when draw rock from the unsupported cut fell without warning, striking the left side operator.

- Never work or travel under unsupported roof
- Conduct a thorough visual examination of the roof, face, and ribs immediately before any work or travel is begun, and thereafter as conditions warrant
- When a visual examination does not disclose a hazard, sound and vibration roof tests shall be conducted
- Know and follow the approved roof control plan
- Be alert to changing roof conditions
- Make sure you are positioned in a safe location at all times
