REPORT OF INVESTIGATION

Fatal Powered Haulage Accident  
July 21, 2011

P&H Mine Pro Services, Inc (P001)  
Gillette, WY

Navajo Mine  
BHP Navajo Coal Company  
Fruitland, San Juan County, New Mexico  
MSHA I.D. No. 29-00097

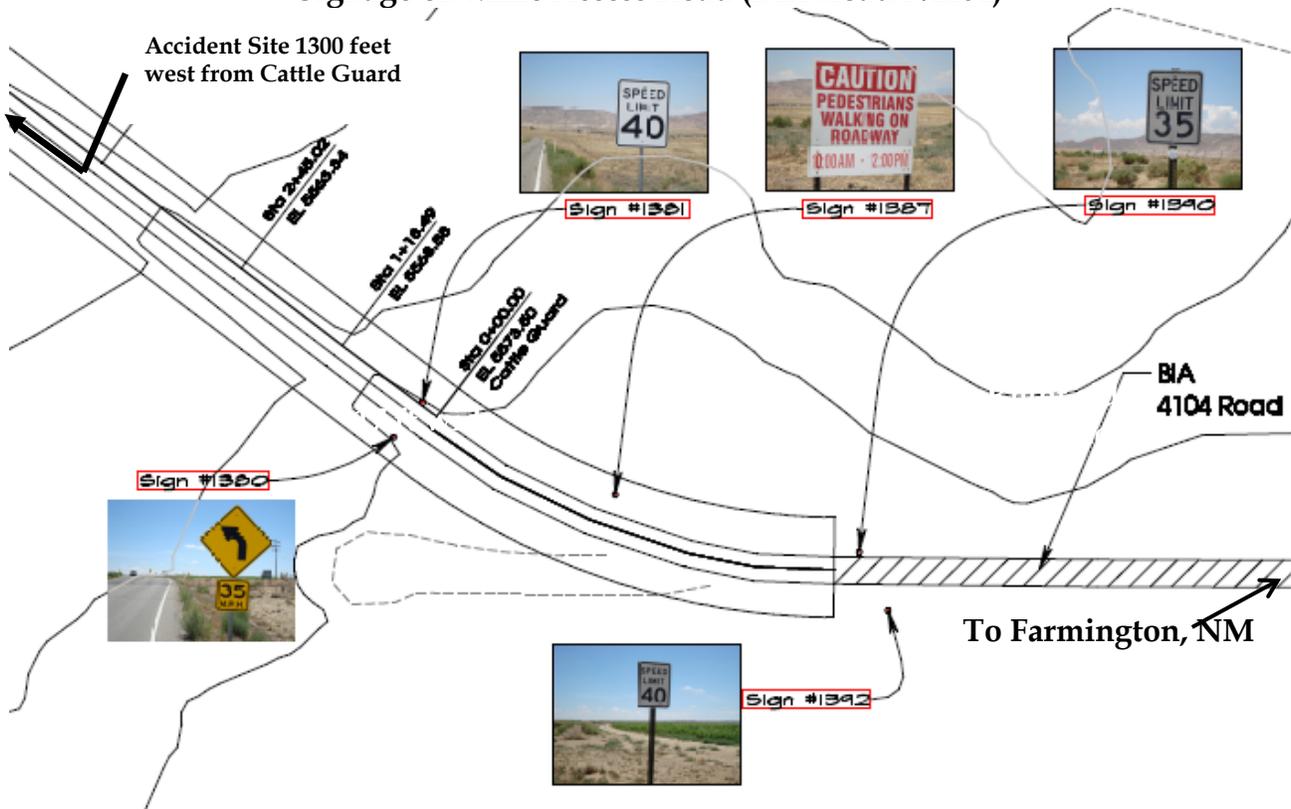
## Appendix D Signage on Mine Access Road (BIA Road N4104)

The speed limit on this section of the roadway was posted as 40 mph. Signage included a 35 mph speed limit sign for the curve before the cattle guard and the mine had erected a "CAUTION PEDESTRIANS WALKING ON ROADWAY, 10:00 a.m.– 2:00 p.m." sign. This warning sign had been in place since the late 1980's. The sign had misleading information. Pedestrian traffic used the roadway at other times than stated.

On the opposite side of the road, there was a curve sign and a 40 mph speed limit sign (See Appendix D for pictures and the locations of these signs). Begay stated that crossing the road to walk on the same side as oncoming traffic was a common practice for the women.

motorists that pedestrians could be walking on the mine access road at anytime. The sign stated " CAUTION PEDESTRIANS WALKING ON ROADWAY, 10:00 a.m. - 2:00 p.m." The sign had been in place for several years. On July 21, 2011, at approximately 9:05 p.m., a fatal accident occurred when a 2010 Ford Model F150 pickup truck (VIN 1FTEX1E81AKE63311) struck an Administrative Technician from behind, while she was walking on the mine access road (BIA N4104 Road). The accident site on the mine access road was approximately 1300 feet east of a cattle guard and about 4000 feet west of the A3 facilities area. Mine management knew that miners had walked on this mine access road at times other than the time stated on the "CAUTION" sign. This violation is an unwarrantable failure to comply with a mandatory standard.

Corrective Action: New signs have been erected to inform anyone traveling on the access road of the possibility of pedestrians in the area.

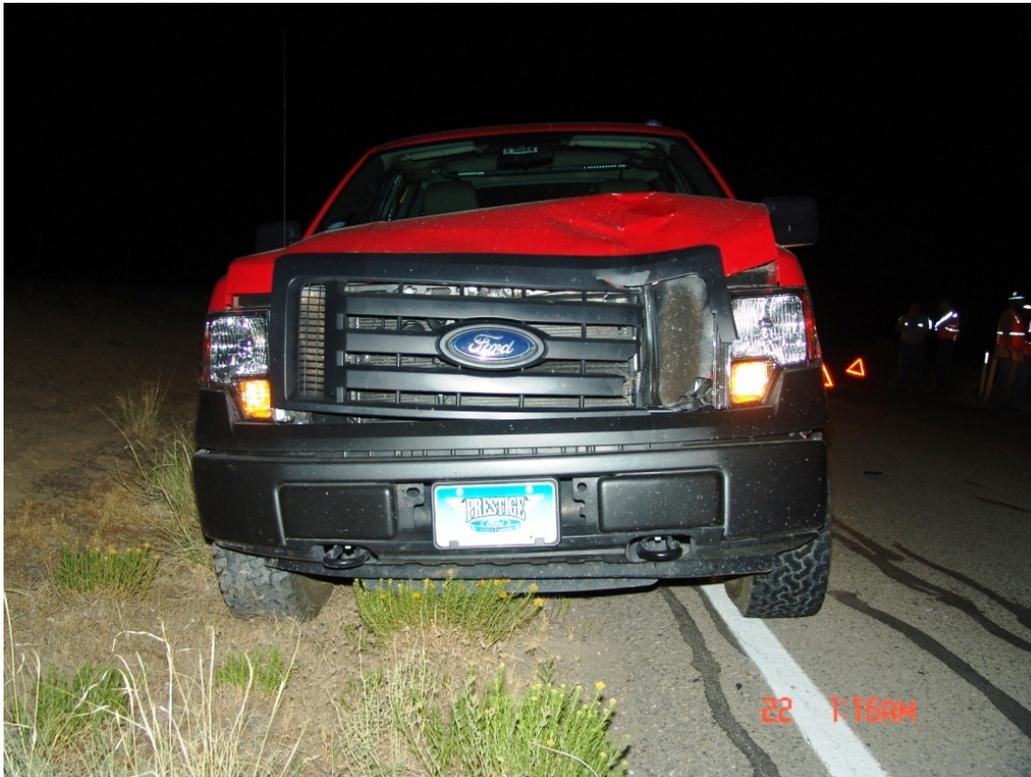
### Final Location of Truck

Measurements from the accident scene showed the pickup truck travelled about 69 feet from when the right front tire left the edge of the pavement to where the truck came to a complete stop. The final location of the victim was approximately 50 feet in front of the stopped vehicle and positioned face down on the edge of the roadway (see Appendix E). The pickup truck came to a complete stop with the right front wheel off the pavement and the left front wheel on the edge of the pavement (see Appendix D).

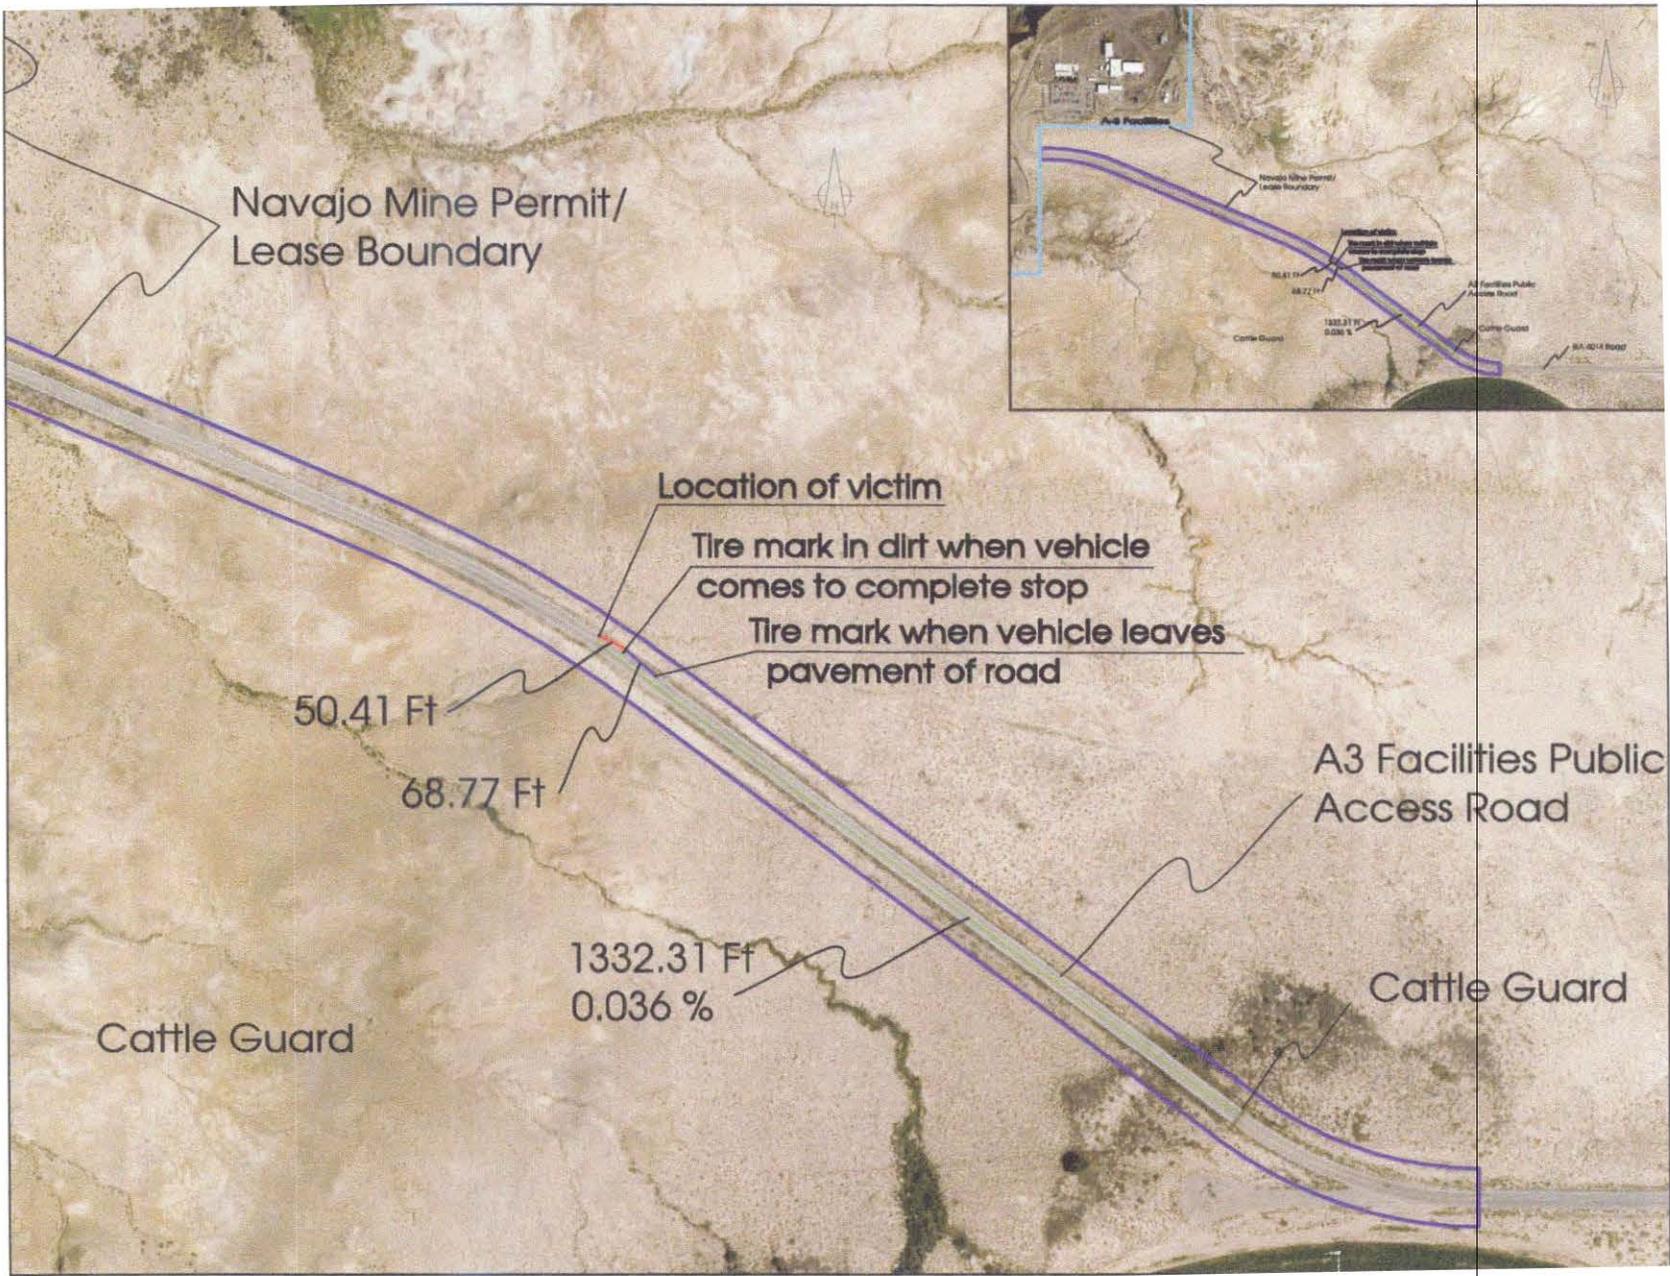
Appendix E  
Locations of Pickup Truck and Victim

The length of the mine access road from the cattle guard to the Area 3 Facilities area was about one mile. The accident occurred about 1,300 feet from the cattle guard. The width of the pavement at the accident site was 24 feet and the slope of the roadway was approximately 3.6 percent downgrade, from the cattle guard to the accident site. The road surface in this section had numerous bumps and humping of the pavement, due to settlement of the road over the years. These conditions caused a noticeable washboard effect in this section of the road and the conditions were present, intermittently, over the entire BIA N4104 road.
