UNITED STATES DEPARTMENT OF LABOR  
MINE SAFETY AND HEALTH TECHNOLOGY CENTER

NOISE CONTROL ASSISTANCE

Pueblo County Road and Bridge (ID 05-04158)  
Pueblo, Pueblo County, Colorado

April 7, 1988

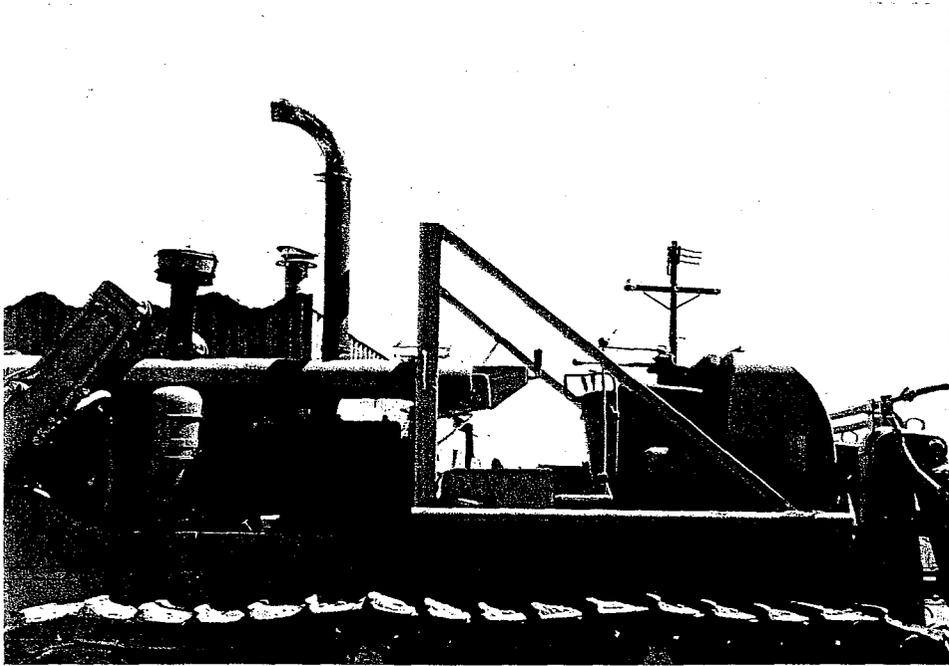
FIGURE 1. - D8-46 dozer.

Figure 1 is a view of the dozer with the windshield frame. The frame was welded to the floor and stabilizers were then bolted to the frame, directed to the rear of the platform and bolted to the floor. This particular design afforded stability with little flexing. Angle iron was welded to the inside of the main frame as a framework for the window panels. The panel corners were then rounded off to facilitate installation of the glass (figure 2). Used conveyor belting was used as a flexible filler between the cowl and windshield (figure 3). The completed shield consisted of five window panels with safety glass mounted on rubber gaskets (figure 4).

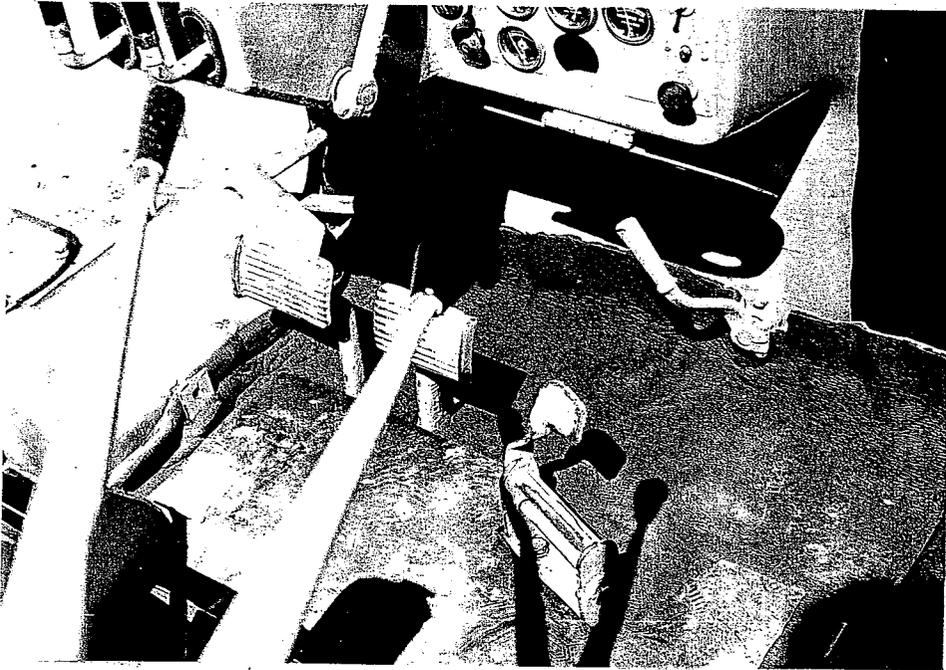
FIGURE 5.— Acoustical floor mat w/ belting.

An acoustical floormat was cut and laid on the compartment floor. A piece of belting was then placed over the floormat to help reduce wear and tear (figure 5). Belting was also placed under the operator's seat to block transmission noise (figure 6). Finally, a piece of loaded vinyl was draped in the rear of the engine compartment to prevent noise from coming through the dash panel controls (figure 7). An elbow extension was installed on the exhaust stock to direct noise away from the operator (figure 8).

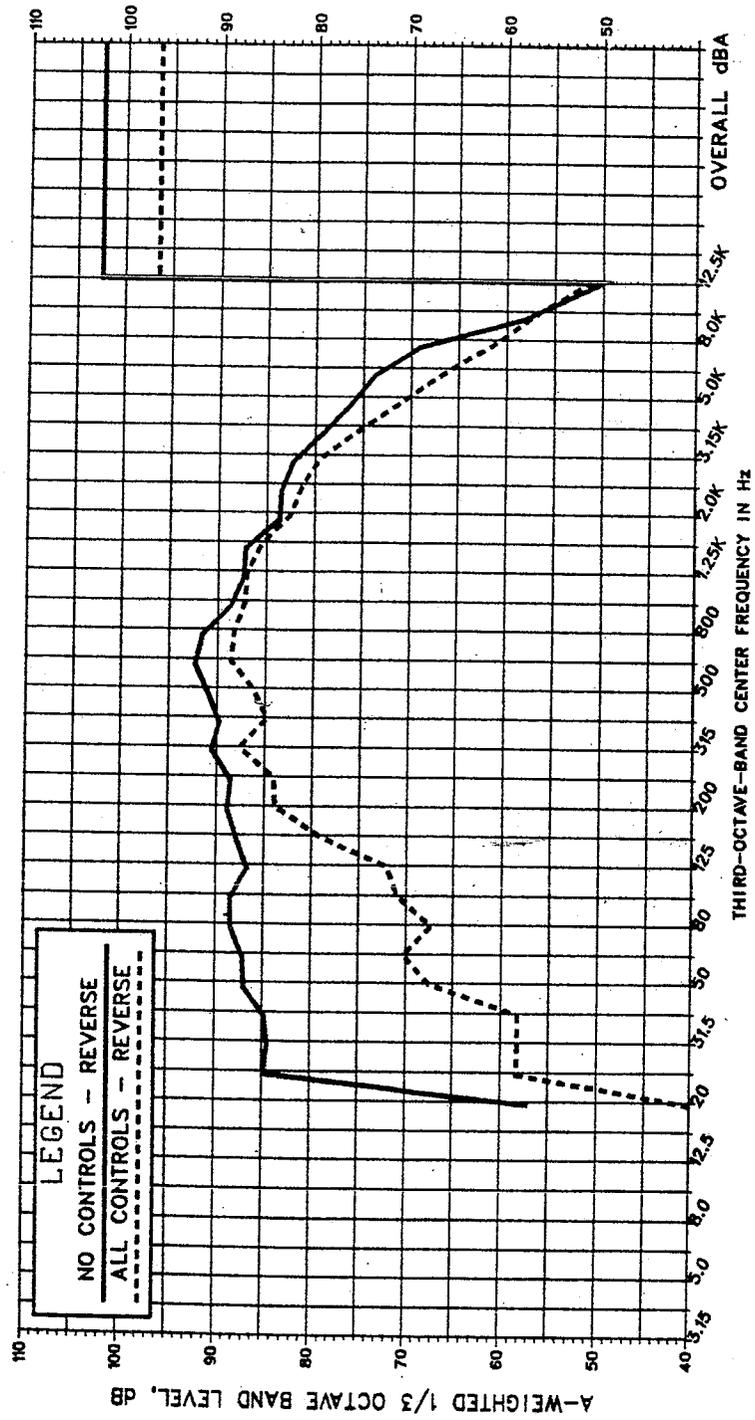
**FIGURE 9 - NOISE MEASUREMENTS**

Noise levels were measured before and after controls were installed and the results are summarized in table 1 and figures 9 and 10.

Figures 9 and 10 show reduction only in the lower frequencies. The lack of reduction in the upper frequencies was due to the mode of dozer operation during the tests. The dozer was run in high gear without pushing a load, which tended to increase the contribution of the track noise. A regular work-cycle test of pushing a load was then conducted and the results are given in figure 1. These results show low levels in all the frequencies and an overall dBA level of 84.
