U. S. Department of Labor

Mine Safety and Health Administration
 4800 Forbes Avenue
 Pittsburgh, Pennsylvania 15213
 Pittsburgh Health Technology Center
 Physical and Toxic Agents Division

May 6, 1983

Letter to Mr. L. C. Marraccini, 04/26/83, Subject: Reduced-noise auger miner cutting head problems investigated by Wyle Laboratories and Bureau of Mines personnel

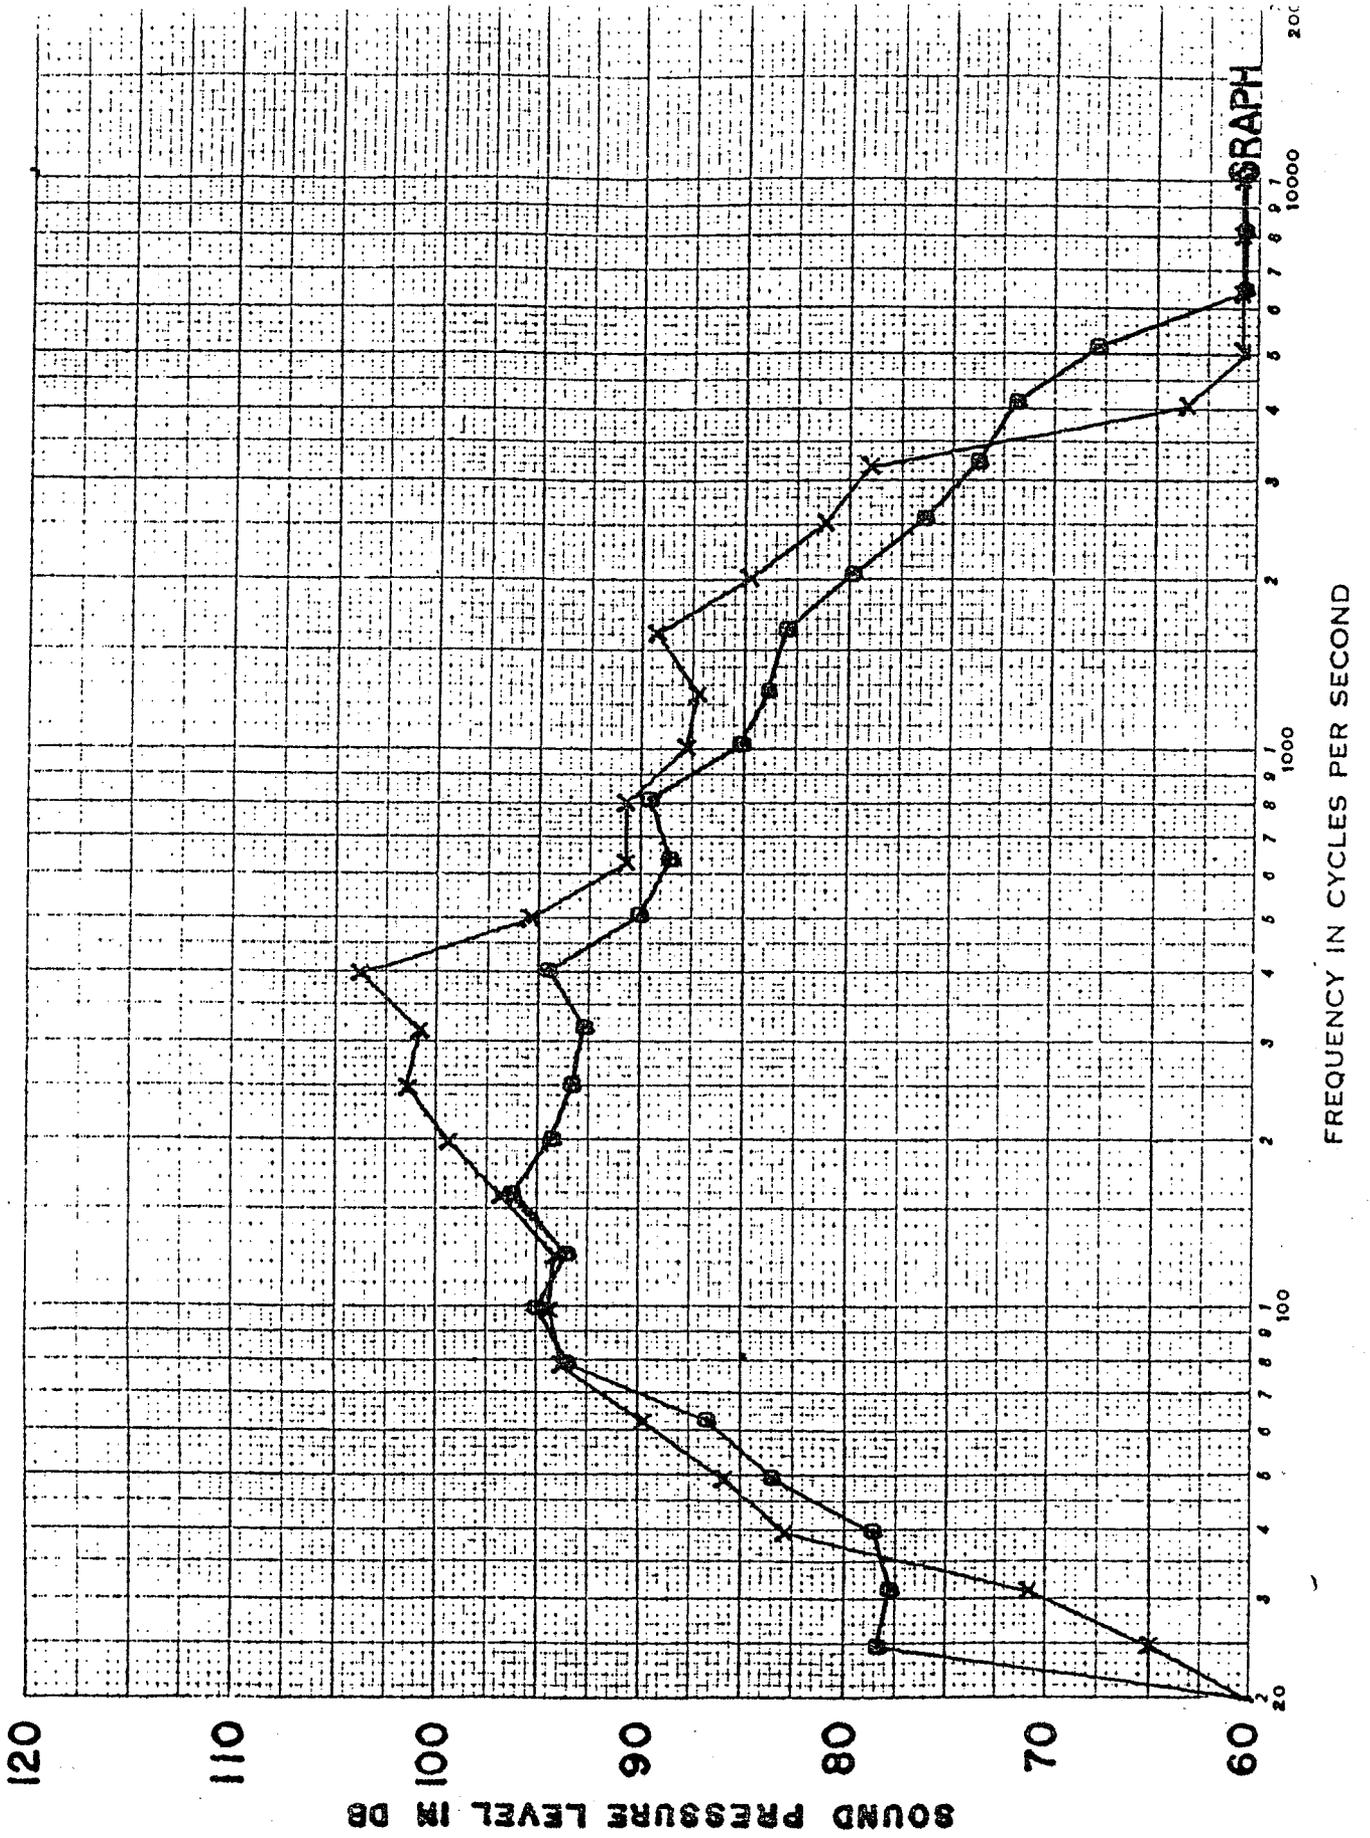
FIGURE 1. - Operator Position, cut and load

<u>Position, Condition</u>	<u>Ave. Noise Levels, dba</u>	
	<u>Standard Heads</u>	<u>Modified Heads</u>
Operator, cutting coal	103.3	98.6
Right Jacksetter, cutting coal	104.0	98.8
Bridge Conveyor Operator, w/coal	96.0	96.0

<u>Position</u>	<u>Noise Exposure, %</u>	
	<u>Standard Heads</u>	<u>Modified Heads</u>
Operator	308	182
Jacksetter	466	295

As can be seen, there was a significant noise reduction due to the cutting heads. To further illustrate this reduction, enclosed with this letter are charts showing the frequency distribution of the noise.

x-x-x Untreated System
o-o-o Modified Cutting Heads

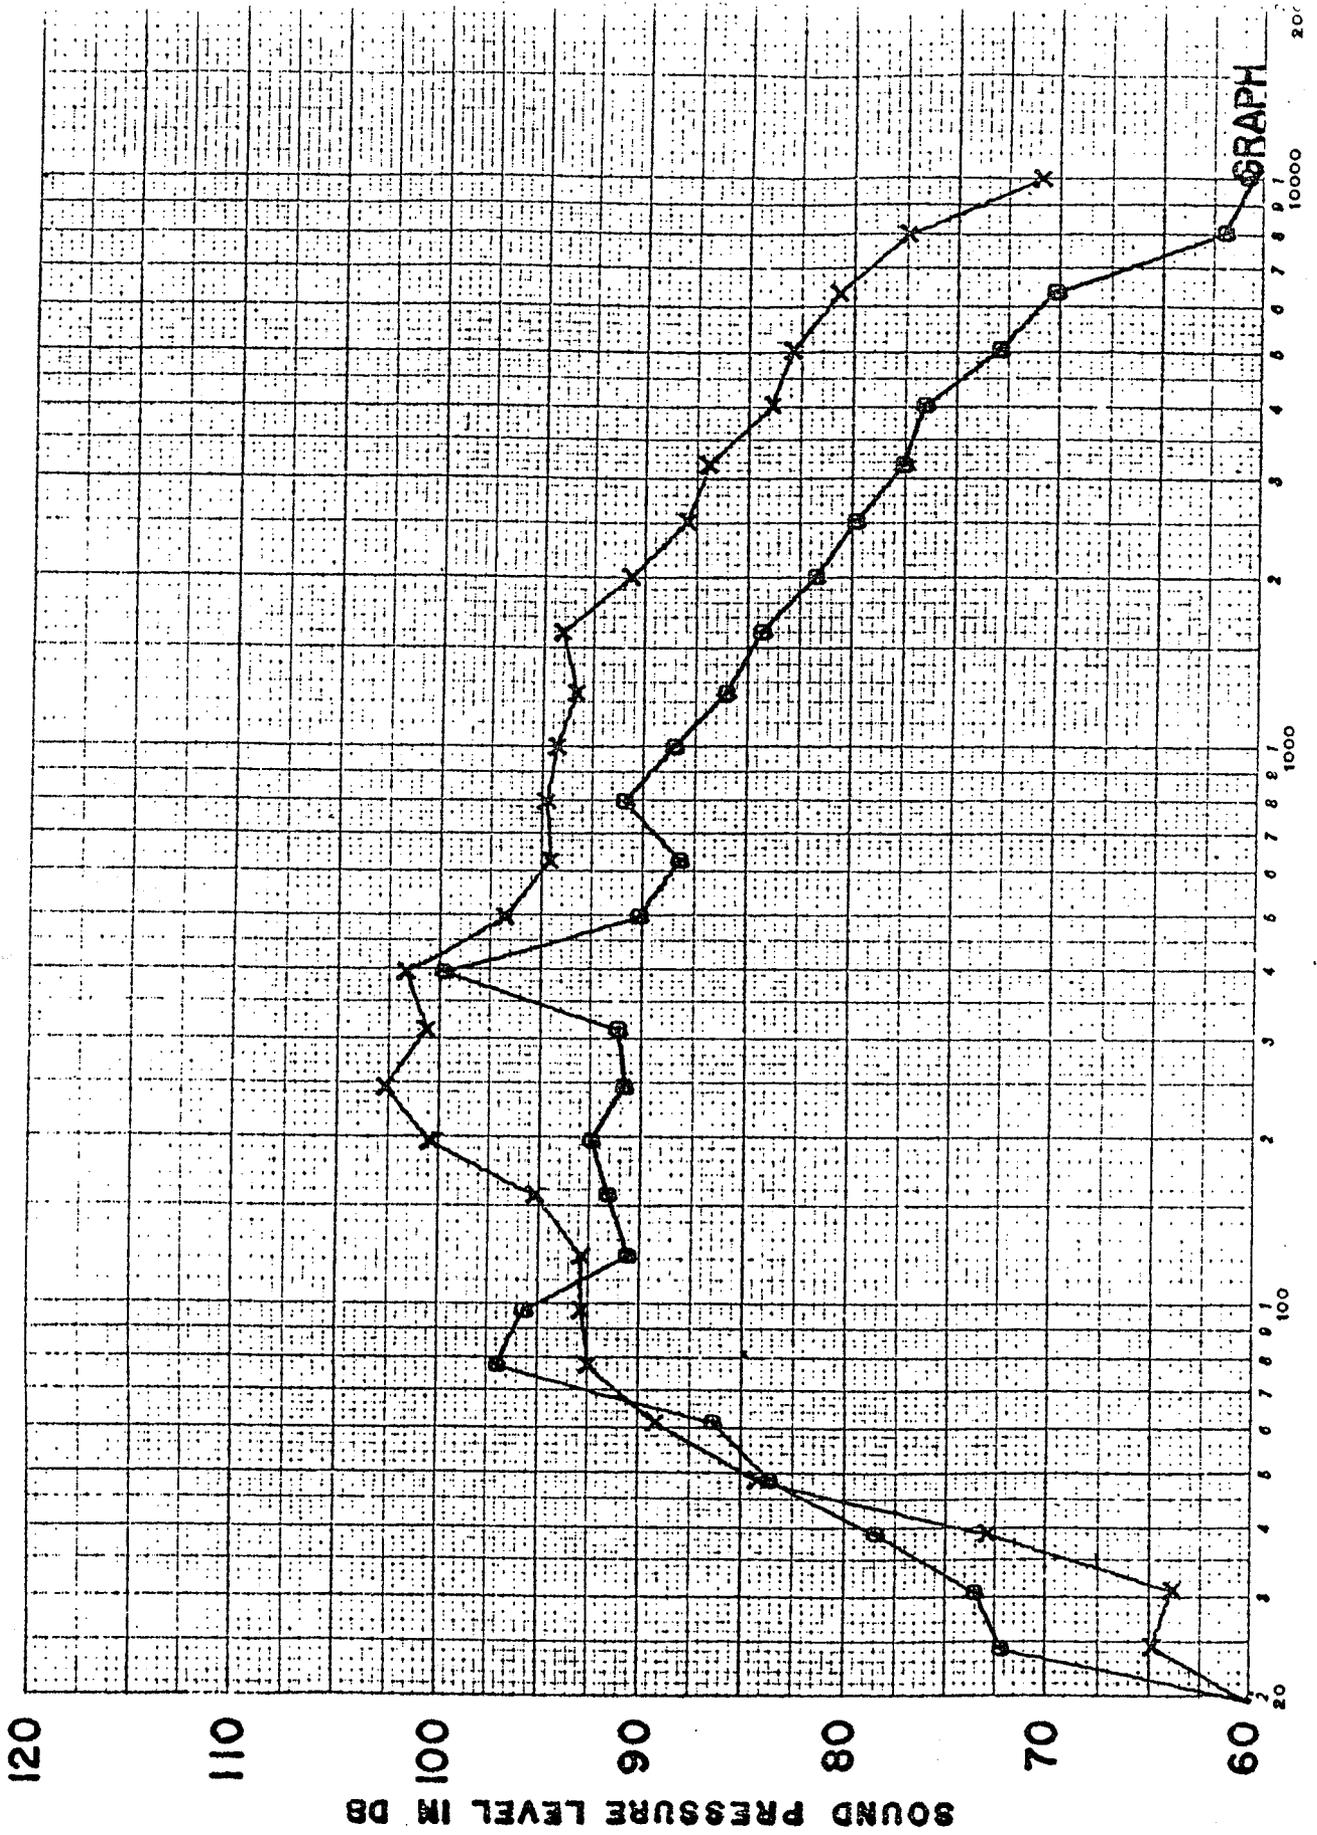
FIGURE 2. - Jacksetter Position, cut and load

x---x Untreated System
o---o Modified Cutting Heads

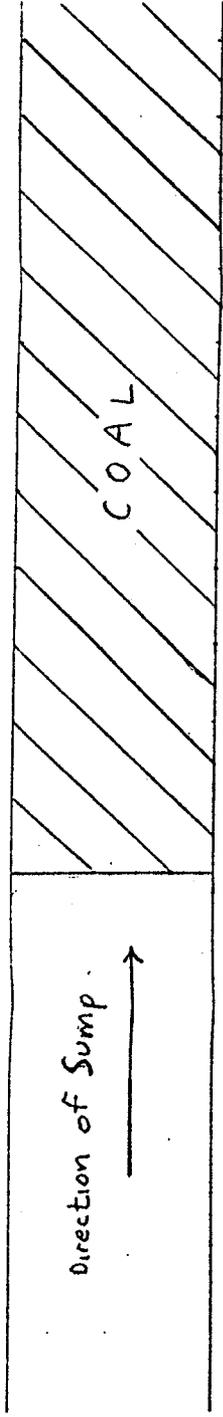
2. The reason for the "ridge of coal" problem was not as obvious, but it probably resulted from Copper Valley's inexperience with the "new" Fairchild auger designs. The head castings of the "old" augers now being used by Copper Valley are of the same diameter as the helixes; cutting bits are also located on both helixes of these "old" augers. When Fairchild redesigned the "old" augers to place all cutting bits on one helix (leaving one "bitless" helix), they also reduced the diameter of the head castings by about 2 inches.*** The reduced-noise augers designed by Wyle contained both the smaller head castings and the identical bit lacing patterns of the "new" Fairchild augers.

Figures 1 through 4 show how the "ridge of coal" problem could have occurred. Because of the smaller head castings of the "new" augers, the profile of the finished coal face assumed a more concave shape than with the "old" augers (Figures 1 and 2). The machine operator at Copper Valley would not have expected this, so he sumped the Wyle augers until the outby bits were fully "buried" into the face, as was standard practice with the "old" augers (Figure 3). This placed the outby bits slightly inby the point at which the face became concave. When the operator raised the lead auger and lowered the trailing auger to begin his sweep toward the rib (Figure 4), a ridge of coal was left behind the outby bits.

Figure 1 - Flat face profile resulting from "old" augers

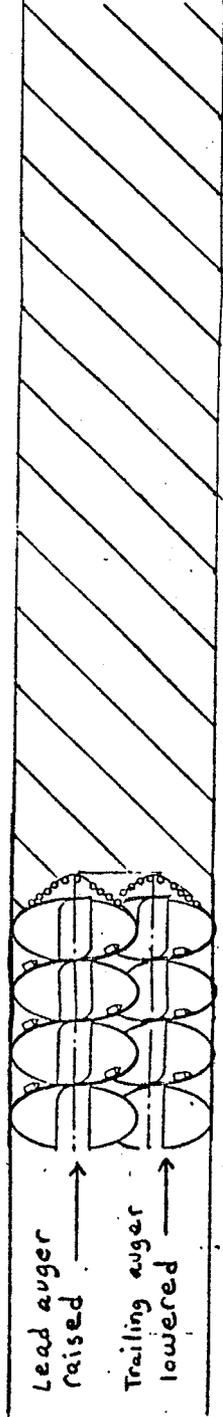
Figure 2 - Concave face profile resulting from "new" augers (smaller head castings)

1. The clean-up problem can be eliminated by removing the plates on the conveying sides of the auger helixes.
2. The "ridge of coal" problem was the result of machine operator unfamiliarity with the face conditions resulting from the use of augers with smaller head castings, and the resulting need for shallower sumps.
3. In future retrofit applications of the reduced-noise augers, the design of the "present" augers should be noted. If the "present" augers are the "new" Fairchild augers (bits on one helix, smaller head castings), problems should be minimal; if the "present" augers are the "old" augers (bits on both helixes), the machine operator should be alerted to the "ridge of coal" problem and instructed to make shallower sumps. Alternatively, Fairchild could be asked to place the "old" style (larger) head castings on all reduced-noise augers built in the future.

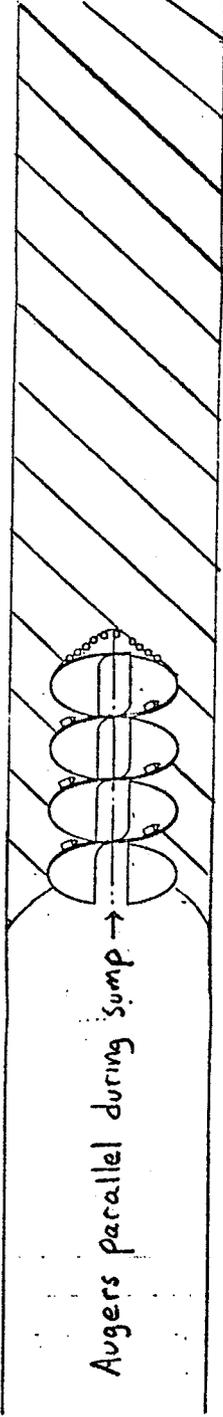
eliminated if the machine operator had not sumped as far into the face on each pass (2 to 4 inches shallower than with the "old" augers). Since the reduced-noise augers were used for less than three full operating shifts, the operator may not have become "used to" the new face profile and the shallower sump depth required.

Figure 3 - Augers sumped until outby bit is buried in coal

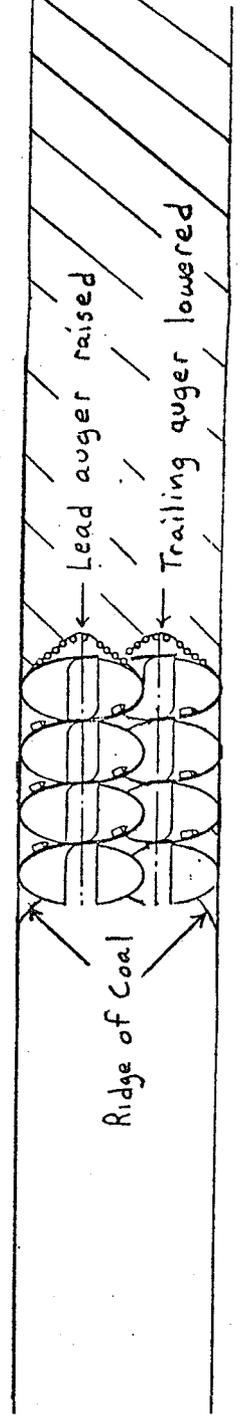
It is important to note that the noise control treatments were not responsible for the "ridge of coal" problem. The same problem would probably have occurred if Copper Valley had switched to the "new," unquieted Fairchild augers with the smaller head castings. The problem could probably have been

Figure 4 - "Ridge of coal" left during sweep toward rib
