REPORT OF INVESTIGATION

Fatal Powered-Haulage Accident  
July 1, 2010

Pocahontas Mine  
White Buck Coal Company  
Rupert, Greenbrier County, West Virginia  
I.D. No. 46-09154

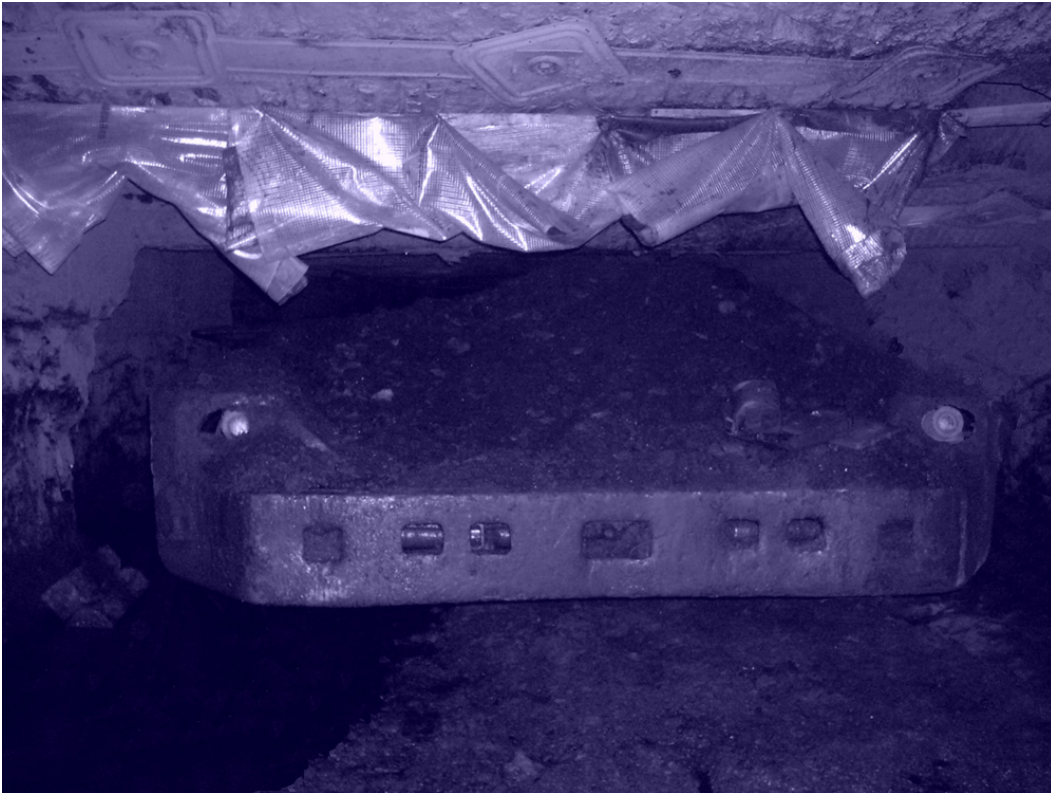
The accident occurred because the left side shuttle car had an improper sideboard installed between the operator's deck and the bed of the shuttle car. The sideboard severely limited the field of vision of the shuttle car operator on the off-side of the car. Additionally, lack of communication between the victim and the shuttle car operator contributed to the accident.

The height of the shuttle car canopy measured 50 ½ inches from the mine floor. The space inside the operator's deck between the body side canopy posts was 54 inches wide. The shuttle car had a solid metal sideboard installed between the operator's deck and the shuttle car bed to prevent coal from spilling into the operator's deck. The sideboard had a narrow slit cut out between the sideboard and the bottom of the canopy. The slit measured ¾ inches on the outby or dump end, and 1 inch on the inby or load end. A window 10 ¾ inches wide, by 3 inch high, had been cut into the sideboard below the canopy, four inches back from the inby canopy post. The sideboard created a visibility hazard because a person walking or positioned in the left side of the entry would not be visible to the shuttle car operator.

*Root Cause:* A safety hazard involving visibility existed on the No. 1 shuttle car. The metal sideboard between the operator's deck and the bed had only a narrow slit between the sideboard and the canopy. The shuttle car operator's field of vision was blocked by this metal, preventing the operator from seeing the victim as he walked toward the continuous mining machine.

*Corrective Actions:* The solid metal sideboard was replaced with an the original Joy Manufacture shuttle car sideboard, which allows the operator to see above the frame of the shuttle car.

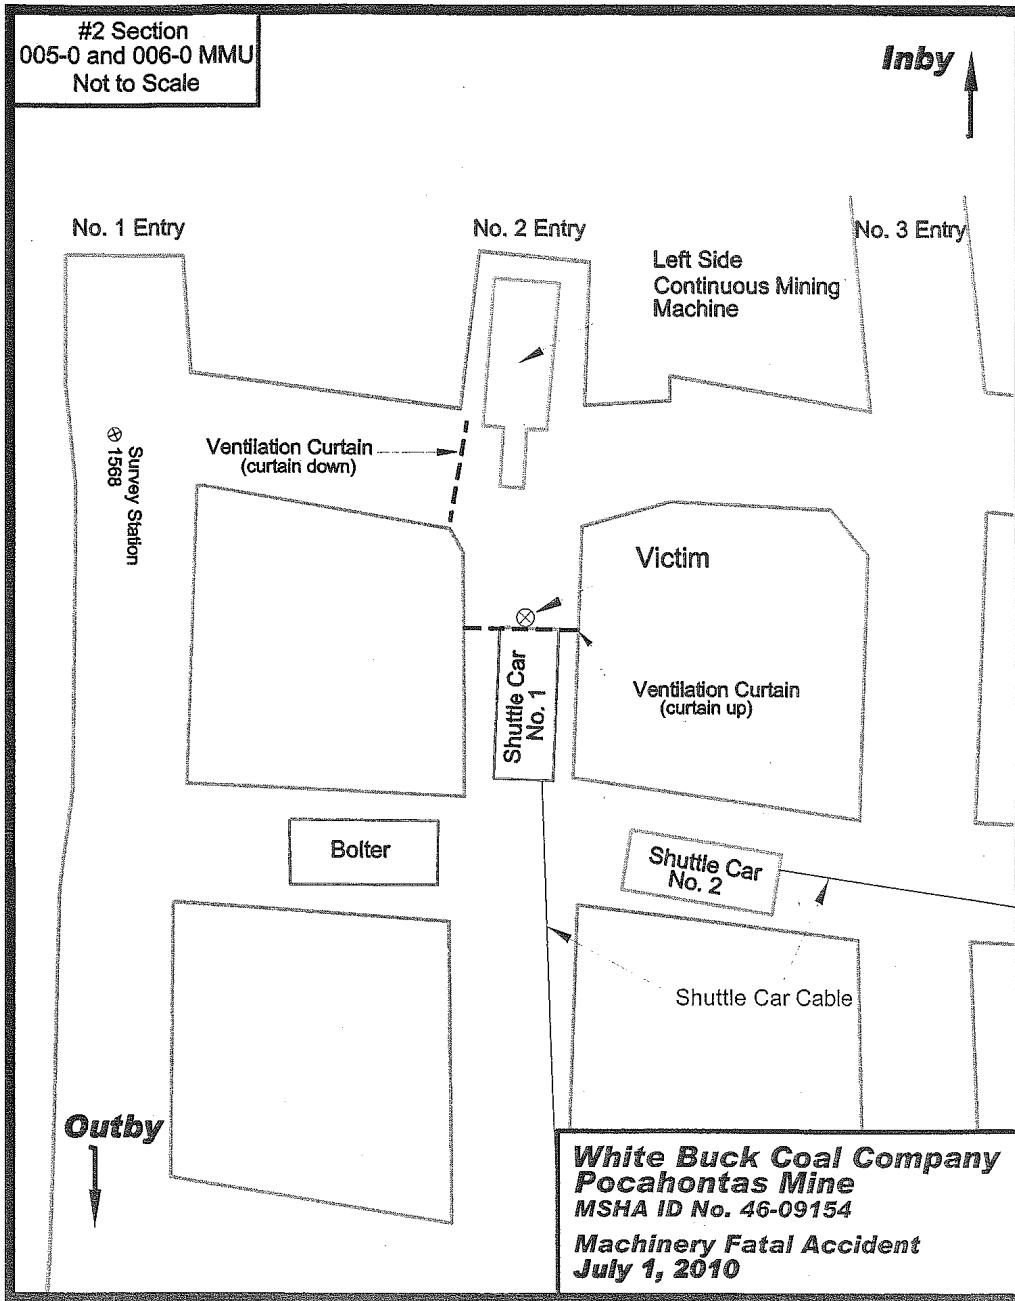
APPENDIX C  
Sketch of the Accident

The accident occurred between the first and second crosscuts outby the face in the No. 2 Entry. The No. 2 Entry height measured between 74 inches, to 83 inches. The coal pillar on the right between these two crosscuts measured 44 feet long. The entry width varied from 18 to 20 feet. Looking outby, an eighteen inch offset was present in the right rib line, located 25 feet and 3 inches from the inby corner of the right pillar (about 7 feet outby the set of fly pads), which narrowed the entry to 18 feet. This would have forced the shuttle cars to bear left while tramming towards the continuous miner.

A set of translucent fly pads was installed 18 feet from the inby rib corner, or 26 feet from the outby corner in the pillars immediately outby the last open crosscut. Placement of the fly pads near the inby end of the pillar created further visibility issues for the shuttle car operator. If the victim was inby the fly pads with his back to the approaching shuttle car, he would not be visible to the shuttle car operator.
