REPORT OF INVESTIGATION

Fatal Falling Material Accident
August 19, 2015

Mine No. 1
Hamilton County Coal, LLC
McLeansboro, Hamilton County, Illinois
I.D. No. 11-03203

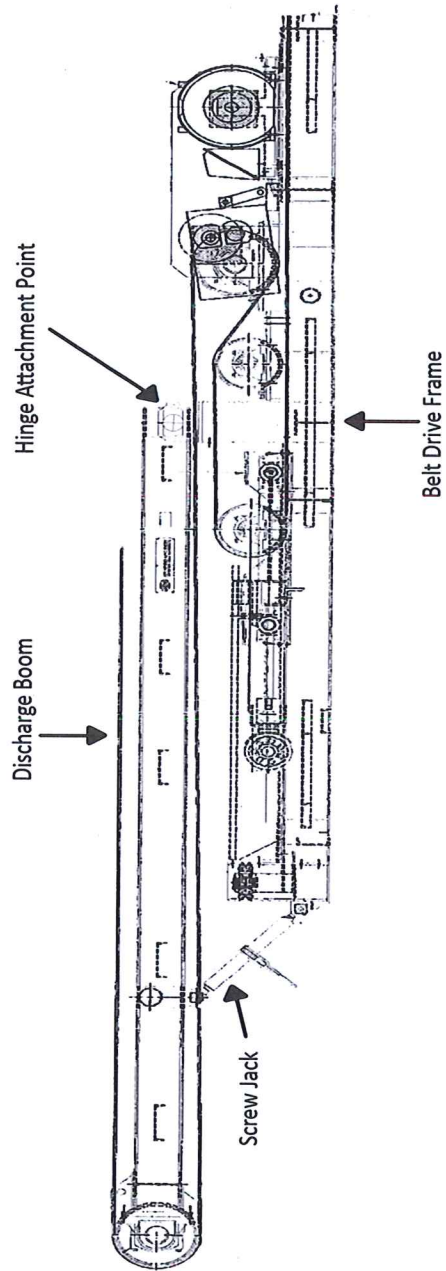
Drawing of Conveyor Belt Drive Unit

in the belt drive frame so they could install the pins to hold the boom in place. At approximately 8:45 p.m., the chain hangers holding the chain hoist pulled out of the mine roof, due to the weight of the discharge boom, allowing it to suddenly drop and strike Swain on the left shoulder and neck area.

The 42" BW, single 150 H.P. belt drive unit, that was being installed on a temporary basis, was manufactured by Joy Global Inc. Typically, a smaller conveyor belt is installed in a new longwall gate panel so the panel can be developed to allow room for the larger longwall conveyor belt drive and its components. The discharge boom of this belt drive unit was connected to the main belt drive frame by hinge pins and screw jacks (see Appendix C). The screw jacks were installed from the bottom of the drive frame to the bottom of the discharge boom to provide support and allow the discharge roller to be raised or lowered in small increments.

When the boom fell, it did not pin the victim to the mine floor. Due to the design of the belt drive unit, when the pins are installed at the hinge point, the boom will hit the frame of the belt drive, leaving approximately 4 feet between the bottom of the discharge boom and the mine floor.

Corrective action: The mine operator developed a written blocking policy to comply with 30 CFR § 75.1726(b) when miners work on or under equipment or machinery that is in a raised position. Miners have been trained in the blocking policy. This policy will be reviewed during annual refresher, newly employed inexperienced miner, experienced miner, and new task training.

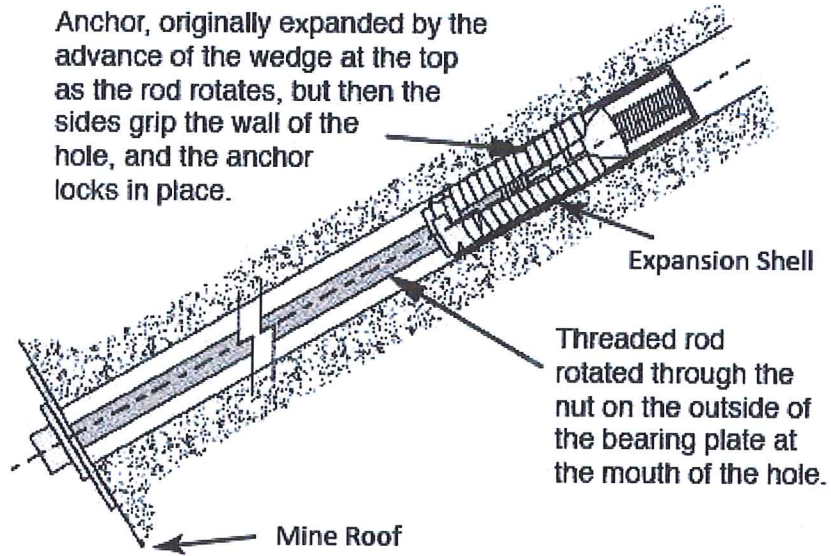
Conventional Roof Bolt

The chain hoist used to lift the discharge boom was attached to the mine roof by hooking it into chain hangers that had been installed in the roof to permanently support the conveyor belt structure. The chain hangers were installed in the mine roof using 36 inch long, 5/8 inch diameter, conventional roof bolts equipped with a bail type expansion shell (see Appendix D). The holes drilled into the mine roof measured 37 inches deep for the north hole and 36 inches deep for the south hole. The inside diameter of the holes measured $1 \frac{7}{16}$ inch for the north hole and $1 \frac{1}{2}$ inch for the south hole. The manufacturer recommends $1 \frac{3}{8}$ inch drill hole for these bolts. MSHA standard 30 CFR § 75.204(e)(1) requires: "the diameter of finishing bits shall be within a tolerance of plus or minus 0.030 inch of the manufacturer's recommended hole diameter for the anchor used." Both the north and south drill holes exceeded the 0.030 inch tolerance of the manufacturer's recommended hole diameter. MSHA issued a noncontributory citation for a violation of 30 CFR § 75.204(e)(1).
