U.S. Department of Labor
Mine Safety and Health Administration
Technical Support
Approval and Certification Center
Division of Electrical Safety

Remote Control Fatal Accident Analysis Report

Victim's Physical Location With Respect to the Mining Machine

May 9, 2008

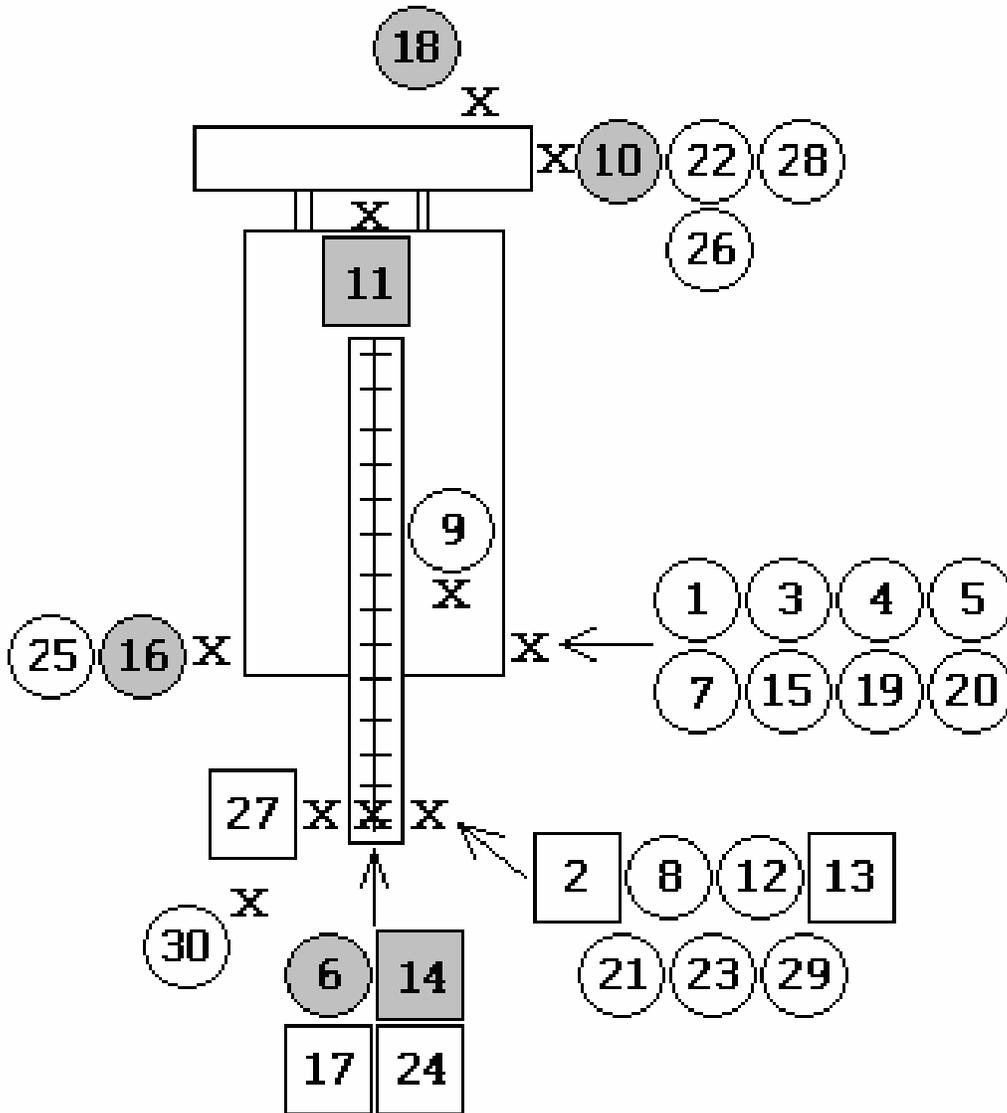
Figure 1

5. The machine operator was most at risk (22 out of 30 fatalities).
6. Most pinning and crushing accidents occurred on the right rear side of the machine (16 out of 30) with nine fatalities involving the right rear machine corner and seven involving the conveyor boom. The one operator fatality occurring at the left rear machine corner during non-maintenance work was with a machine designed for left side operation.

Location of Remote Control Victims With Respect to Machine

Note: Numbers refer to the number of the accident in the Accident Summary of this analysis. The "X" indicates general location of fatality. Accidents 2, 8, 12, 13, 17, 21, 23, 24, 27 and 29 were a result of tramping, not a result of moving the boom. Gray background indicates accidents that occurred while performing maintenance. All accidents with white background, except number 30, occurred while tramping the machine. The square around numbers indicates the victim was not operating the machine, and circled numbers indicate the victim was operating the machine (person in possession of remote control at time of the accident).
