U.S. Department of Labor
Mine Safety and Health Administration
Technical Support
Approval and Certification Center
Electrical Safety Division

Remote Control Fatal Accident Analysis Report

Victim's Physical Location With Respect to the Mining Machine

September 25, 2009

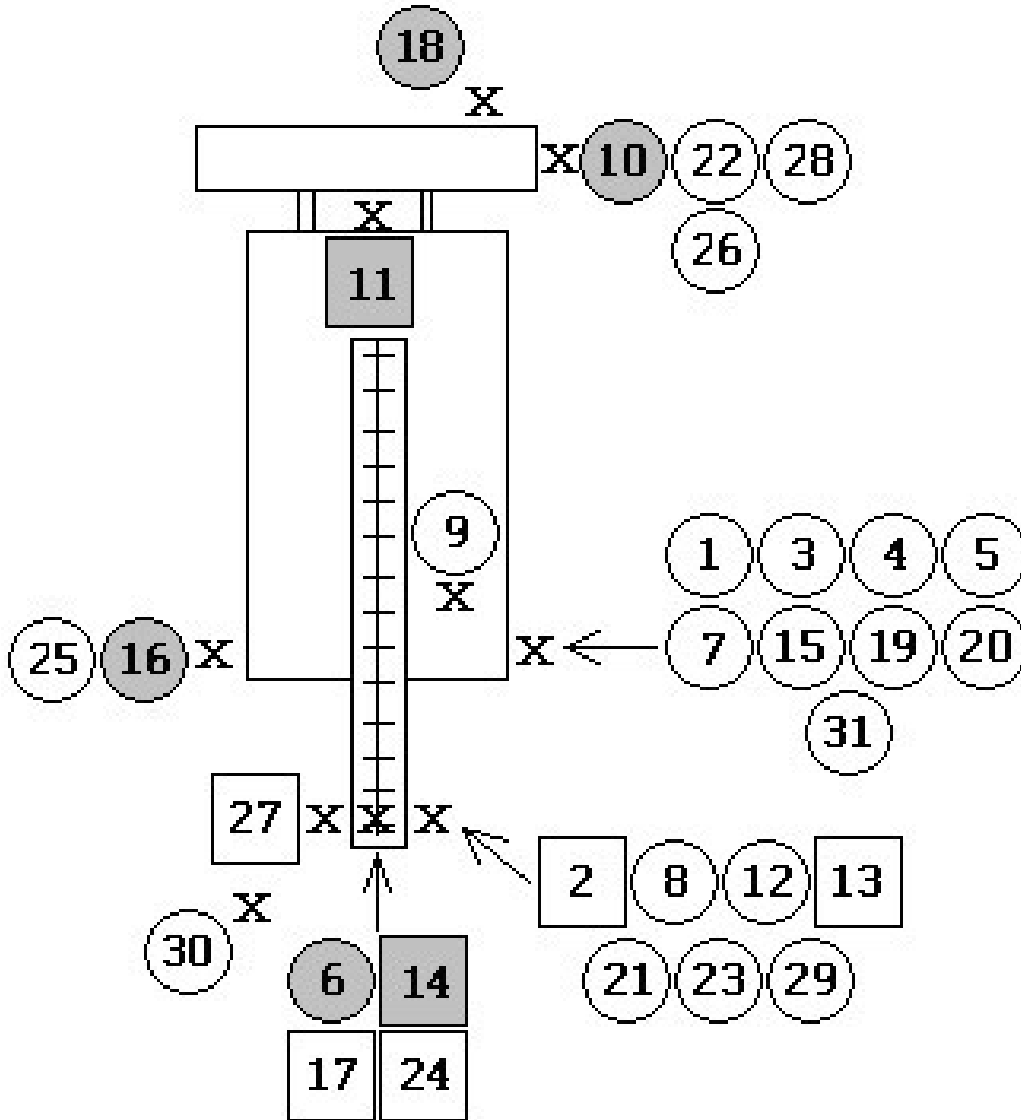
Figure 1

5. The machine operator was most at risk (23 out of 31 fatalities).
6. Most pinning and crushing accidents occurred on the right rear side of the machine (17 out of 31) with ten fatalities involving the right rear machine corner and seven involving the conveyor boom. The one operator fatality occurring at the left rear machine corner during non-maintenance work was with a machine designed for left side operation.

Location of Remote Control Victims With Respect to Machine

Note: Numbers refer to the number of the accident in the Accident Summary of this analysis. The "X" indicates general location of fatality. Accidents 2, 8, 12, 13, 17, 21, 23, 24, 27 and 29 were a result of tramping, not a result of moving the boom. Gray background indicates accidents that occurred while performing maintenance. All accidents with white background, except number 30, occurred while tramping the machine. The square around numbers indicates the victim was not operating the machine, and circled numbers indicate the victim was operating the machine (person in possession of remote control at time of the accident).
