U.S. Department of Labor
Mine Safety and Health Administration
Technical Support
Approval and Certification Center
Division of Electrical Safety

Remote Control Fatal Accident Analysis Report

Victim's Physical Location With Respect to the Mining Machine

June 7, 2004

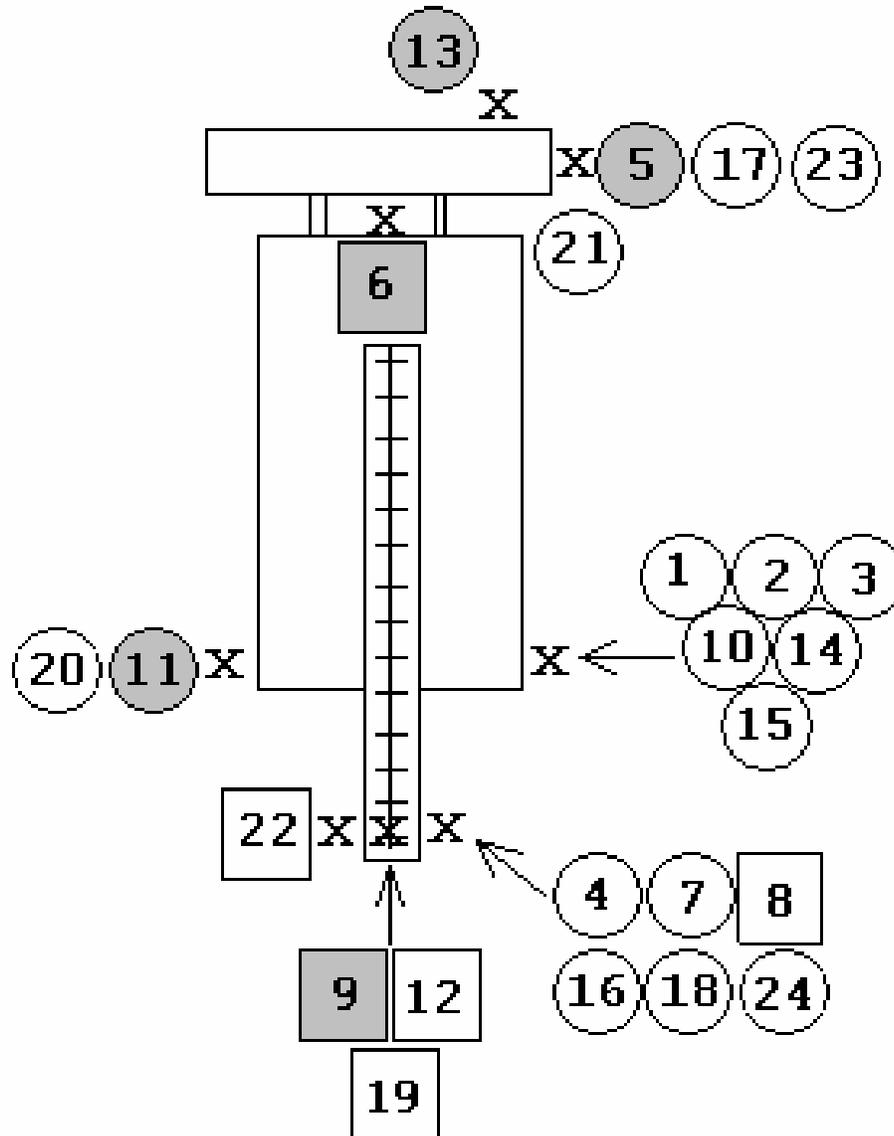
Figure 1

5. The machine operator was most at risk (18 out of 24 fatalities).
6. Most pinning and crushing accidents occurred on the right rear side of the machine (12 out of 24) with six fatalities involving the right rear machine corner and six involving the conveyor boom. The one operator fatality occurring at the left rear machine corner was with a machine designed for left side operation.

7. Of the six fatalities involving the cutter head, three occurred while performing maintenance and three while trimming.

Location of Remote Control Victims With Respect to Machine

Note: Numbers refer to the number of the accident in the Accident Summary of this analysis. The "X" indicates general location of fatality. Accidents 4, 7, 8, 12, 16, 18, 19, 22 and 24 were a result of tramming, not a result of moving the boom. Gray background indicates accidents that occurred while performing maintenance. All accidents with white background occurred while tramming the machine. The square around numbers indicates the victim was not operating the machine, and circled numbers indicate the victim was operating the machine (person in possession of remote control at time of the accident).

Technology has advanced and allowed new design safety features and design approaches that may protect the operating personnel even when safe work practices are not followed. One of these safety features, that may have merit in preventing the type of accidents that have occurred, is personnel proximity protection. This feature provides automatic proximity detection and machine shutdown to protect personnel from being run over, crushed or pinned when they are inadvertently positioned in a hazardous area in close proximity to the machine. It is estimated that the use of proximity protection with machine shutdown could have been a preventative factor in 20 of the 24 fatal accidents (except 6, 9, 16 and 22) analyzed above. The technology for personnel proximity protection currently exists and its development and use on remote controlled mining machinery needs to be pursued.
