UNITED STATES  
DEPARTMENT OF LABOR  
MINE SAFETY AND HEALTH ADMINISTRATION

REPORT OF INVESTIGATION

Fatal Machinery Accident  
June 22, 2023

Chula Vista Quarry  
CalMat Co  
Chula Vista, San Diego County, California  
ID No. 04-04080

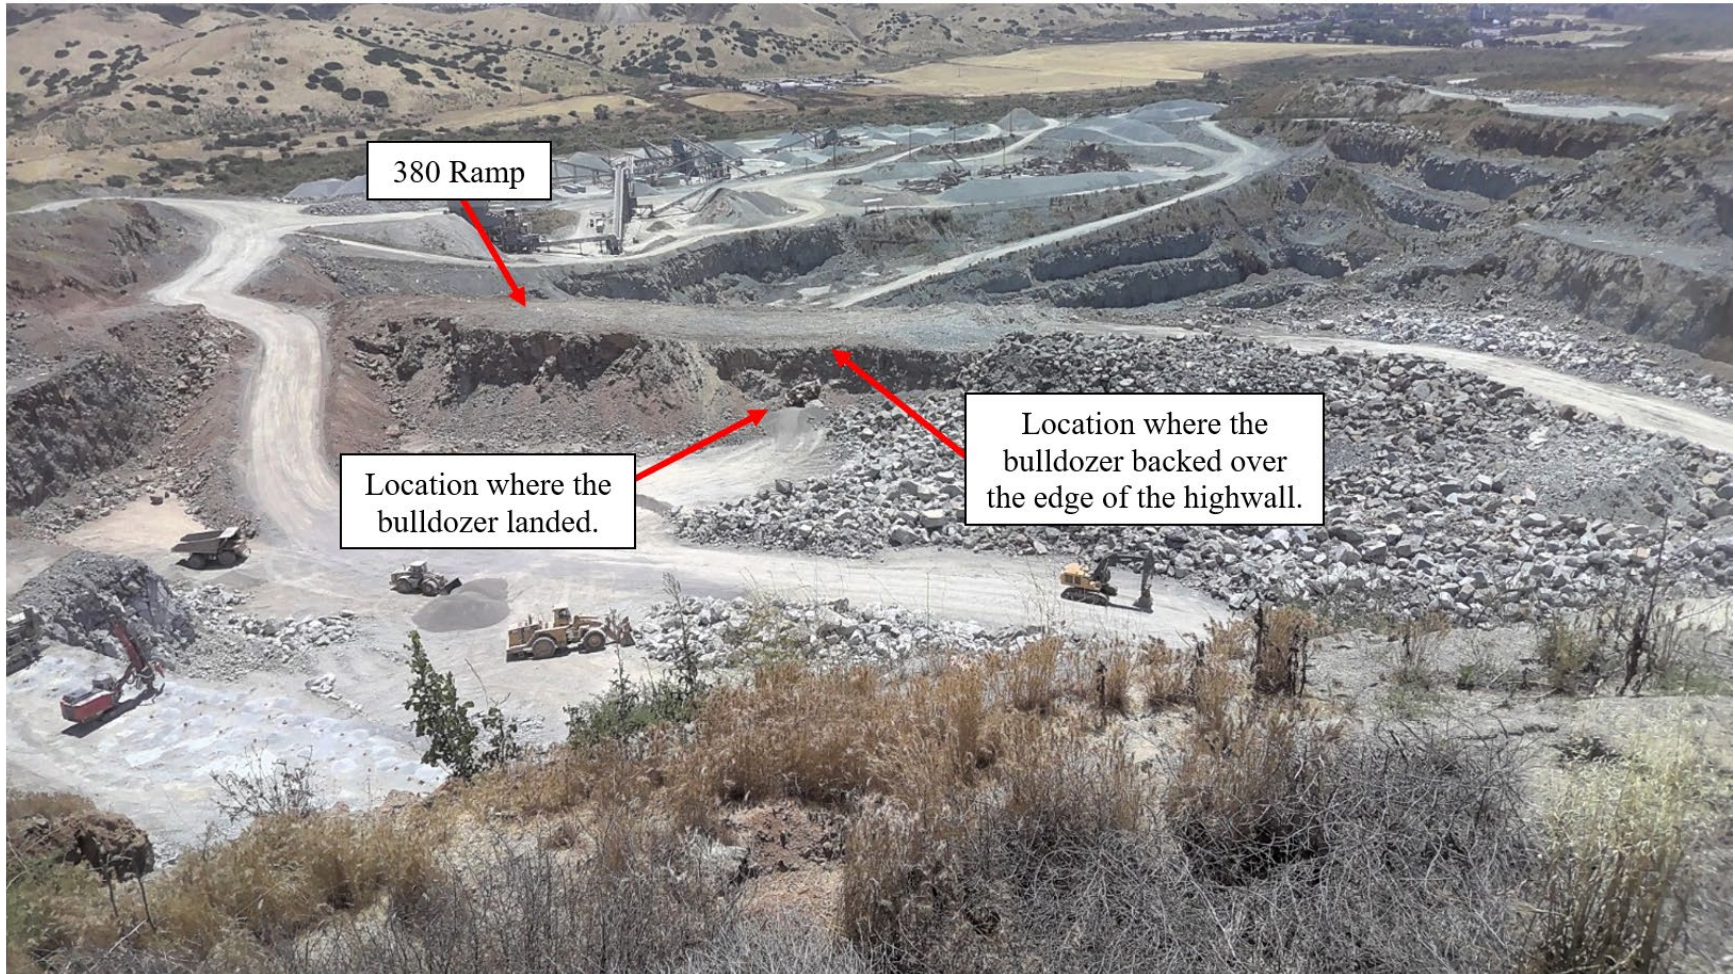
APPENDIX B – Overview of the Accident Scene

The accident occurred at the Northwest side of the 380 ramp, which used to serve as an access road into the pit (see Appendix B). The mine operator installed a new access road, allowing them to mine out the 380 ramp to recover the material.

prohibit access to all wheeled mobile equipment. However, there were no berms on the edge of the 380 ramp, because the mine operator had them removed to clear the area for a new drill pad. The mine operator blocked access to the area where the bulldozer was working to prevent any vehicle traffic from entering.
