REPORT OF INVESTIGATION

Fatal Machinery Accident  
June 9, 2023

JD's Custom Transport, Inc. (C5402)  
Morris, Illinois

Elk Fork, Morgan County, Kentucky  
ID No. 15-19846

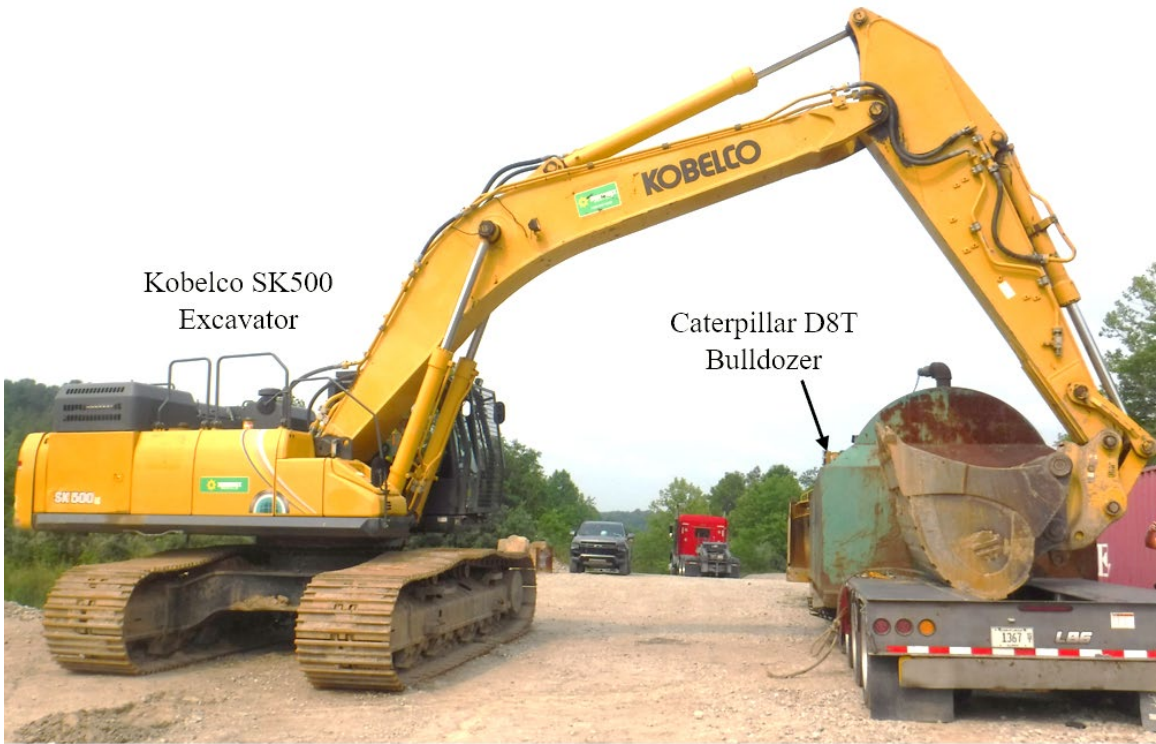
APPENDIX A – Accident Scene

According to interviews, Hillard climbed inside the trailer wheel well opening and stood on the ground between the rear trailer axles, positioning himself between the excavator bucket and right-side trailer frame. Hillard was attempting to attach a one-half inch chain between the cable loop on the tank and the lifting eye on the rear of the excavator bucket (see Appendix B). Doran stood on top of the right-side trailer frame to give direction and signals between Hillard and Rudowicz. Doran told Hillard to get out of the wheel well.

Rudowicz shouted from inside the excavator cab for Hillard to move out of the wheel well, but Hillard did not hear him. Rudowicz leaned out the excavator cab to direct Hillard to get out from beneath the excavator bucket, inadvertently contacting the joystick. The excavator bucket moved forward, striking Hillard and coming to rest on the right-side frame of the trailer. Doran jumped to the ground to avoid being struck from the sudden movement of the excavator bucket. After realizing what happened, Doran returned to the trailer and found Hillard unresponsive.

Corrective Action: The contractor and mine operator developed and implemented a new written procedure forbidding contract employees from loading or unloading equipment on mine property and trained all personnel.

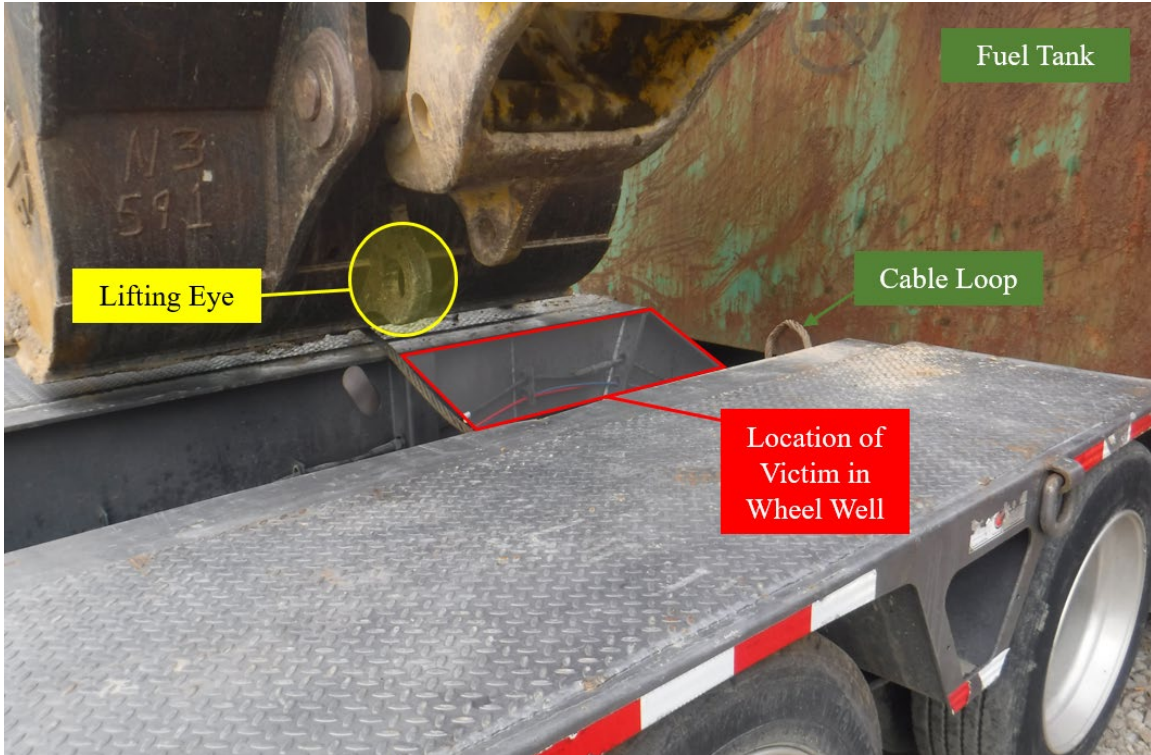
APPENDIX B – Excavator Bucket (Rear)

The rigging consisted of a one-inch steel wire rope with a tensile strength of more than 50 tons threaded through the center support rail of the rear of the tank, creating a loop with clamps. A one-half inch chain was threaded through the loop and was to be connected to the lifting eye on the excavator at the time of the accident.

The excavator involved in the accident was a Kobelco standard model SK500LC-10 excavator and was used to assist rigging and lifting the tank. The 2.49 cubic yard bucket was equipped with digging shanks and teeth with a lifting eye on the rear of the bucket. A safety locking mechanism was located inside the operator's cab to prevent any hydraulic functions from engaging when applied. Tests conducted during the investigation concluded all controls and safety features operated as designed. The investigator determined that the excavator operator did not engage the safety locking mechanism before leaning out the window of the excavator, inadvertently contacting the joystick.
