**Internal Review of MSHA's
Actions at the Upper Big Branch Mine-South
Performance Coal Company
Montcoal, Raleigh County, West Virginia**

U.S. Department of Labor
Mine Safety and Health Administration
Program Evaluation and Information Resources

March 6, 2012

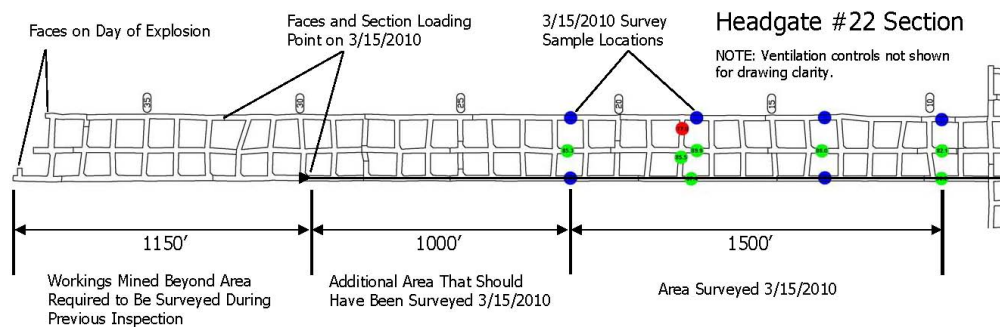
Figure 12 - Headgate #22 Section showing faces at time of explosion relevant to face and belt locations during March 15, 2010, rock dust survey.

MSHA procedures directed inspectors to make visual observations of rock dust application adequacy when inspecting sections between surveys. However, accurate visual estimation of mine dust IC was not reliable. In January 2010, District 4 managers provided additional guidance for determining compliance with rock dusting requirements on working sections when they instructed inspectors to collect spot samples of mine dust inby section loading points during each regular inspection. During interviews, District 4 managers stated that these instructions were intended to stress the requirement to rock dust within 40 feet of working faces, as well as to improve compliance with clean-up programs. An inspector collected one spot sample in accordance with this guidance at UBB, which was compliant, on March 17, 2010, on 4 Section (Barrier Section).

Active sections not surveyed to within 50 feet of the loading point. MSHA procedures direct inspectors to conduct a rock dust survey to within 50 feet outby the section dumping point on each advancing active working section. However, these procedures did not direct inspectors to document the location of the section loading point when conducting rock dust surveys. Thus, supervisors could not verify that inspectors sampled to within 50 feet of the loading point. Failure to follow this directive resulted in two un-surveyed zones within the explosion area.

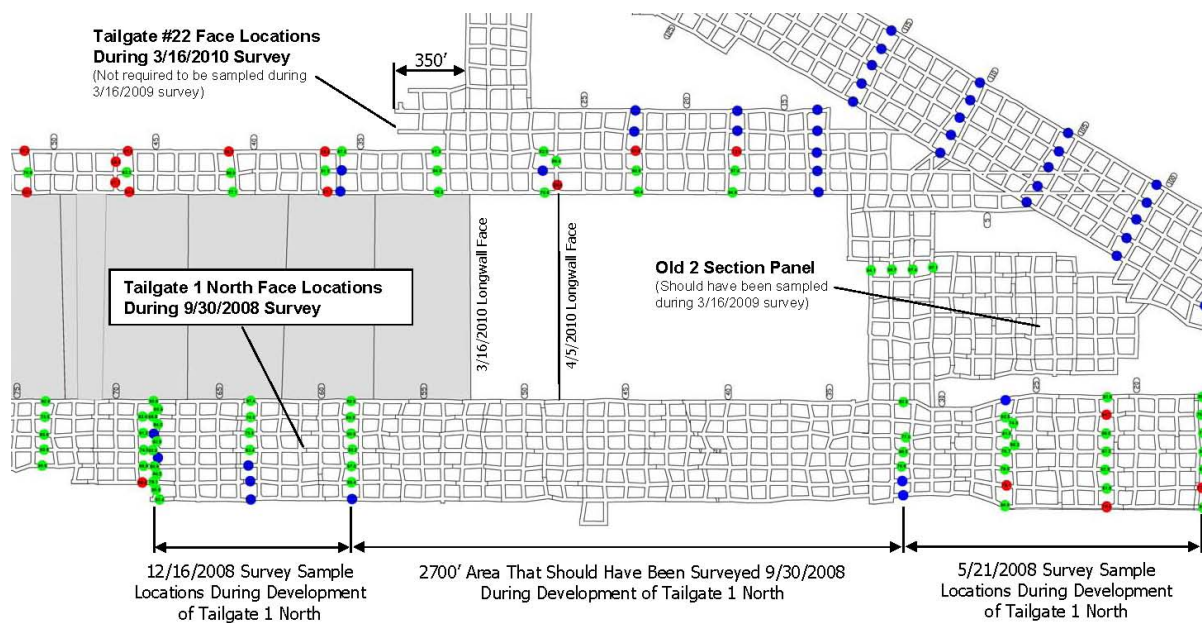
Figure 13 - Survey samples collected near the 1 North Longwall Panel.

In another case, an inspector uploaded data for a September 30, 2008, rock dust survey during development of Tailgate 1 North. However, he did not provide a zero point that precisely identified the sampling area so it could be located on the mine map. The inspector listed two rows of samples rather than the five rows of samples needed to survey the area mined since the last inspection (see Figure 13). He also listed all of the survey sample locations as being too wet to sample. With no way to map these wet sample locations, subsequent inspectors could not accurately determine where to begin the next survey or to collect samples if the area dried out.

On December 16, 2008, another inspector started the next rock dust survey in Tailgate 1 North at Crosscut 58, which would have corresponded to the section loading point at the time of the previous survey. However, deficiencies in documentation for the September 30 survey and lack of sampling at previously wet locations resulted in a 2,700-foot long area where MSHA did not collect rock dust samples. At the time of the explosion, this unsampled area extended from 1,000 feet inby to 1,700 feet outby the longwall face.

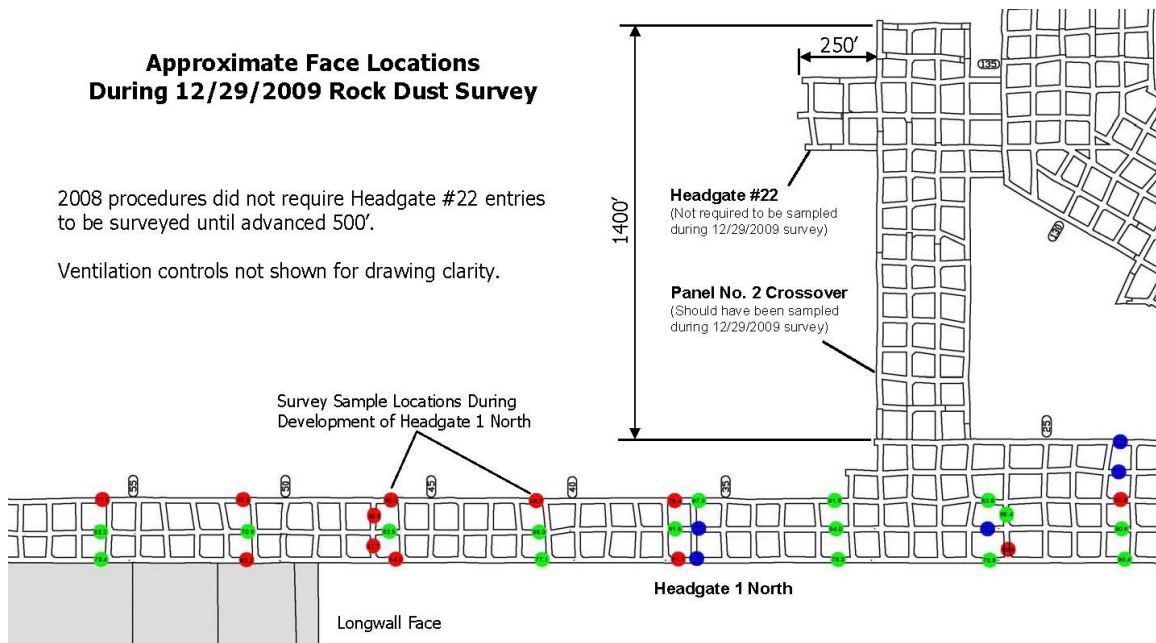
Figure 14 - Face locations at time of December 29, 2009, rock dust survey for MMU 029-0.

After MSHA implemented the revised inspection procedures in 2008, some inspectors continued to sample only the set of entries being mined at the time of the survey. On December 29, 2009, an inspector documented conducting a survey for 1 Section in which he did not collect any samples, reporting a single location as “No Sample.” The inspector commented on the Rock Dust Sample Submission Form, “The mine operator has mined less than 500 feet since last survey area.” However, since the prior rock dust survey for 1 Section, it had mined the last 500 feet of Headgate 1 North (Bandytown Shaft bottom area), the entire 1,400-foot long Panel No. 2 Crossover, and the first 250 feet of Headgate #22 (refer to the Figure 14). The April 5 explosion propagated through the two latter areas.

During interviews, the inspector stated that he did not conduct a rock dust survey in Headgate #22 because the distance from the mouth of the section to the tailpiece was less than 500 feet. While MSHA procedures did not direct him to sample Headgate #22 entries at that time, he did not consider surveying the two areas from which the MMU was removed. He also stated that he primarily learned how to conduct surveys by traveling with other inspectors. The only National Mine Health and Safety Academy training he remembered was the instruction to take samples every 500 feet and how to collect band samples. This further demonstrated that at least some inspectors continued to follow superseded procedures, passed on by more experienced inspectors and supervisors, regardless of training to the contrary. As a result, MSHA did not collect survey samples before the explosion in the Bandytown Shaft bottom area and the Panel No. 2 Crossover.

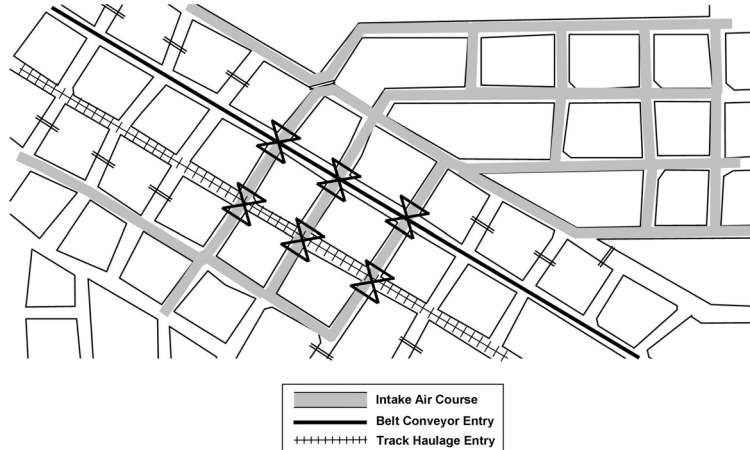
Figure 20 - Six Overcast Alternative to Eliminate Equipment Doors

Figure 20 shows how the separation of the two air courses could have been maintained using two sets of overcasts and no equipment doors. This method would have provided access to the track haulage entry without the need to open and close doors. Overcasts would have maintained separation of these air courses with less risk to the ventilation system because equipment doors are more prone to damage and excessive leakage. Therefore, the method illustrated in Figure 20 has historically been the preferred industry practice in areas of high traffic, such as in main haulage roads.

Another advantage to the use of overcasts is that the common air split is maintained in two entries rather than one in the area of the air lock, which reduces ventilating pressure losses when overcasts are properly installed. Vehicular access between air courses still can be accomplished by installing equipment doors to replace stoppings in crosscuts between the air courses.

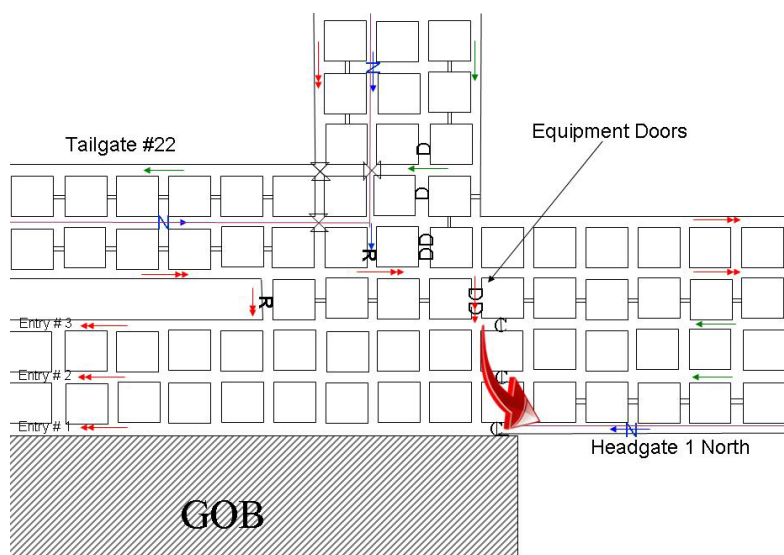
Figure 21 - Latest Headgate Ventilation Design

The MSHA Accident Investigation team found that open equipment doors at key locations would not have caused a dramatic decrease in the intake air quantity for the 1 North Longwall. However, some reductions on the Headgate #22 and Tailgate #22 development sections were possible when equipment doors installed on the longwall intake were opened. The Accident Investigation team also found that return air from the development sections could be routed to the longwall face when equipment doors between the No. 3 entry of the longwall headgate and the No. 1 entry of Tailgate #22 were left open (see Figure 21). The Accident Investigation team determined through interviews with miners that there was at least one occasion when this occurred.

Conclusion: Mine design and plans incorporating equipment doors in critical areas often create a ventilation system too fragile to maintain an acceptable degree of safety for miners. Currently, regulations address the use of equipment doors to separate air courses in lieu of stoppings. However, the proper installation, operation, and maintenance of equipment doors are critical for maintaining a safe and effectively ventilated mine.
