REPORT OF INVESTIGATION

Fatal Fall of Roof or Back Accident
March 20, 2022

D-29 Darby Fork
INMET Mining, LLC.
Holmes Mill, Harlan County, Kentucky
ID No. 15-02263

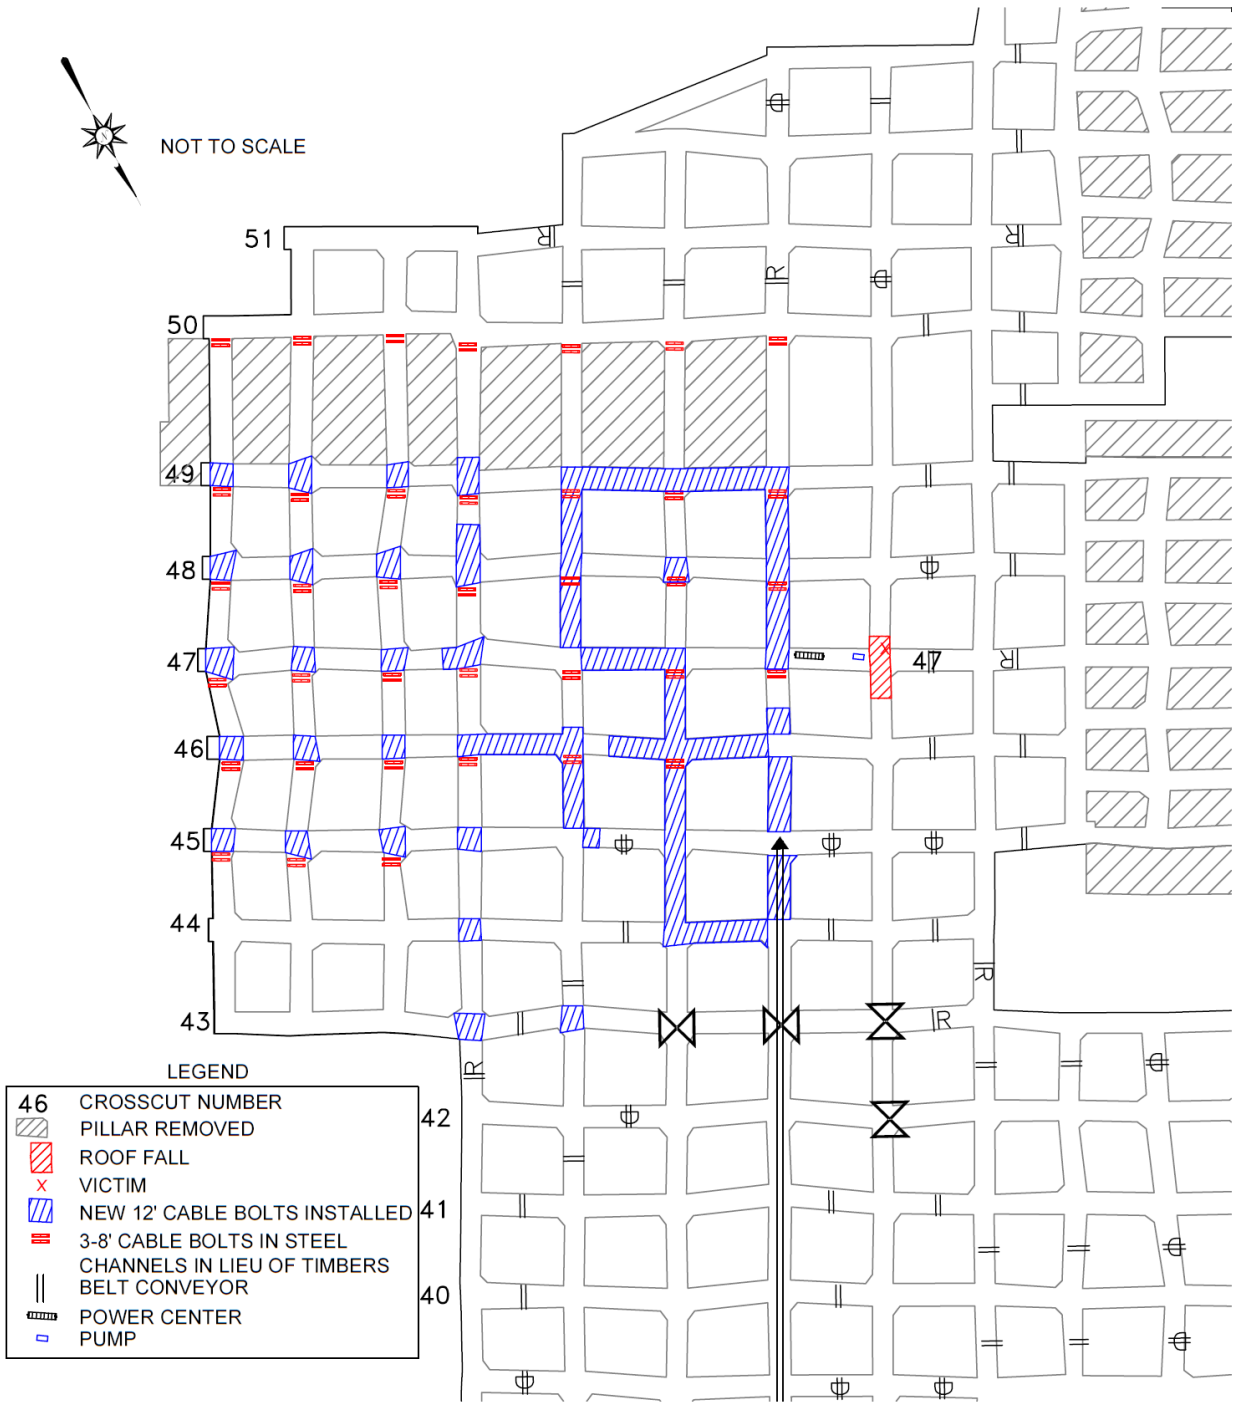
APPENDIX B – 3 South Mains Section Map

The accident occurred in the intersection of #8 entry, crosscut #47, on the 3 South Mains, approximately 180 feet outby the retreat mining section, in an area that was not projected for retreat mining (see Appendix B and C).

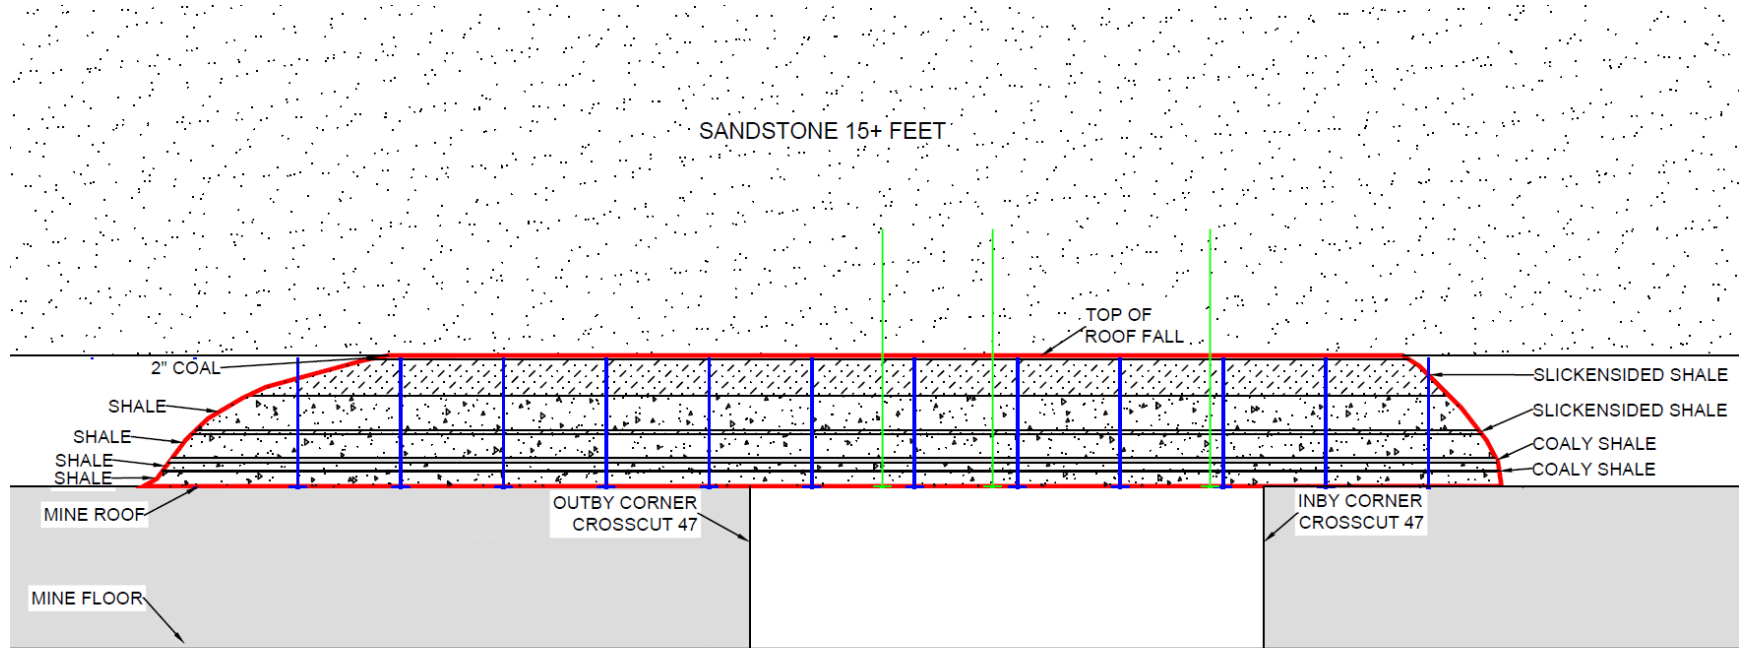
APPENDIX D – Profile View Sketch of the Roof Strata in the Fall Area

The immediate roof (layer of roof immediately above the mined area) of the fall area was five feet thick and consisted of slickensided (compressed to form a slick surface) and laminated shale with coal and slickensided and laminated shale with a two-inch thick coal rider below a massive layer of sandstone. The roof fell up to the beginning of the sandstone where the coal rider created a weak plane. When the 3 South Mains were advance mined (initially mined leaving pillars to support the overburden) in 2017, the mine operator bolted the area with five-foot fully grouted resin bolts on four-foot centers and supplemented the support with ten-foot cable bolts, in accordance with the approved Roof Control Plan (see Appendix D). The five-foot resin bolts did not anchor into the sandstone and relied on the ten-foot cable bolts for anchorage. On March 17, 2022, before the accident, the mine operator began retreat mining and anticipated the need for supplemental roof support in the #1 through #7 entries in the 3 South Mains due to the additional stress on the roof caused by retreat mining in those entries. According to interviews and investigator observations, the mine operator directed miners to install additional ten-foot cable bolts in the #1 through #7 entries in the 3 South Mains.

The geologic conditions and hazards associated with the five-foot resin bolts not anchoring into the competent or sandstone roof were the same in the 3 South Mains and in the #8 entry where the roof fall occurred. The five-foot resin bolts were installed into slickensided laminated shale roof which was not capable of creating a competent beam. Torque tension resin bolts are more suitable to create a beam in laminated mine roof but were not installed. Additionally, the pattern and spacing of the installed cable bolts did not provide adequate roof support for the span of the intersection. The mine operator had extensive knowledge of the mine geology, roof conditions, and the importance of identifying the location of the sandstone in the mine roof, to provide proper roof bolt anchorage. Despite this knowledge, the mine operator did not install additional ten-foot cable bolts to support the #8 entry. A non-reportable roof fall occurred in the 3 South Mains on December 22, 2021. The primary roof support system installed, during advance mining in 2017 by the previous mine operator, was not suitable in the accident area to create a competent beam in slickensided laminated roof. The current mine operator, based on the mine operator extensive knowledge of the mine geology, did not add supplemental cable bolts in a pattern and spacing which would have properly supported the span of the intersection in the area of the accident. Investigators determined that this contributed to the accident.

Corrective Action: The mine operator installed additional roof support, which included 12-foot cable bolts, in the affected area. The mine operator moved the section to a new location and revised the Roof Control Plan. The mine operator trained all miners on the revisions made to the Roof Control Plan.
