# Safety Alert

## Tensioner Bolt Failure

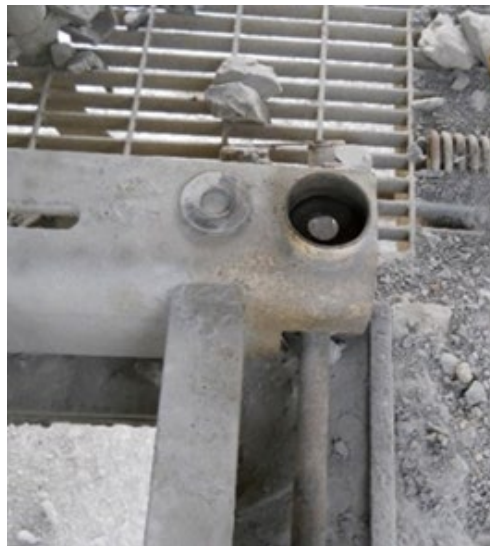
On July 17, 2025, a miner at a surface limestone operation sustained serious injuries while performing repairs on a belt drive motor. During the repair process, the motor's tensioning system was being adjusted when a ¾-inch diameter all-thread tensioner bolt failed, causing the bolt to break loose and strike the miner in the face. Spring-integrated designs with constant pressure and continuous vibrations pose potential safety concerns.

Broken Tension Bolt

- **Ensure all miners** receive thorough training to identify workplace hazards and perform tasks safely.
- **Maintain all equipment** and safety devices in proper working condition to ensure safe operation by reviewing manufacturer manuals prior to service; replace worn or damaged components; and use tightening sequences and tighten as recommended.

- **Check component quality** by examining bolts, washers, springs, and nuts for visible defects like rust, cracks, corrosion, thread damage or deformation.

- **Conduct a risk assessment** before starting work to identify and control all forms of stored energy, including mechanical, electrical, hydraulic, gravitational hazards, and unintended motion of equipment.

- **Alignment matters:** Ensure all components are properly aligned before bolt installation. Misalignment can lead to uneven stress distribution within the system, possibly leading to their premature failure.
