# Safety Alert

## Extended Cuts with Continuous Mining Machines

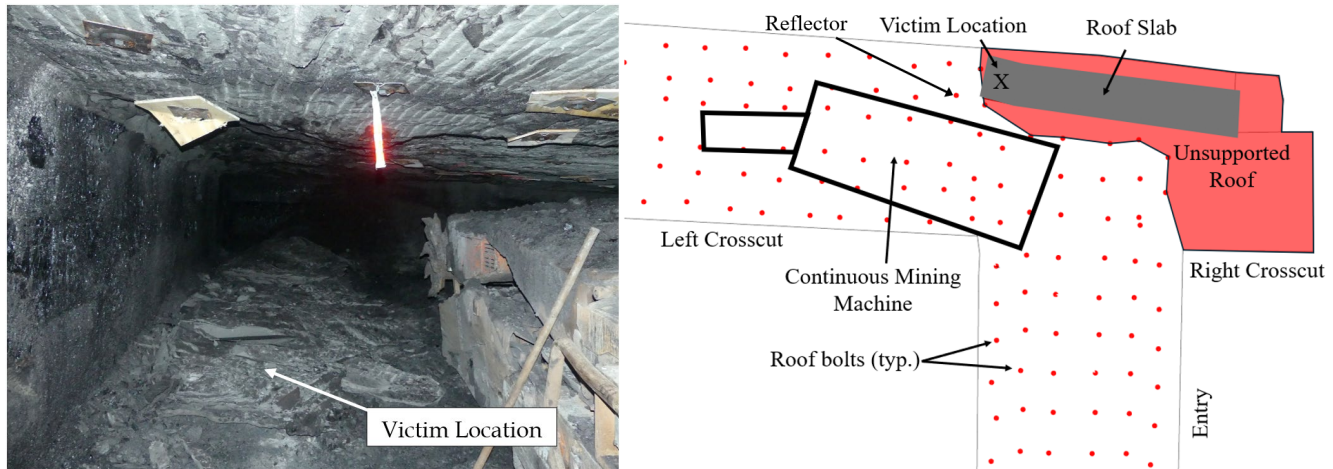
On September 6, 2024, a continuous mining machine (CMM) operator died when roof rock fell and struck him while he worked under unsupported roof. At the time of the accident, the operator was repositioning the CMM after taking an extended cut through an intersection into the adjacent crosscut.

- **Never travel under unsupported roof.**
- Install reflectors, lights, and barricades to clearly identify the next to last full row of bolts to warn miners to not travel under unsupported roof.
- Follow the extended cut requirements in the approved roof control plan and train miners on the plan.
- Take extended cuts only in areas with competent roof conditions. Take shorter cuts when adverse roof conditions are encountered.
- Install intersection support in accordance with the approved roof control plan
- Advance headings so they are flush across their width and fully supported. Until headings are flush across their width and fully supported, do not take additional cuts.
- Do not position yourself along either side of the CMM while tramming.
