METAL/NONMETAL Close Call Accident Alert

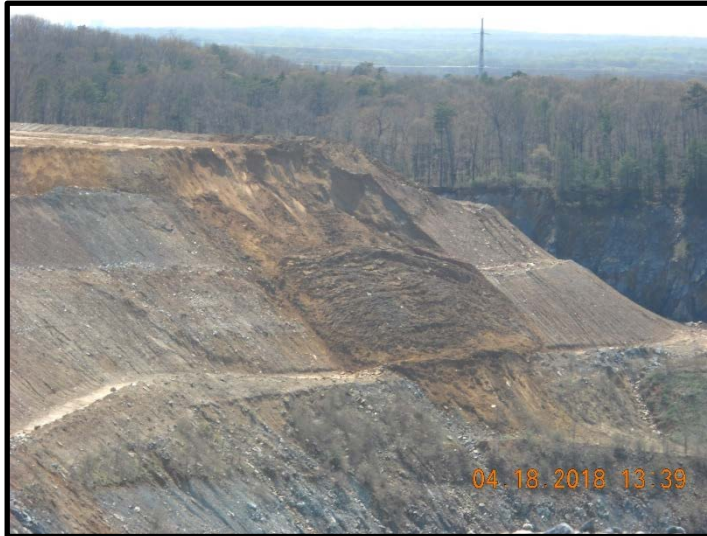
Surface – Slope Failure – On April 18, 2018, a front-end loader operator observed that a portion of the "dirt dump" or refuse pile located on the top rim of the quarry had sloughed and the material had slid down to multiple benches below. An estimated 10,000 to 15,000 tons of material was involved in the slide. There were no injuries. The "dirt dump" was barricaded and posted against entry.

- Diligent monitoring and examination of slopes for signs of instability is imperative for protecting miners.
- Maintain safe operational practices for the protection of personnel, equipment, and facilities.
- Properly grade surfaces of dump piles to permit water to drain from the area.
- Provide warning of instability so action can be taken to minimize the impact of slope displacement.
- Provide crucial geotechnical information to analyze slope stability and design slopes to prevent instability.
- Once cracks are detected, the condition should be evaluated by a qualified engineer. Equipment should not operate across cracks until they are evaluated and the stability of the ground determined.
