Metal and Nonmetal Fatalities in 2016

(as of 9/26/2016)

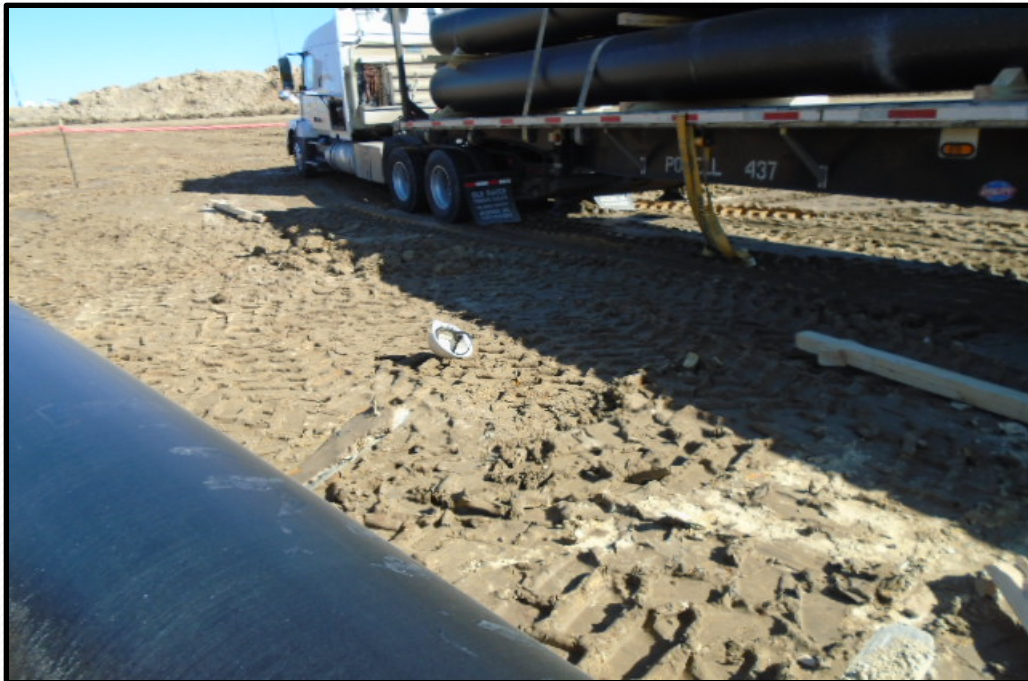
On February 26, 2016, a contract truck driver delivering multiple sections of polyurethane pipe was struck by a section of pipe during the unloading process. A forklift removed two sections of pipe from the passenger side of the truck, and then left the area with the two sections. While the forklift was away, a single, unsecured section of pipe rolled off on the driver's side of the truck and struck the victim. Each section of pipe was approximately 50' long and weighed approximately 1,750 pounds. Miners began first aid but the driver was unresponsive. He was transported to the local hospital and later died.

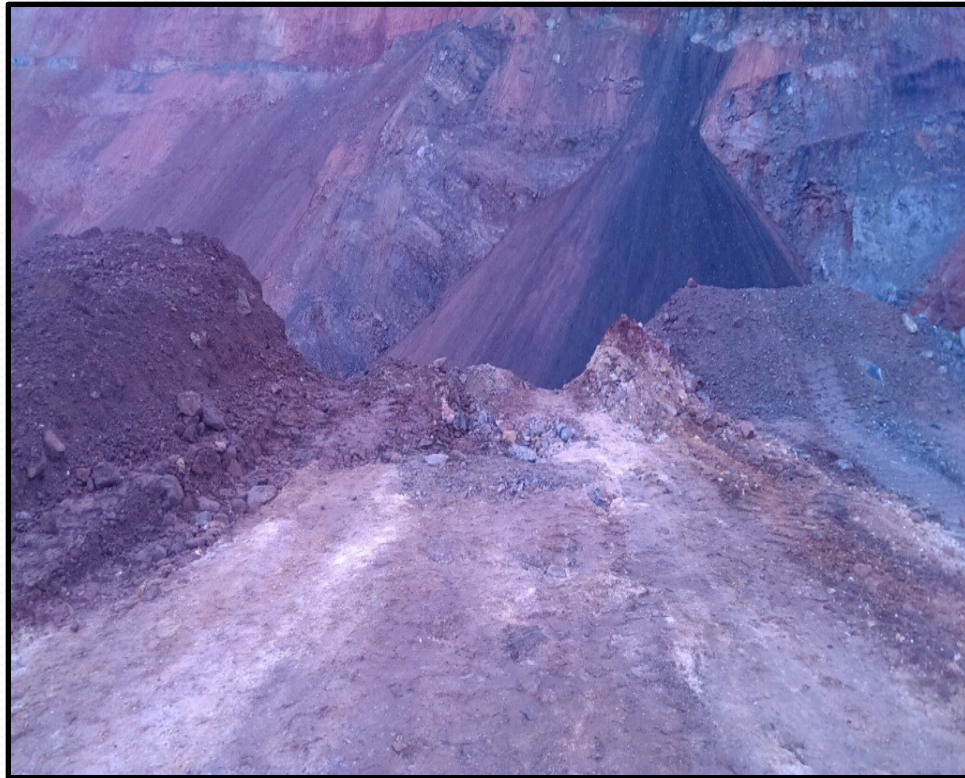
On March 8, 2016, a 54-year old miner with 5 years of mining experience was killed at a surface sand mine. The miner backed his haul truck over a dump site and the driver was found at the bottom of the embankment, 60 feet below the dump point. The victim was found unresponsive and partially submerged in water. CPR was attempted, but the victim was not able to be resuscitated.

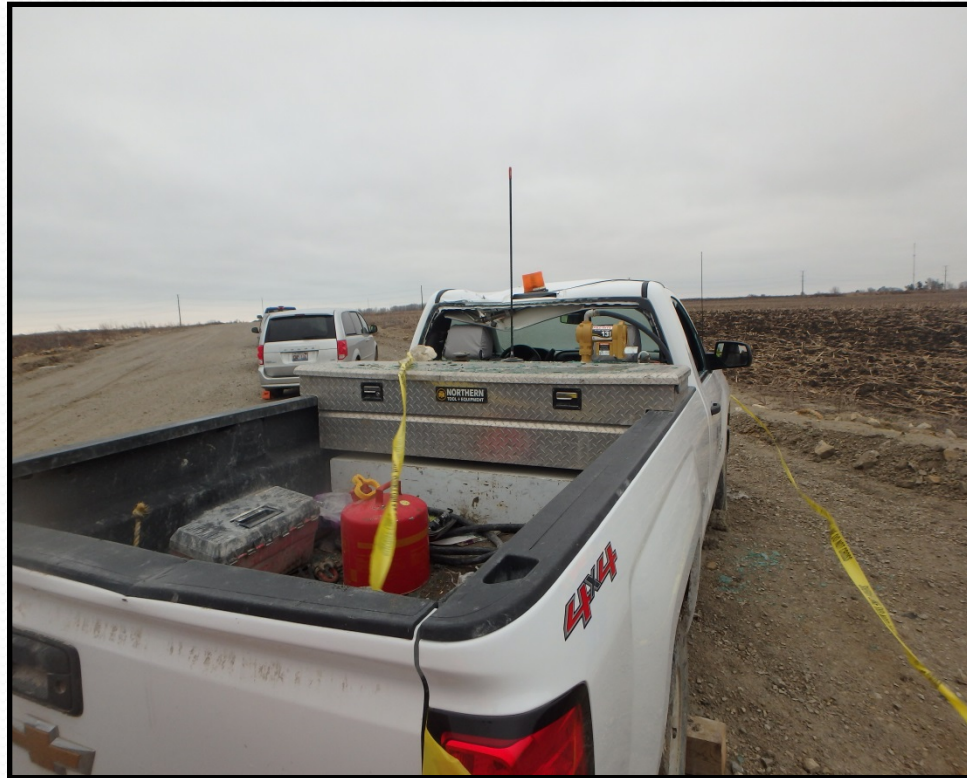
On Tuesday, March 22, 2016, a leadman was struck and killed by flyrock during blasting operations. The victim was over 1,000 feet from the blast site and was waiting in his truck to prevent others from accessing the blast site.

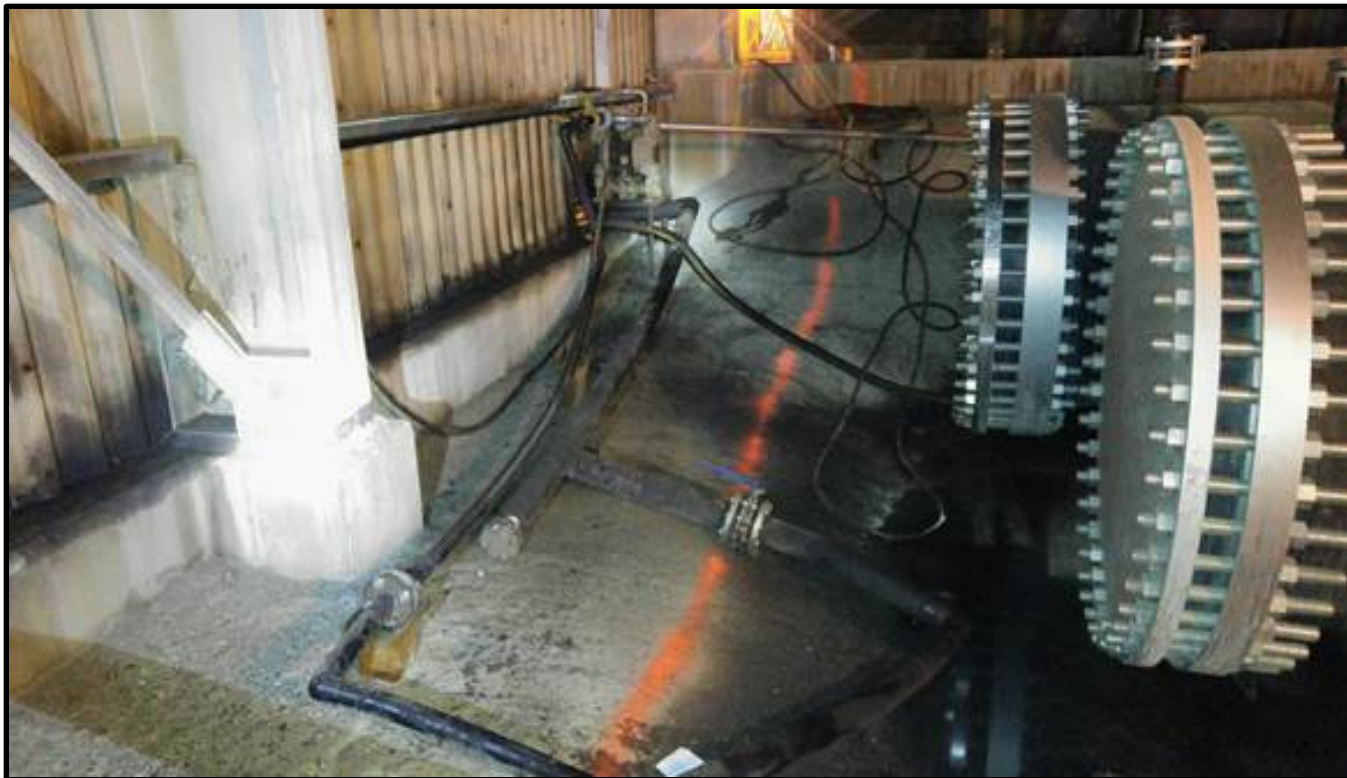
On April 9, 2016, a 25-year old plant operator with 4 years of mining experience was fatally injured at a surface copper ore mine. He was found unresponsive, kneeling with his face against a stainless steel flange that was connected to a high-density polyethylene pipe. The medical examiner ruled the cause of death as probable electrocution.

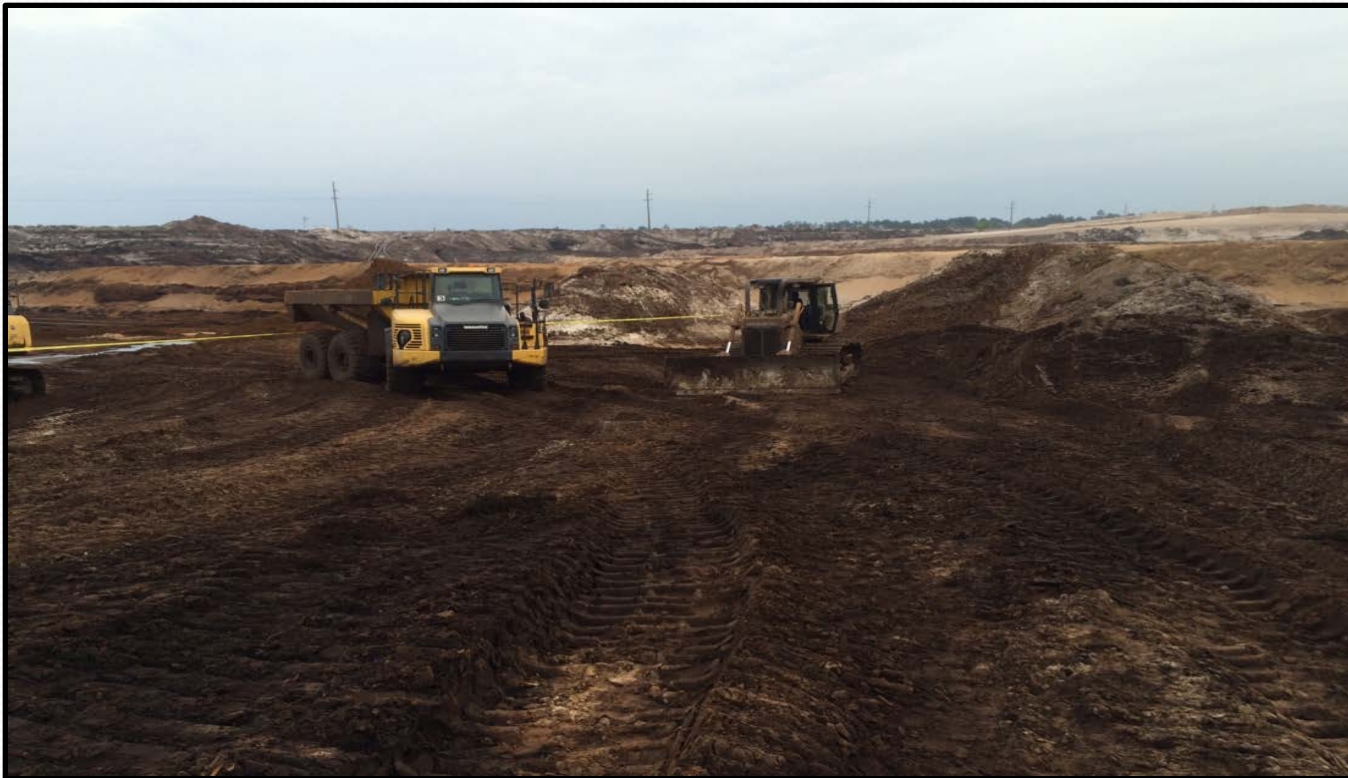
On April 11, 2016, a 61-year old contract dozer operator with 18 years of mining experience was fatally injured at a surface titanium ore mine. The victim had been using a dozer to perform maintenance on the haul road into the pit. The victim either fell or stepped onto the left-side dozer track as the machine started moving backwards down a slope. He was found laying approximately 30 feet in front of the dozer's stopping point.

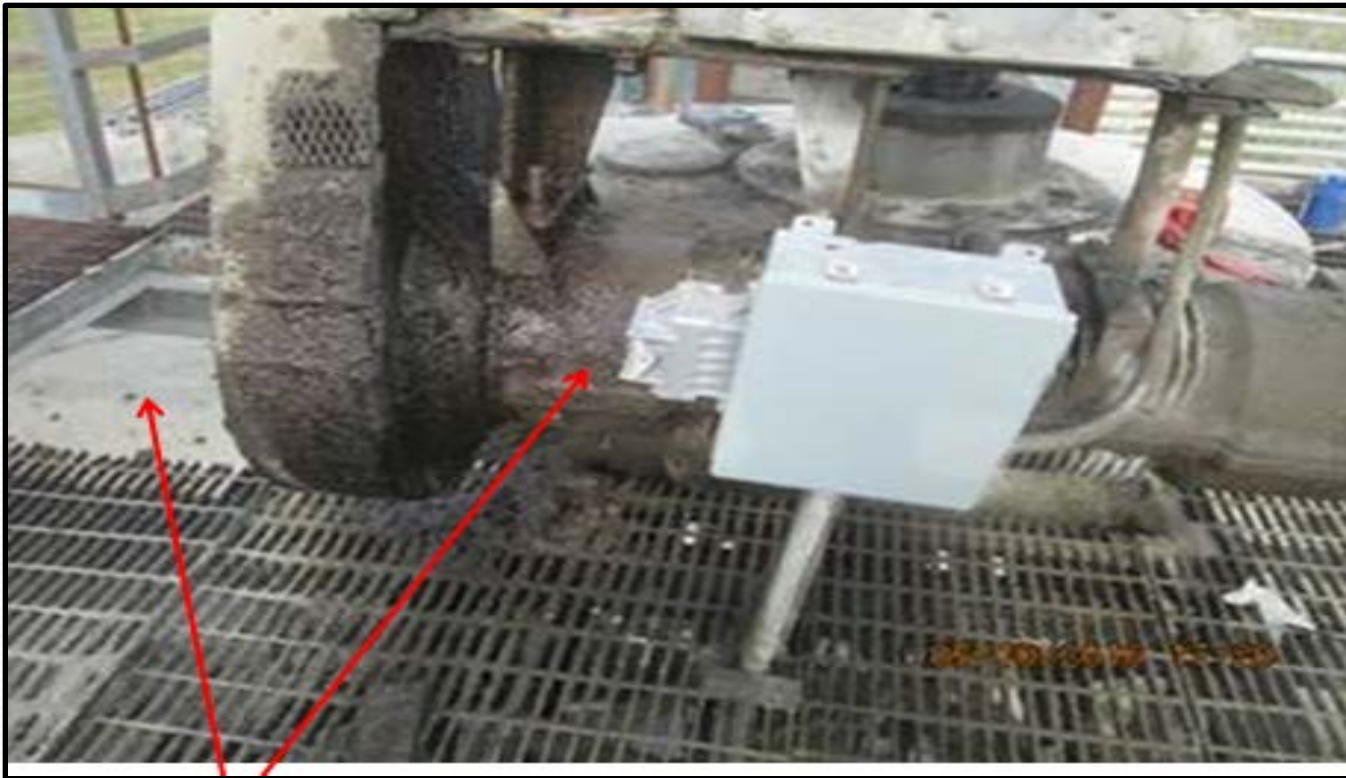
On May 10, 2016, a 46-year old maintenance man with 6 years of experience was fatally injured at a cement plant. The victim went to the top of the slurry tank to start the rake system. He fell 50 feet through a 3-foot by 4-foot opening in the walkway into the empty slurry tank below.

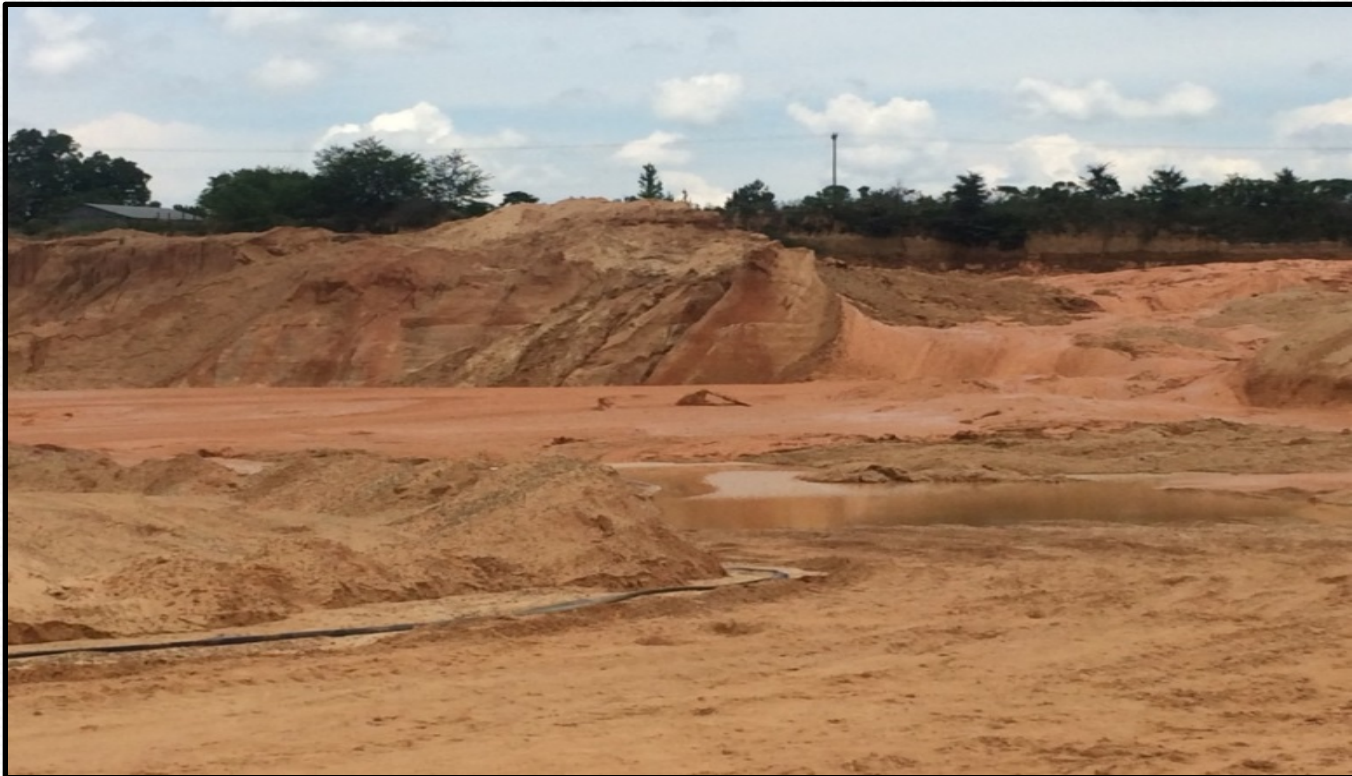
On June 3, 2016, a 24-year old haul truck operator, with 9 months of experience, and a 56-year old hydraulic excavator operator, with 6 years of experience, were killed at a sand and gravel operation. The two miners were working in a pit next to an abandoned roadway embankment, which partially bound an old pit. Waste clay and sand had been placed in the old pit for reclamation purposes. The embankment failed and the waste clay and sand engulfed both miners.

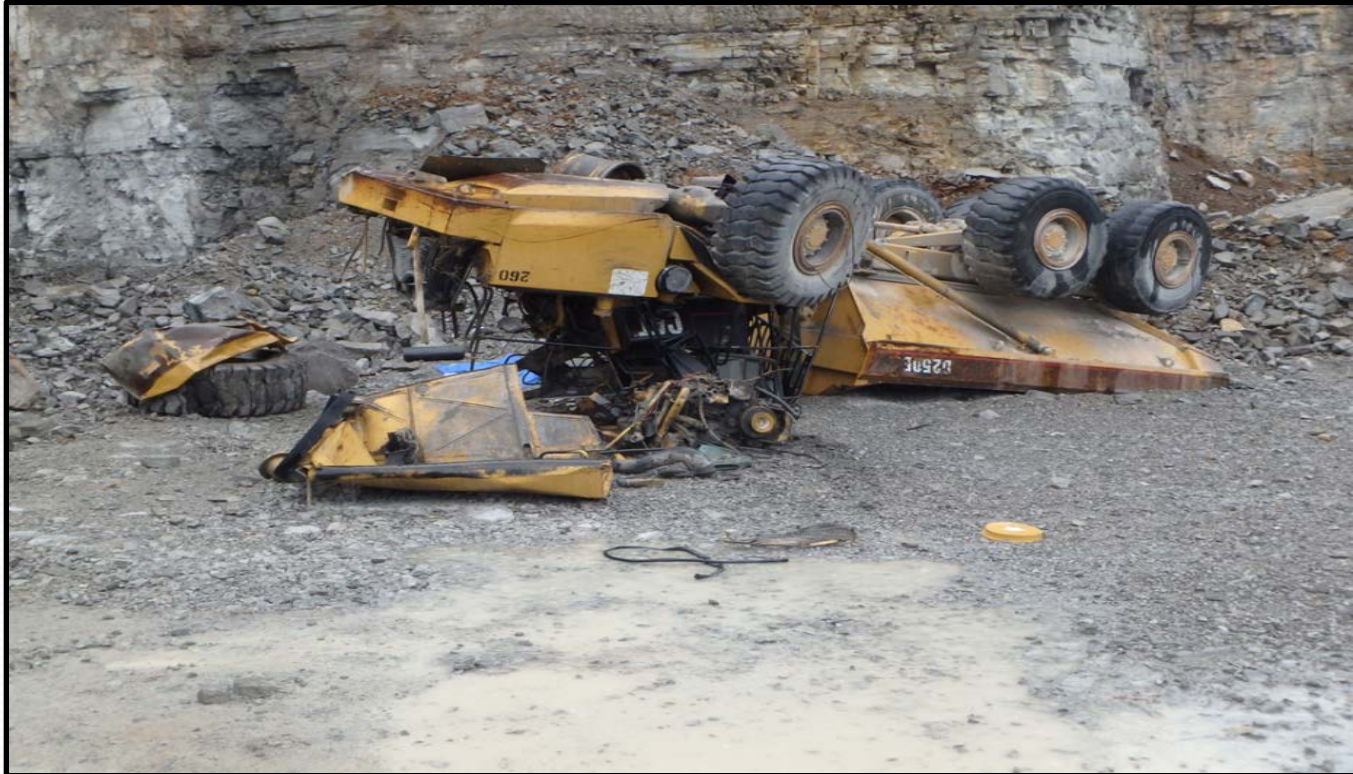
On June 27, 2016, a 61-year old Mine Superintendent, with 24 years of experience, was killed at a limestone quarry. The victim was building a ramp to the lower bench and was positioning his haul truck to dump a load of material near the edge of a highwall and rolled backwards over the 90 foot highwall.

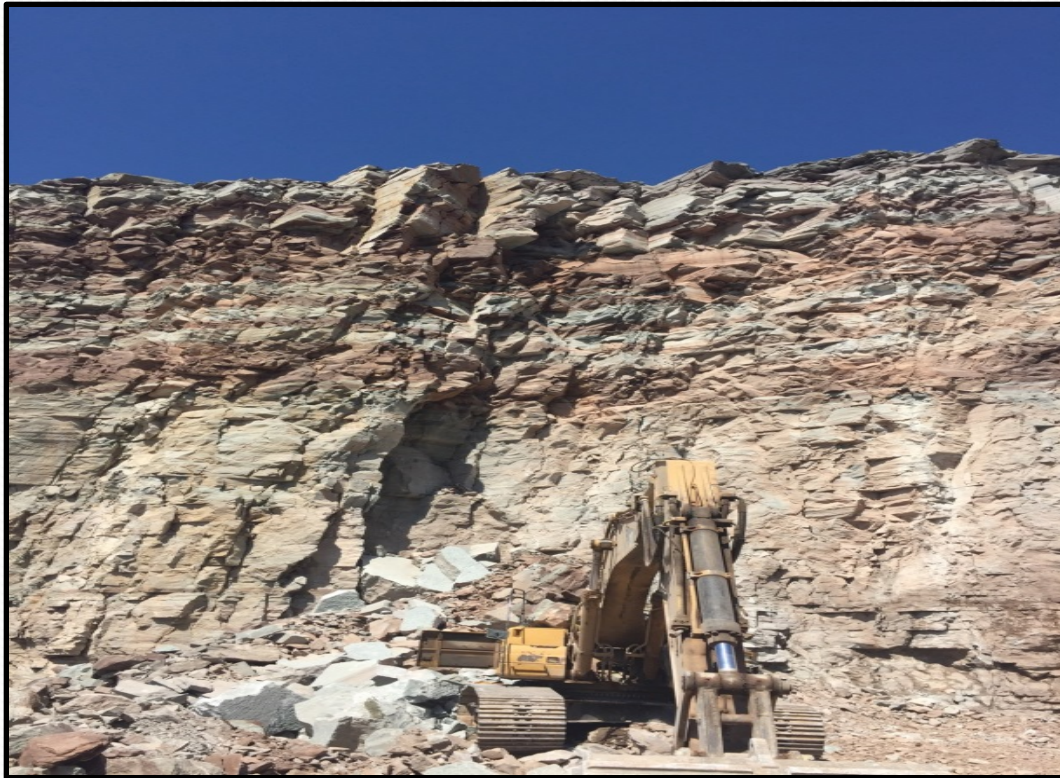
On July 25, 2016, a 59 year old Excavator Operator, with 17 years of experience, was killed at a limestone quarry. Prior to the accident, the victim was loading shot rock into haul trucks. While waiting for the haul trucks to return, the victim was separating out over sized rocks when the cab of his excavator was struck by falling material from the highwall.

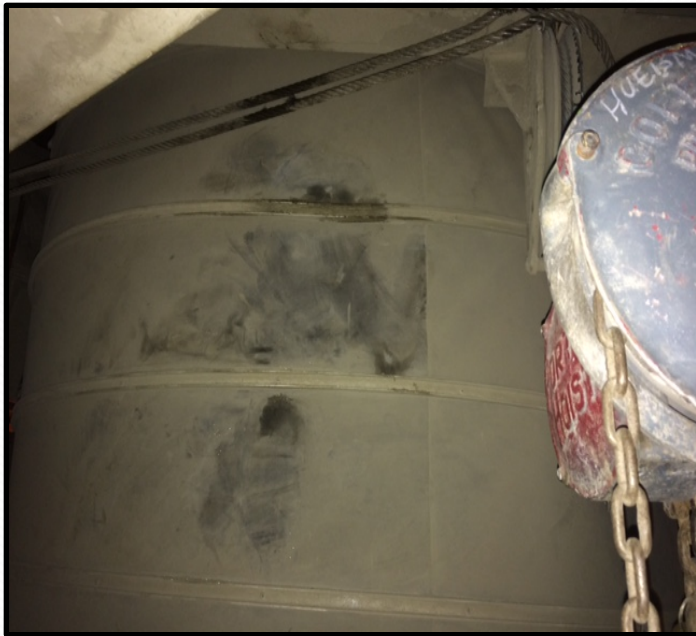
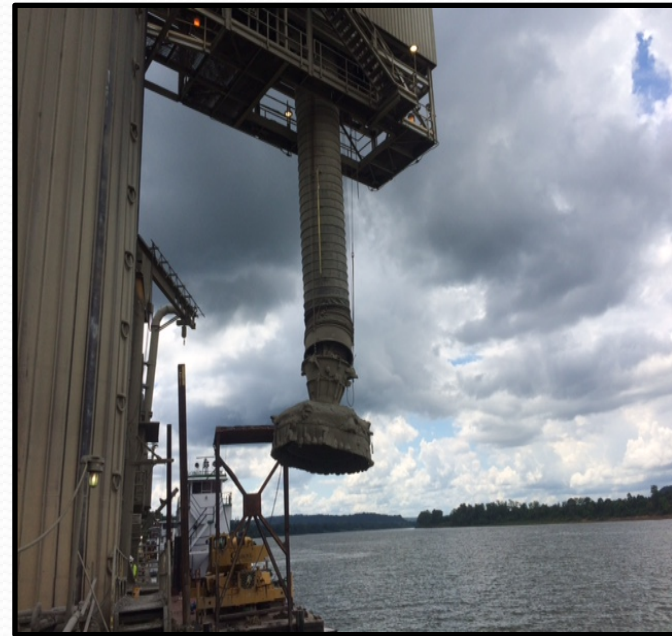
On August 9, 2016, a 33 year old Leadman Contractor, with 4 years of experience, was killed at a cement plant loadout. The victim was attempting to replace the lift cable pulleys on the barge loadout chute, when the anchor point for the temporary rigging separated from the loadout chute and it unexpectedly fell. The falling loadout chute caused the lift cables to tighten and the lift cables pinned the victim to the loadout chute causing fatal injuries.

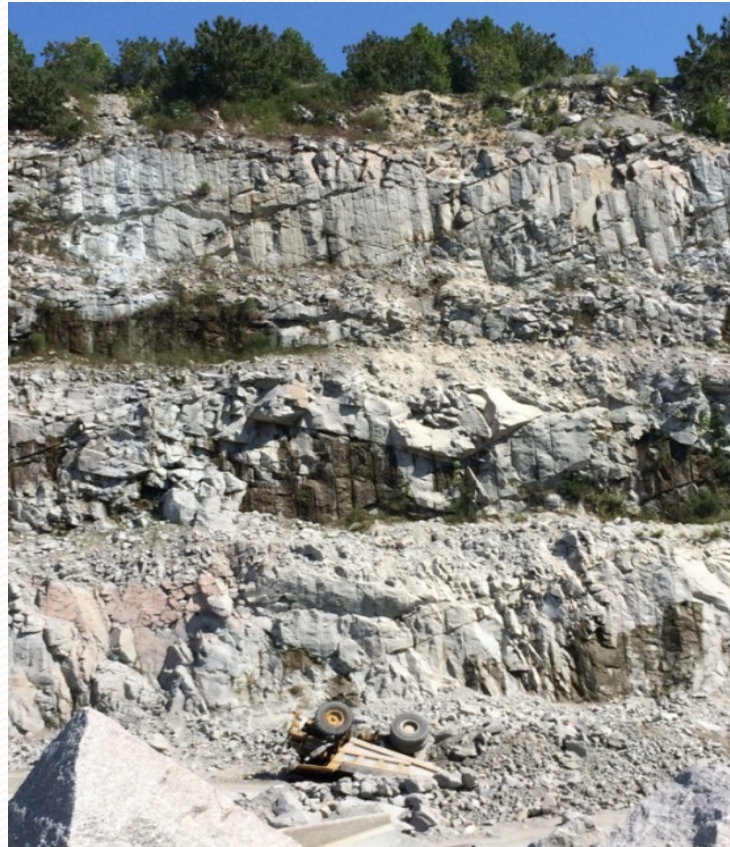
On September 8, 2016, a 58-year old Haul Truck Operator with 23 years of experience was killed at a granite mine. The victim was operating a Caterpillar 773E haul truck and was returning to the pit to be loaded with shot rock. The truck veered from the right side of the haul road to the left and traveled over the berm at the top of the highwall. The truck landed upside down approximately 150 feet below. The victim was found outside the haul truck.

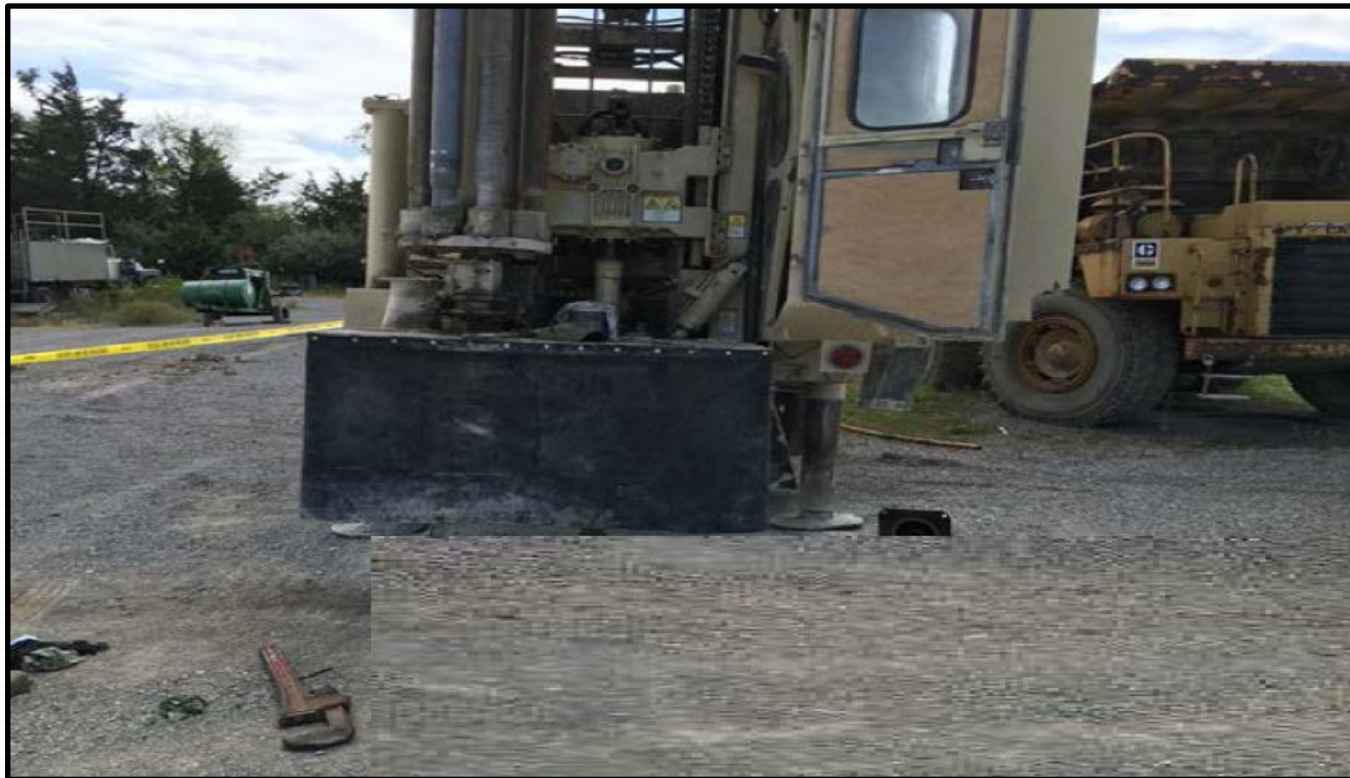
On September 21, 2016, a 52 year old contract Drill Operator contractor, with 27 years of experience, was killed at a limestone mine. The victim was performing maintenance on a truck-mounted rotary drill when a wrench he was using broken free piercing his abdomen. As the victim attempted to climb down an adjacent step ladder, he was observed falling to the ground and striking his head on a breakaway wrench which was laying on the ground. The victim was transported to a hospital and underwent surgery. He died later that day as a result of his injuries.
