# **METAL / NONMETAL**

## **Near Miss Accident**

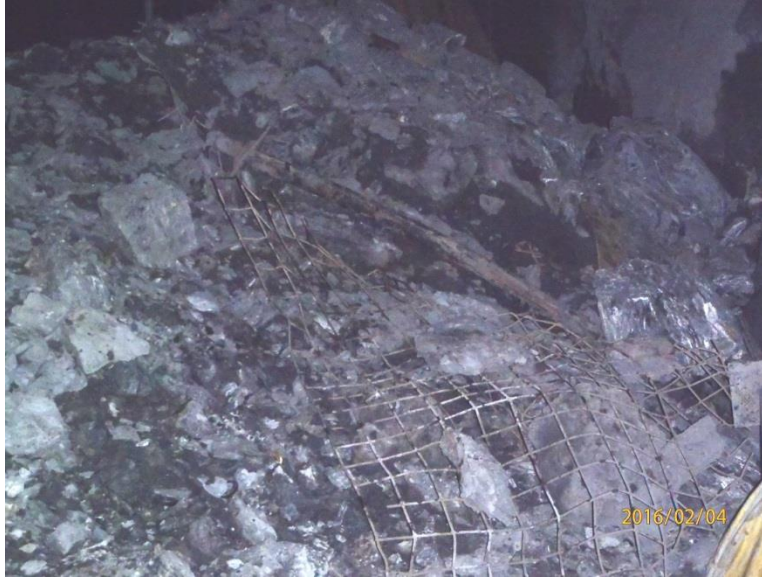
Underground Gold Mine – Two miners were trapped behind a back/roof fall when they could not safely exit their workplace. The roof fall was from rib to rib and extended approximately 15 feet in length and 5 feet high. The miners were safely removed from the area after being trapped for over four hours with no reported injuries.

- Train all miners and supervisors to conduct thorough examinations of the back/roof where persons will be working and traveling.
- Correct all hazardous conditions before allowing persons to work or travel in such areas.
- Provide additional support when back/roof fractures, or other abnormalities are detected.
- Be alert for changing conditions, especially after activities that could cause back/roof disturbance. Report abnormal back/roof conditions to mine management.
- Adequately support or scale any loose back/roof material from a safe location. Use a bar of suitable length and design when scaling.
- Danger off hazardous areas until appropriate corrective measures can be taken.
