## **Equipment Alert -- February 10, 2011**

### **Update on Failure of High Pressure Gas Fittings and Valves in Refuge Alternatives**

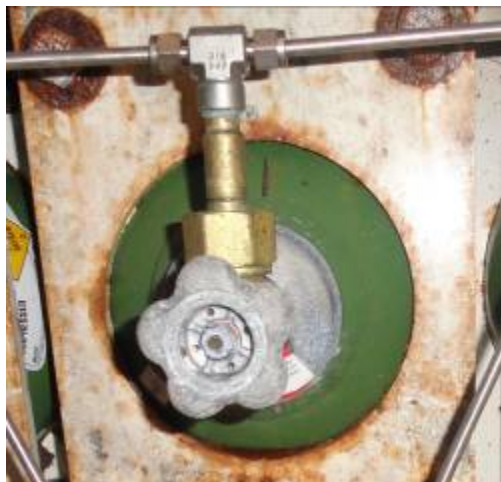
A visual examination may not permit a satisfactory assessment of the condition of the fitting (as seen in Figure 1). However, fittings examined under a microscope showed significant cracking inside the second fitting (Figure 2). This area cannot be viewed without first removing the fitting from the cylinder and nipple.

Figure 1 – View of Installed Fitting

Mine operators should contact their refuge alternative manufacturer and request that the manufacturer conduct a prompt and thorough examination of their units for interior and exterior cracks on fittings and cylinder valves. If this examination identifies any fittings or valves exhibiting cracking, then the refuge alternative should be removed from service until it can be repaired or replaced. These steps are necessary to assure that all refuge alternatives can be safely used in underground coal mines.

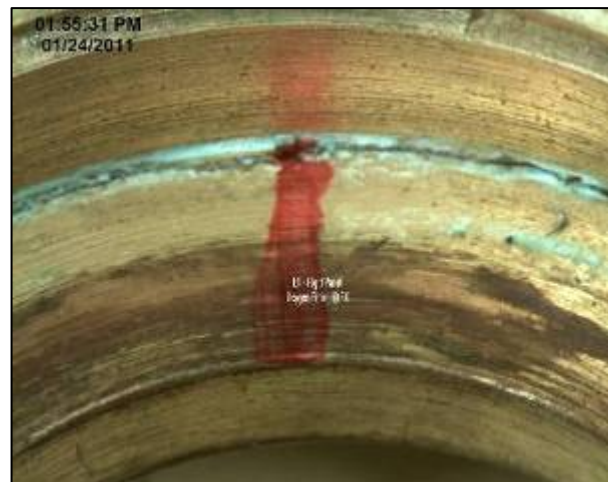
Figure 2 – magnified view inside brass fitting showing cracking (this fitting was still intact and held compressed gas)

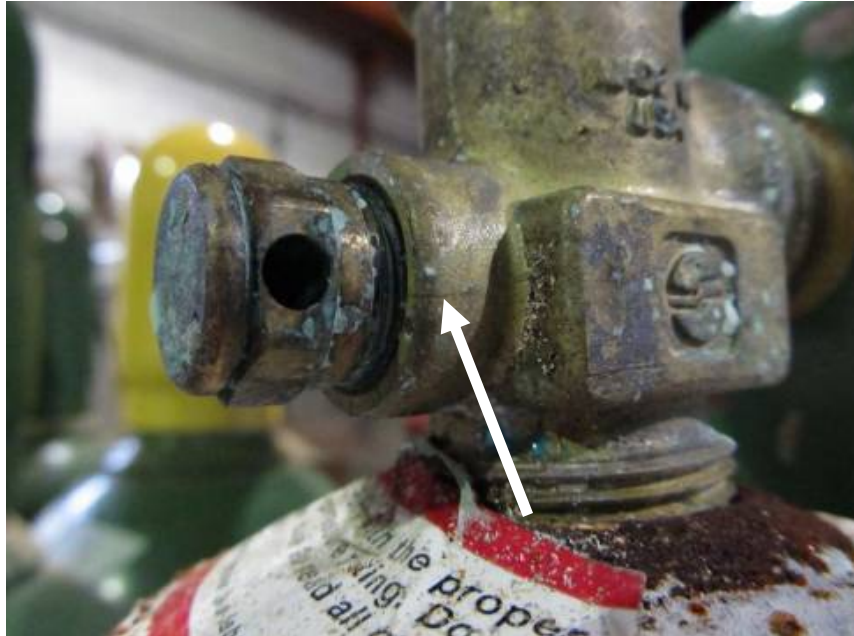
Likewise, the cracks in the cylinder valves associated with the third refuge unit were not readily visible until the cylinders had been removed from the refuge alternative.

Figure 3 – View of cracked cylinder valve. Arrow points to crack.
