# Safety Alert

## Bulldozer Accident

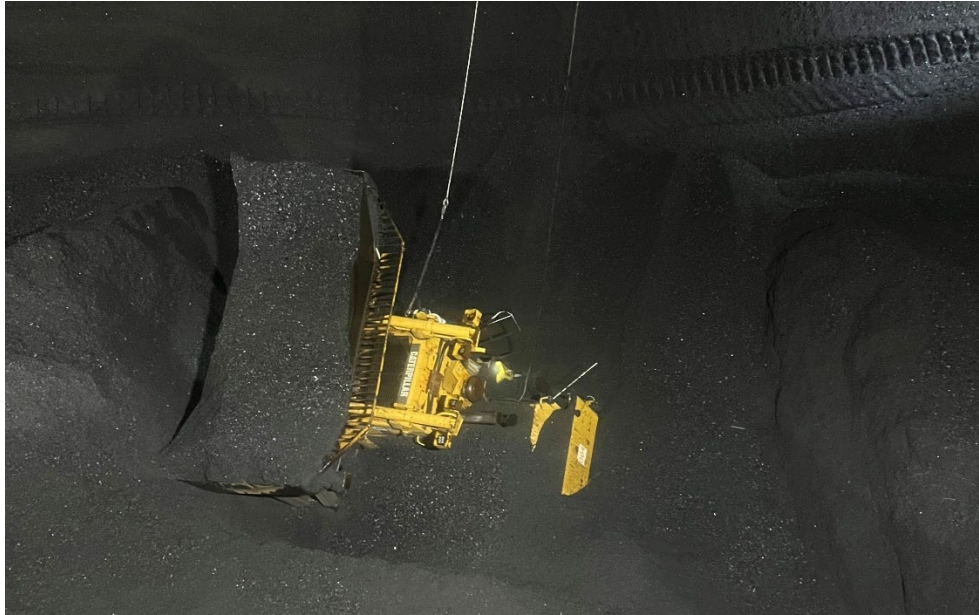
On May 22, 2025, a bulldozer fell into a void above a feeder. The loose material from the coal pile collapsed around the bulldozer, engulfing the bulldozer and trapping the miner inside the cab. The bulldozer was equipped with a “submarine kit”, consisting of high-strength glass, self contained self rescuers, and two-way communication. From January 2020 to May 2025, there have been seven entrapment accidents involving bulldozers.

- **Maintain stability.** Do not operate equipment directly over feeders and clearly mark the location of the draw holes.
- **Identify and communicate significant changes in feed rate** that may indicate the presence of a void in the stockpile.

- **Stock equipment cabs with safety equipment.** Include emergency oxygen, remote shut offs, and two-way communication. Ensure all safety devices are properly maintained.

- **Install high-strength glass** certified for at least 40 psi with a frame and supports designed to withstand the added loading of entrapment conditions.

- **Train miners and other persons at the mine** to identify and address or avoid hazards related to surface mobile equipment.
- **Always wear seatbelts** when operating mobile equipment and stay in the cab to ensure safety.

- **Identify currently available and newly emerging feasible technologies** that can enhance safety at the mine and evaluate whether to adopt them.
