REPORT OF INVESTIGATION

Fatal Machinery Accident  
April 20, 2023

Tri State Maintenance Solutions LLC (C3953)  
Washington, Daviess County, Indiana

Bear Run Mine  
Peabody Bear Run Mining LLC  
Carlisle, Sullivan County, Indiana  
ID No. 12-02422

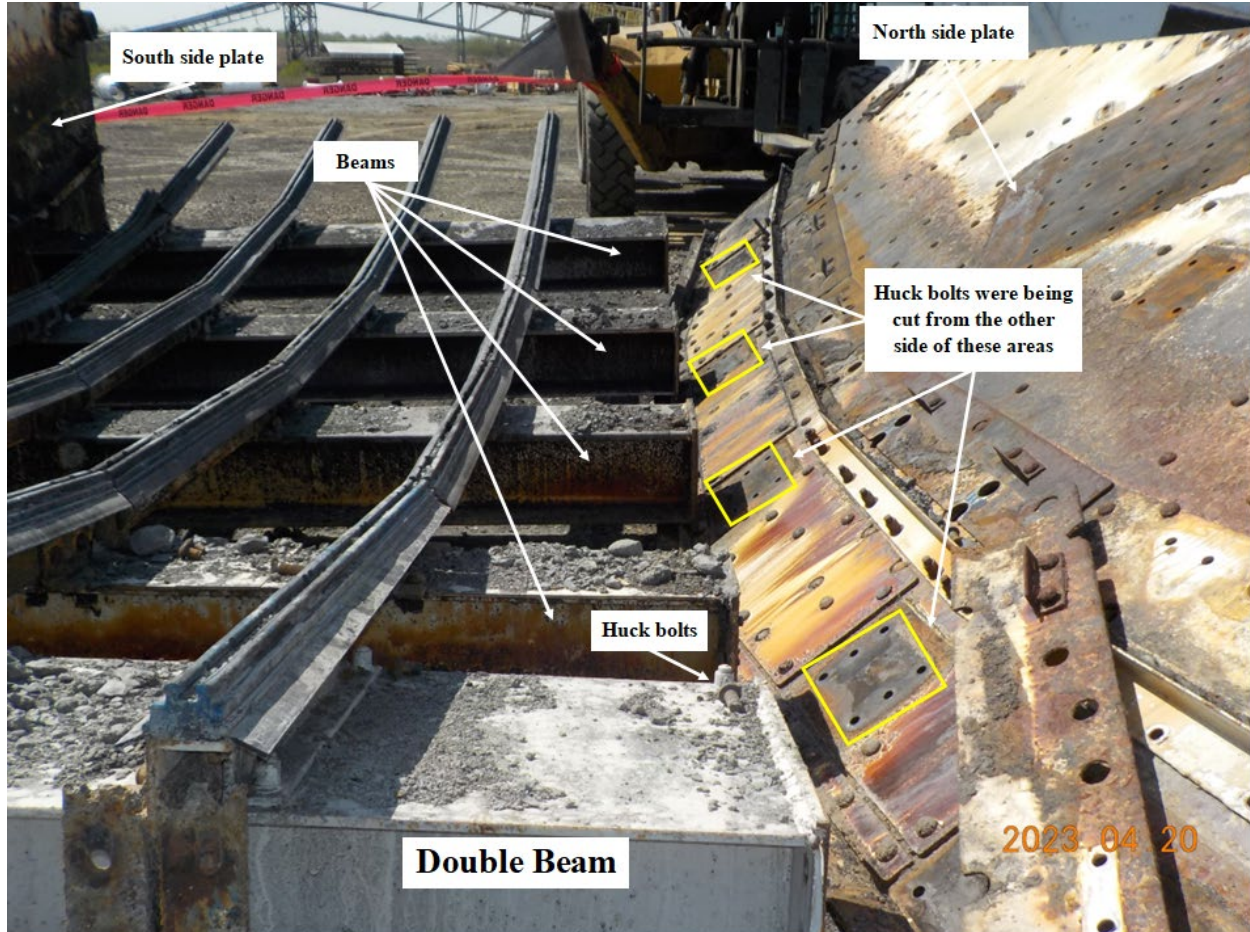
APPENDIX B – Photo of Shaker Screen

The shaker screen involved in the accident was a Conn-Weld Industries, Inc., ten-foot by 20-foot five-angle vibrating screen. The mine operator uses the shaker screen in the preparation plant to separate the fine material from the coarse material. This shaker screen was taken out of service on March 15, 2023, to be discarded. The total weight of the shaker screen was approximately 39,000 lbs. The north side plate weighed approximately 4,600 lbs. Both ends of the shaker screen's north side plate measured three feet, two and one-half inches in height, and increased to eight feet, four and one-half inches at its highest point.

Interviews with the Tri State crew revealed that they did not block any part of the shaker screen against motion while disassembling it throughout the day. The contractor did not block against motion the shaker screen side plates before the crew cut out the inside support pipes. These support pipes were welded to the inside of the shaker screen side plates to give them stability. The contractor cut loose at least one of these inside support pipes and allowed it to fall to the screen deck below before the crew began removing the bolts. In addition, the contractor did not block against motion either shaker screen side plate before the crew removed the bolts. All bolts holding the east end double beam to the shaker screen were cut by Bedwell earlier in the shift. The sideboards held this beam in place until the north side plate fell. When the north side plate fell, however, the north end of the double beam dropped, becoming suspended off the ground.

According to interviews, Tri State planned to use the telehandler forks and slings to secure the side plate before they removed the final bolts. Wininger instructed Bedwell and Zimmerman to leave enough bolts in place to hold the side plate in place until the side plate could be rigged to the telehandler. Once secured, the remaining bolts would be removed, and the telehandler would be used to lay the side plate down. Wininger told investigators he was not aware that Zimmerman had removed the three bolts from the middle beam until he walked around to where Zimmerman was cutting. Investigators found no materials appropriate for blocking the shaker screen against motion at or near the disassembly work area. Investigators determined that the mine operator and the contractor did not ensure the side plate being removed was blocked against motion, which contributed to the accident.

Corrective Action: The mine operator revised their safety procedure to include a checklist of energies to look for and additional hazard checklist questions focusing on stored energy and blocking against motion. The mine operator retrained miners and contractors on isolation and blocking against motion.

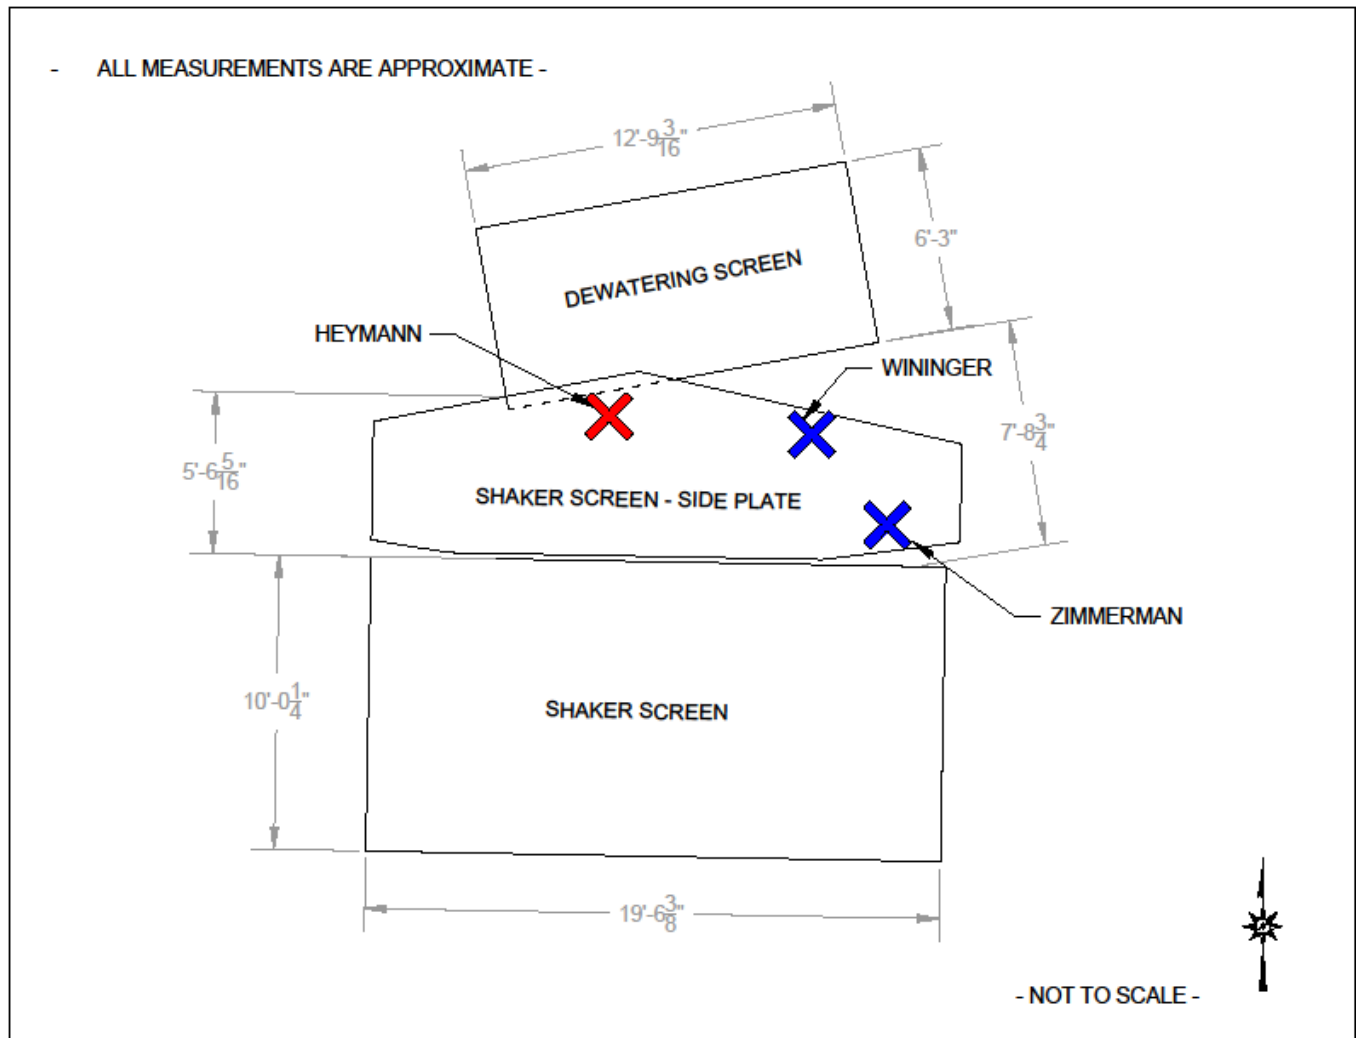
## APPENDIX C – Aerial Sketch of Accident Scene

The accident occurred 100 yards southeast of the preparation plant. The shaker screen and dewatering screen were next to each other in the preparation plant yard. The shaker screen was located on the south side of the dewatering screen. The distance between the shaker screen's north side plate and the dewatering screen's south side plate measured five feet on the west end and seven feet and eight inches on the east end. The ground was dry and mostly level in this area.

The dewatering screen involved in the accident was a Conn-Weld Industries, Inc. six-foot by 12-foot screen. It was used in the preparation plant to separate water from fine material. This dewatering screen was taken out of service on March 13, 2023, to be discarded. When the shaker screen's north side plate fell, it came to rest on the dewatering screen's south side plate, which was still secured to the dewatering screen.
