REPORT OF INVESTIGATION

Fatal Powered Haulage Accident  
May 2, 2023

Plant 280  
Bowes Construction Inc  
Brookings, Brookings County, South Dakota  
ID No. 39-01505

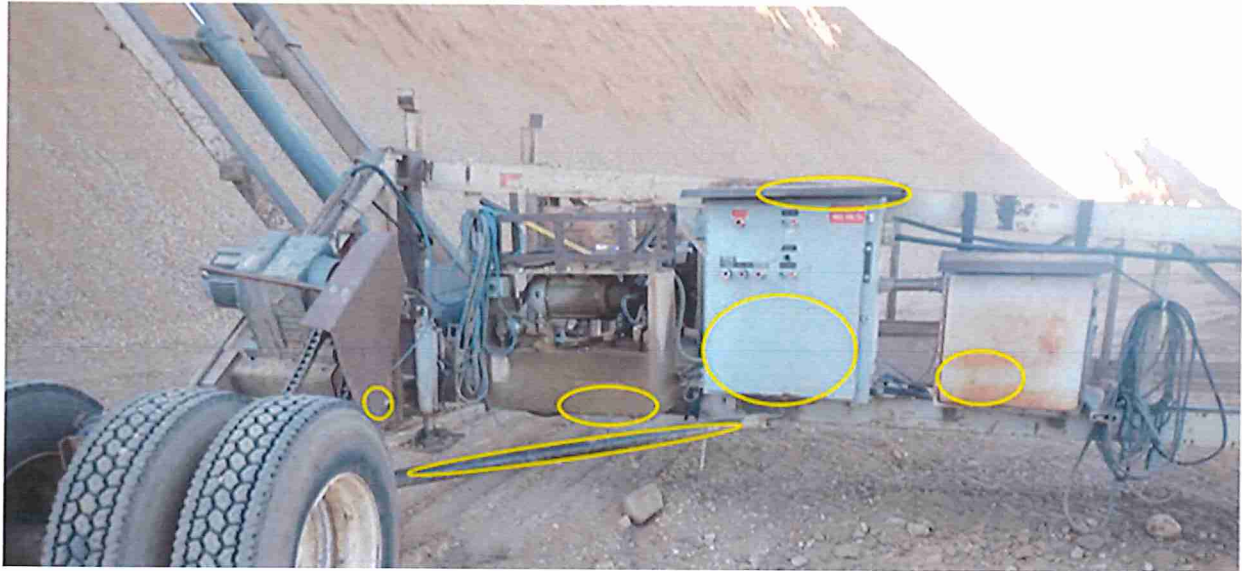
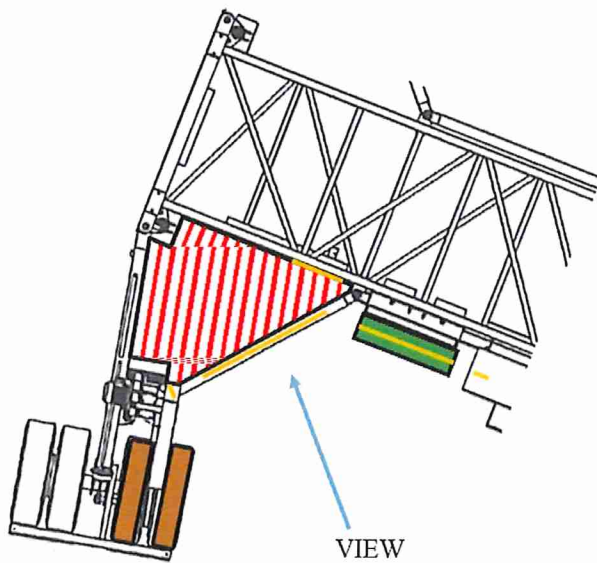
## APPENDIX C – Penetrating Oil Residue Location

The accident occurred at the plant's radial stacker, located on the north end of the mine (see Appendix B). Interviews revealed that Waddel found Wixon with a crushed can of penetrating oil at his side. A pattern of oily residue distributed throughout the left side radial axle restricted access area indicates the location of the accident (see Appendix C). The manufacturer designed the area to allow miners to have access to the controls for the hydraulic jacking cylinders while the radial stacker was not in motion. The radial axle support, the left radial axle arm, the undercarriage, and the left radial arm locking bar enclose the left side radial drive access area, with no signage or conspicuous markings to warn against entry into this area when the equipment is operating. To travel into the area, a miner must step on or over the left radial arm locking bar which is approximately eight feet long and 19 inches above grade.

Location of oil residue

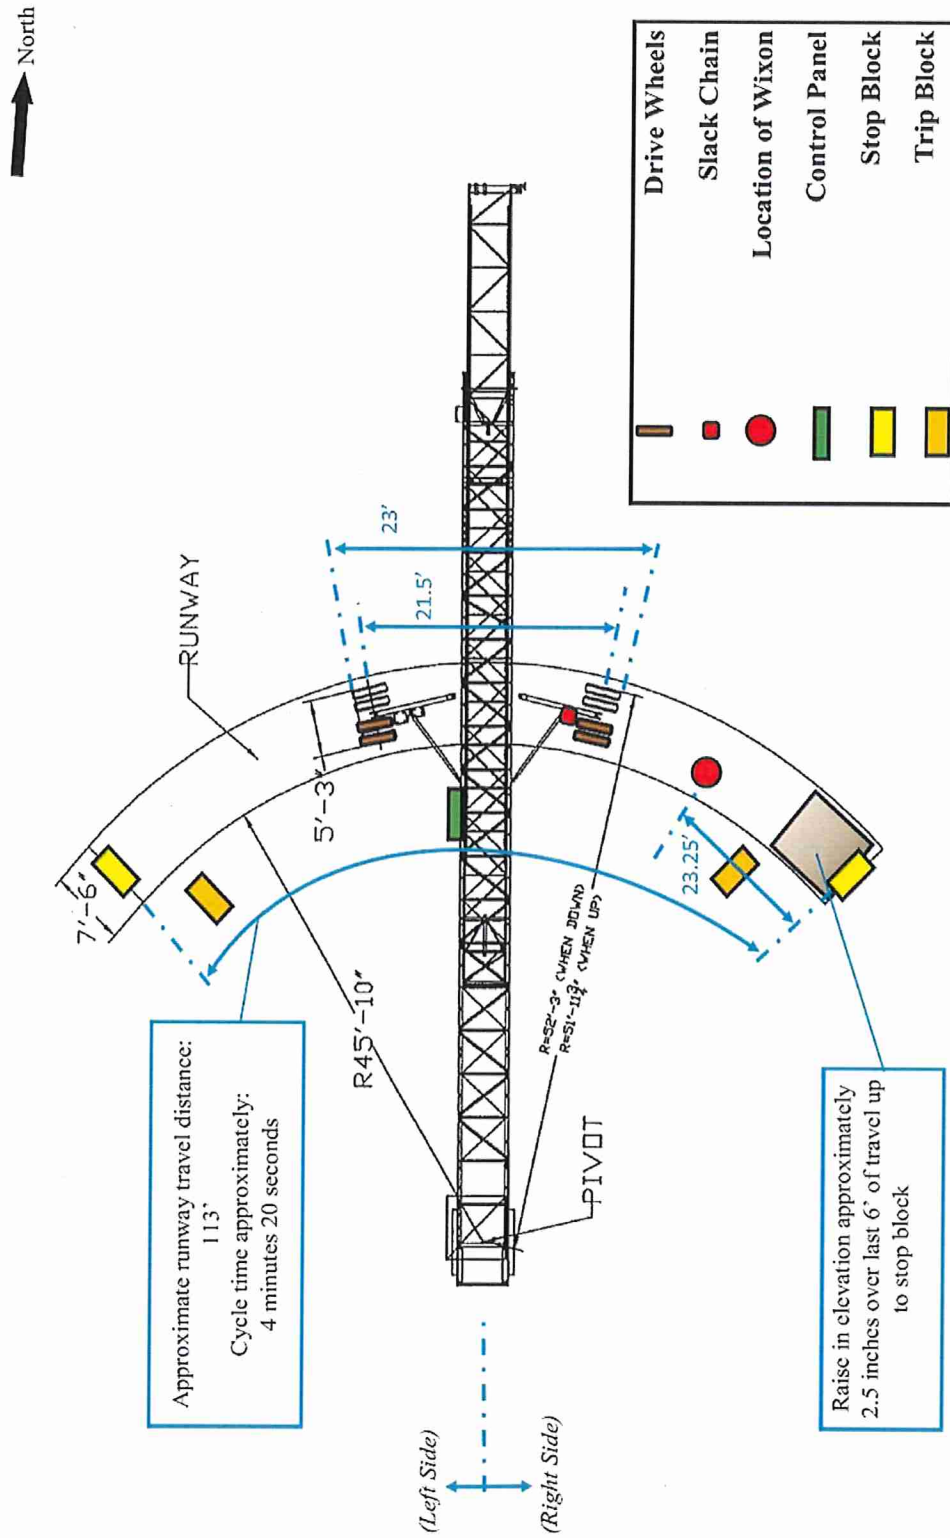
# APPENDIX D – Aerial Diagram Radial Stacker Accident

Wixon was 23¼ feet from the east end of the radial stacker's travel runway, in line with the drive wheels, which corresponds with the left side radial drive restricted access area at the time of the accident (see Appendix D). Investigators determined the mine operator did not conspicuously mark this restricted area, which contributed to the accident.

Corrective Action: The mine operator has installed signage stating that left and right side drive tire areas adjacent to the respective drive tires prohibiting miners from accessing the stacker while in automated operation.

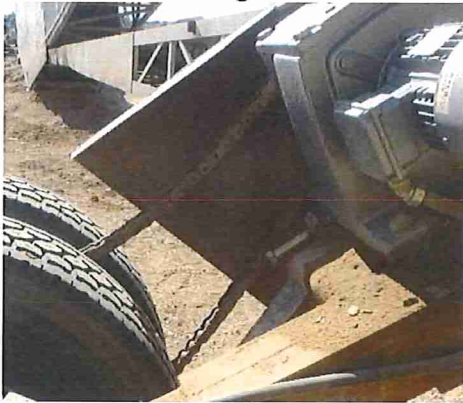
## APPENDIX E – Examples of Excessive Right Side Drive Chain Slack

While Granum and Donald Bingham, Mechanic, demonstrated the automated functionality, investigators observed the right-side drive motor chain had excess slack. When movement produced tension on the top portion of the chain, the chain did not fall from the small upper

Drive chain resting without tension.

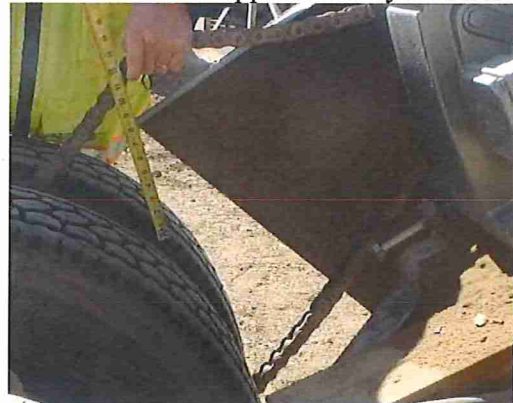
drive sprocket. This tendency to maintain contact with the small sprocket teeth allowed the chain to nearly wrap upon itself. When movement produced tension on the bottom portion of the chain, the upper portion produced a slapping action. This slack in the chain caused erratic motion of the right-side drive wheels (see Appendix E). Once the radial stacker was at rest, the deflection in the top portion of the chain measured approximately 14 inches. Investigators determined the mine operator did not maintain the right-side drive chain and keep the runway level at the time of the accident, both of which contributed to the accident.

Drive chain slack approximately 14 inches.

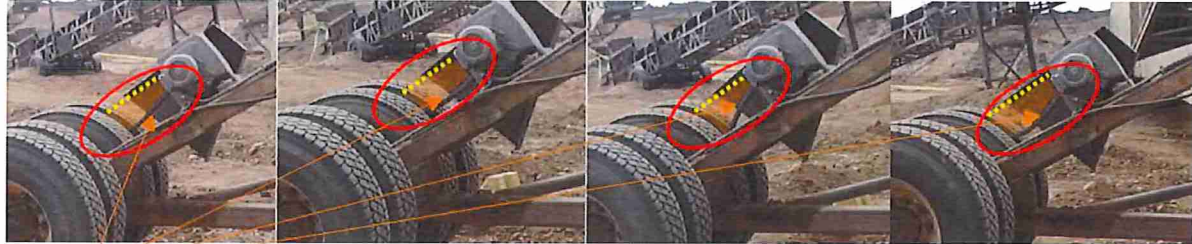
Right hand Drive Chain reaction when bottom in tension.

Loose portion  
of chain

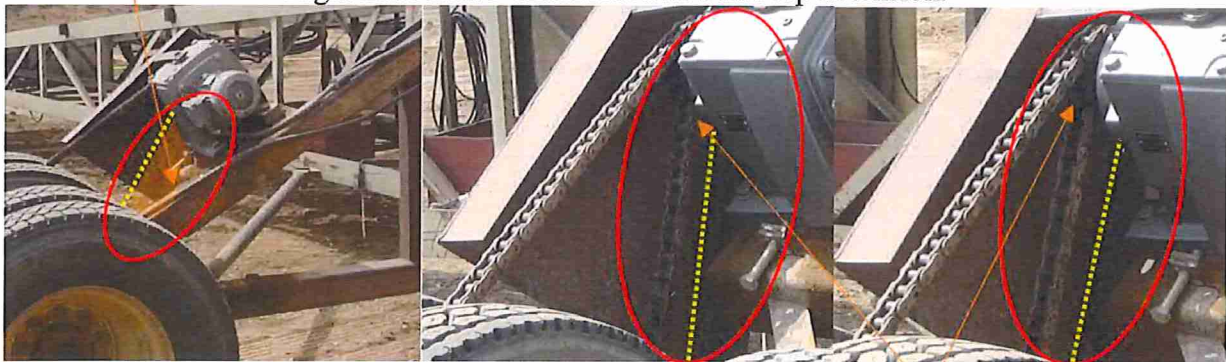
Right hand Drive Chain reaction when top in tension.

Loose portion of  
chain riding up cogs.

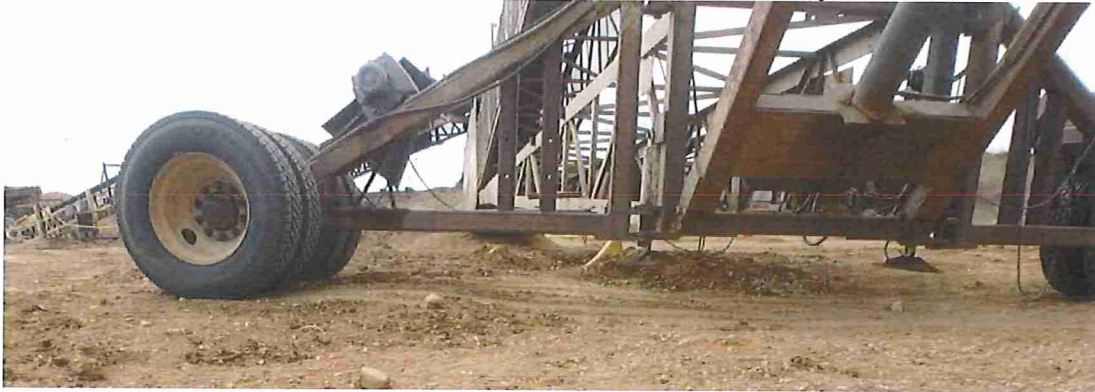
## APPENDIX F – Uneven Ground at East End of Radial Stacker Runway Travel

The operation of the radial stacker demonstrated inconsistency between the wheel speeds along the runway which caused the wheels to dig into the ground. According to interviews, when the radial stacker no longer advanced, normal practice was to bump the radial stacker with the bucket of the skid steer loader and fill in the displaced material immediately with the skid steer's bucket. When investigators attempted to stop the radial stacker near the inclined area at the east end of the runway, the radial stacker stopped unreliably and rolled approximately six to 12 inches in an inconsistent direction correlating to which portion of the right-side drive chain had slack. At the east end of the runway, the final six feet inclines approximately 2½ inches. The operations manual states, "IMPORTANT – The "runway" for the radial wheels must be level."

Radial stacker at east end of travel in runway.

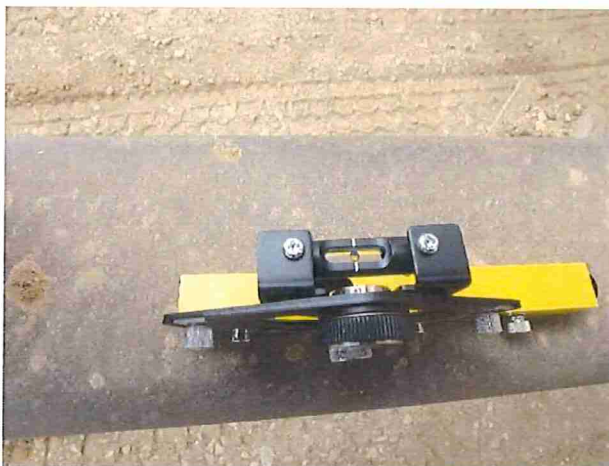
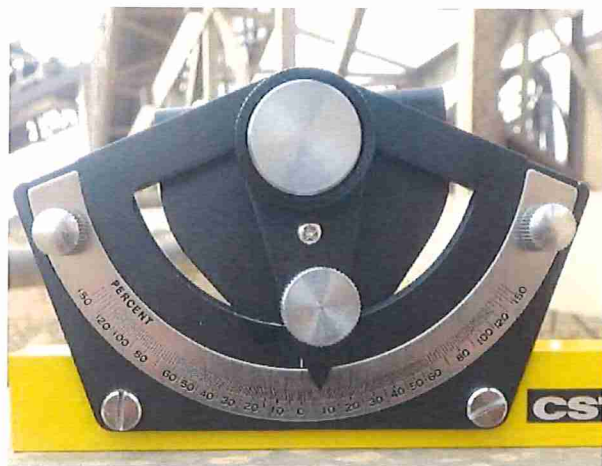
Horizontal frame of carriage at approximately 7.5% grade
