REPORT OF INVESTIGATION

Surface Nonmetal Mine
(Cement)

Fatal Exploding Vessel Under Pressure Accident
May 14, 2010

Knoxville Cement Plant Cemex Inc.
Cemex Construction Materials Atlantic, LLC
Knoxville, Knox County, Tennessee
Mine I.D. No. 40-00840

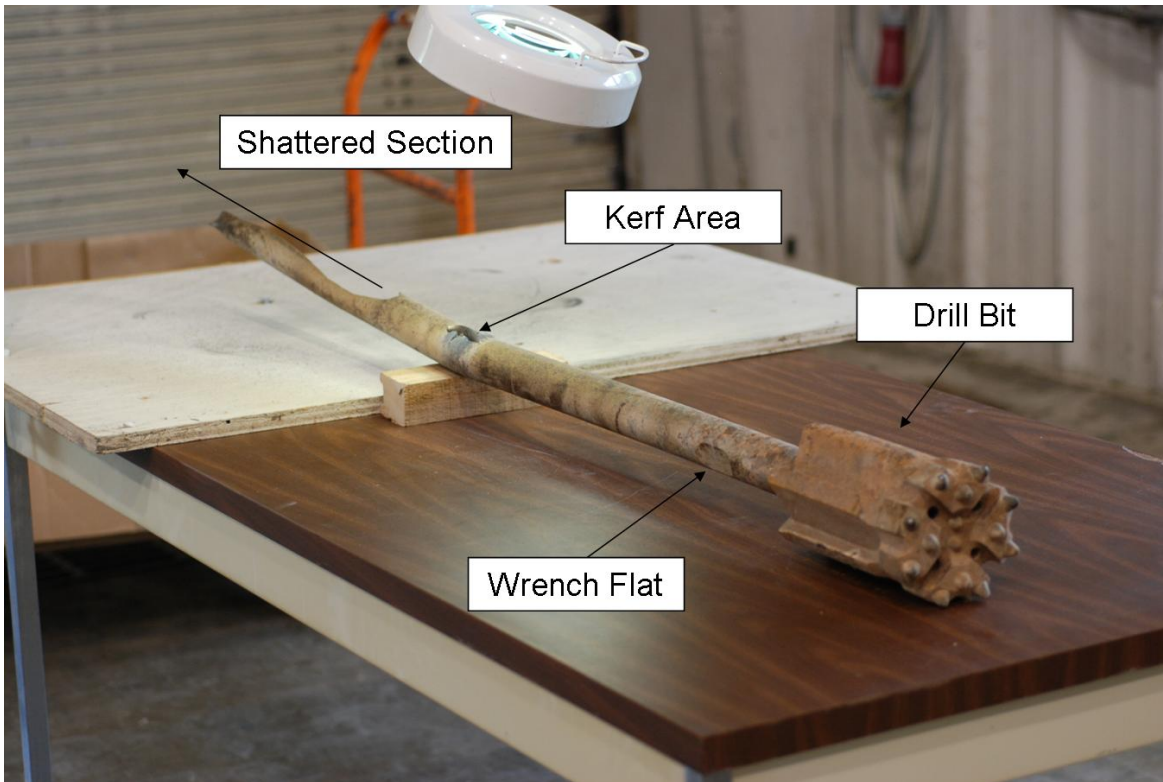
The drill steel shattered primarily toward the end opposite the drill bit. The area being cut by the victim (kerf area) was approximately 2 feet from the drill bit and was between the drill bit and the shattered section of the drill steel (see Photo No. 1). Investigators estimated that approximately 8 feet of the drill steel was shattered during the event. Smaller sections of the drill steel body had also shattered from either side of the kerf area (cut area) as shown in Photo No. 2. The sections missing in this kerf area contained marks that would visibly confirm whether or not the cut actually breached the inner diameter of the drill steel.

Photo No. 1: General Features of Drill Steel Involved in Accident

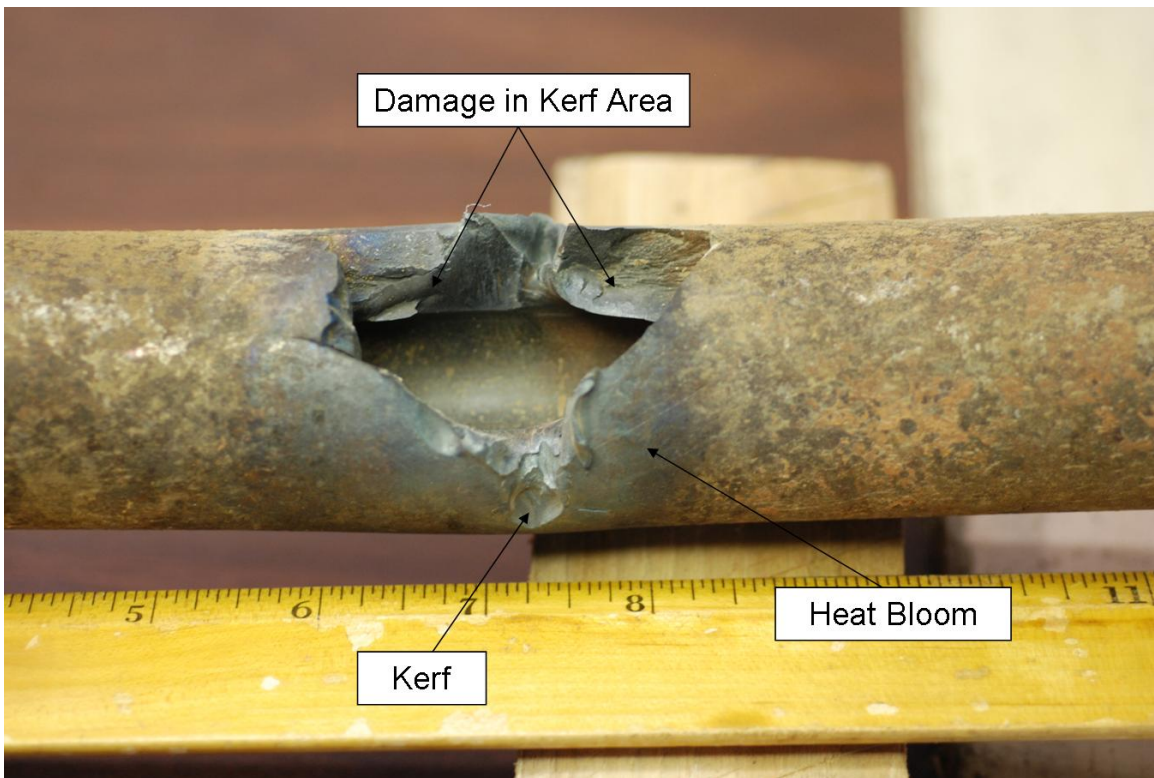
Photo No. 2: Damage to Kerf Area

Based on the relative sizes of the visible heat blooms and the position of the visible kerf, it appears that the victim was cutting the drill steel body in the counterclockwise direction (bottom towards top of Photo No. 2).

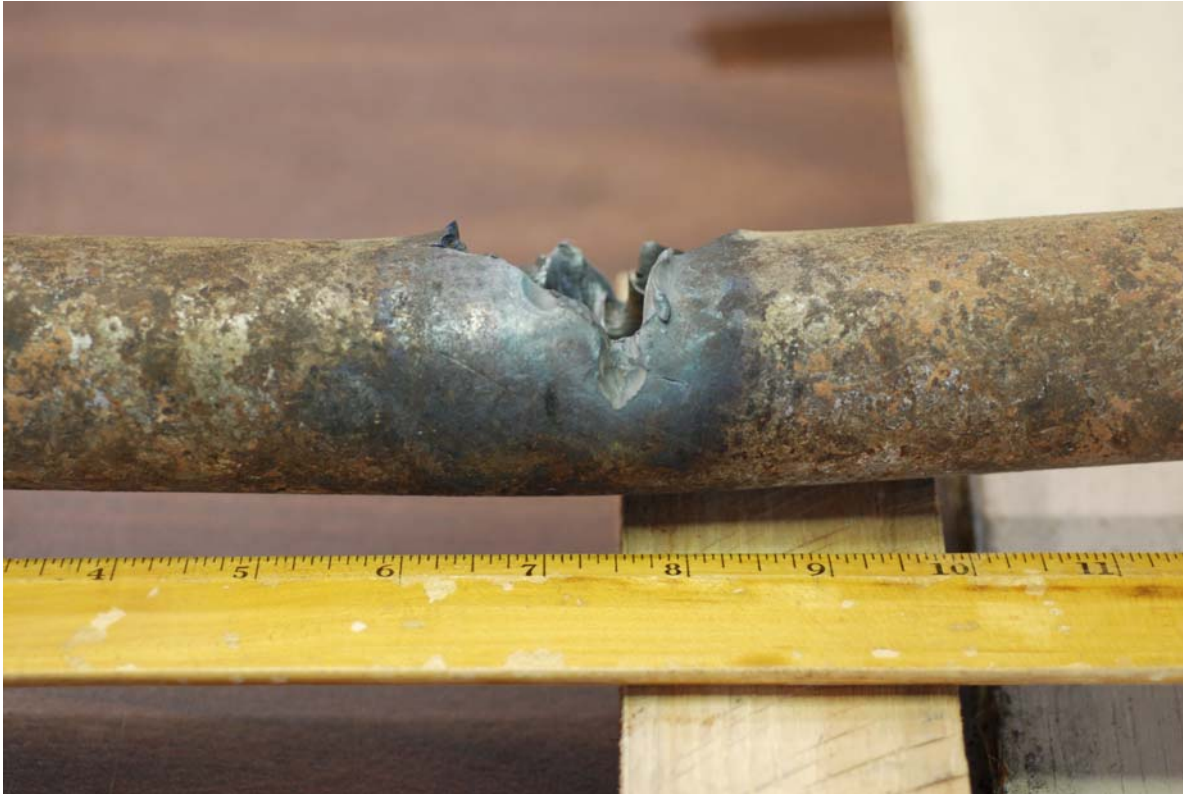
The area of the drill steel being cut by the victim at the time of the accident had a heat bloom (visible surface discoloration due to heat) on either side of the drill steel body. For discussion purposes, references hereafter will refer to the locations when viewing the end of the drill steel from the drill bit end. The heat bloom observed clockwise of the cutting area was visibly larger than the heat bloom in the counterclockwise direction of the cutting area; see Photo No. 3 and Photo No. 4, respectively.

Photo No. 3: View of Heat Bloom Clockwise of Cutting Area

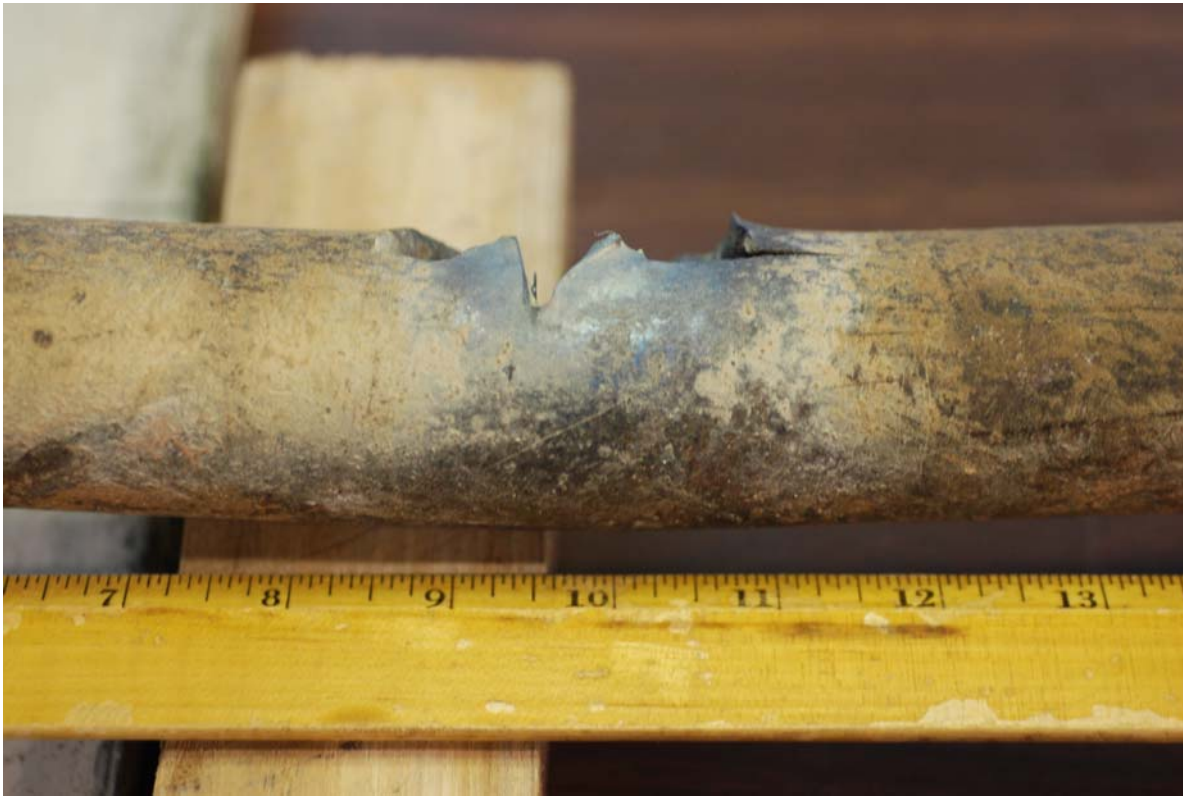
Photo No. 4: View of Heat Bloom Counterclockwise of Cutting Area

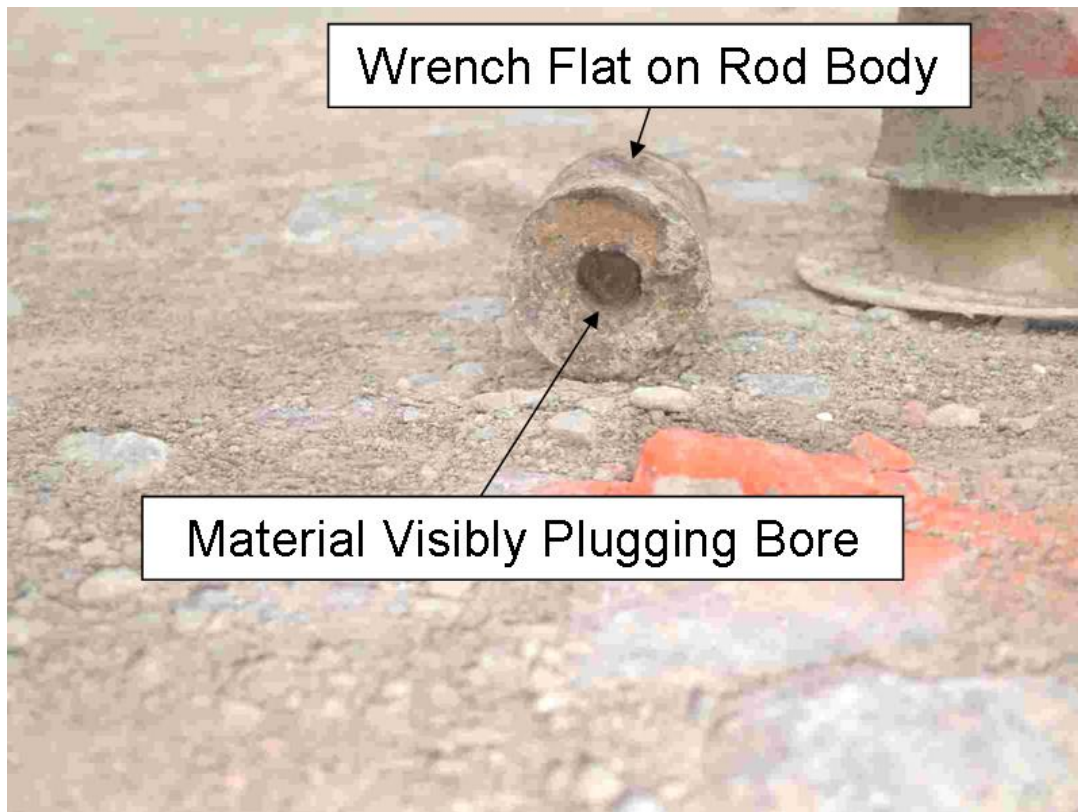
A piece of the ruptured drill steel recovered at the accident scene had material visually plugging the inner diameter of the drill steel (labeled Item No. 18 during the investigation), see Photo No. 5. This plugged section of the drill steel had wrench flats on the rod body which are only present near the threaded ends of the drill steel (See Photo No. 1 for relative locations). This indicated that this plugged section was near the threaded end of the drill steel and on the end opposite to that of the drill bit, i.e. in the end of the section of drill steel that shattered. Additionally, a photo of a section of the ruptured drill steel (labeled Item No. 13 during the investigation) taken by the Knoxville police department shortly after the accident (see Photo No. 6) shows material within the bore area and on the fracture surfaces visibly similar in color to that within the plugged bore of Item No. 18. These observations confirm that conditions existed to provide some level of pressure confinement and to cause reflective pressures axially (along the length of the rod bore) in the end of the drill steel that shattered.

Photo No. 5: Visible Material Plugging Inner Bore of Item No. 18

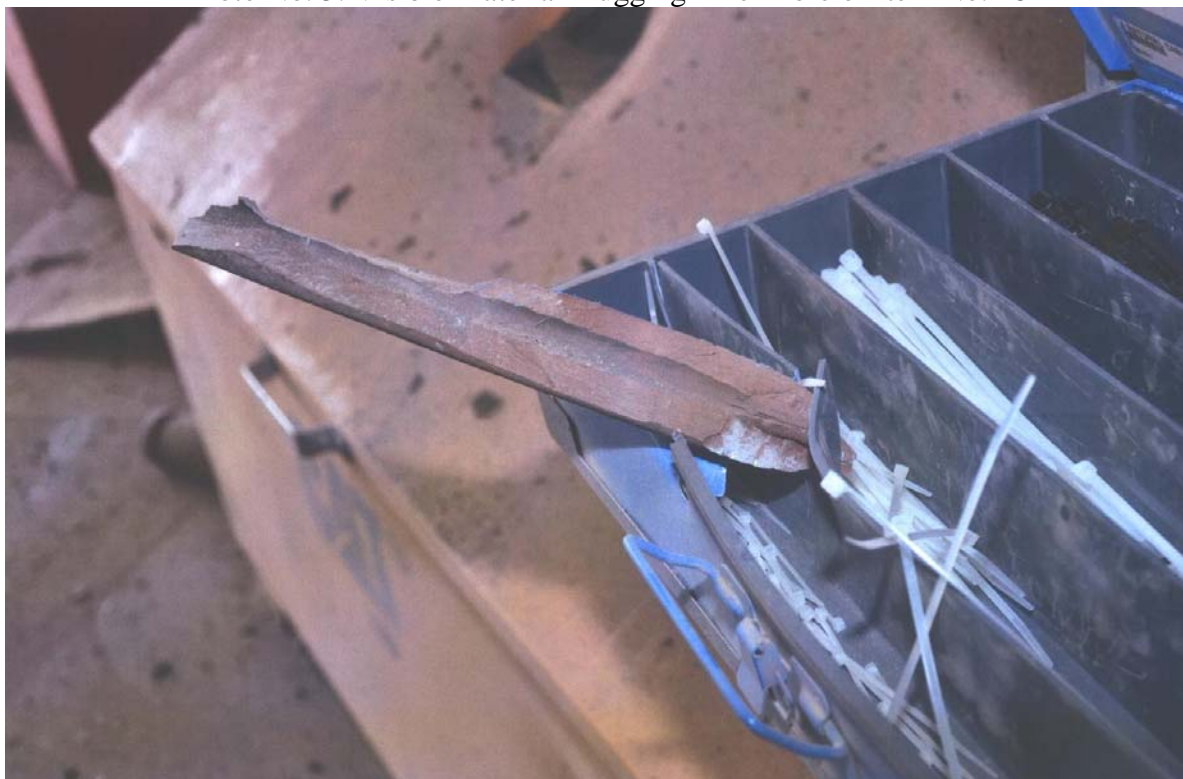
Photo No. 6: Visible Material on Inner Bore and Fractured Surfaces of Item No. 13

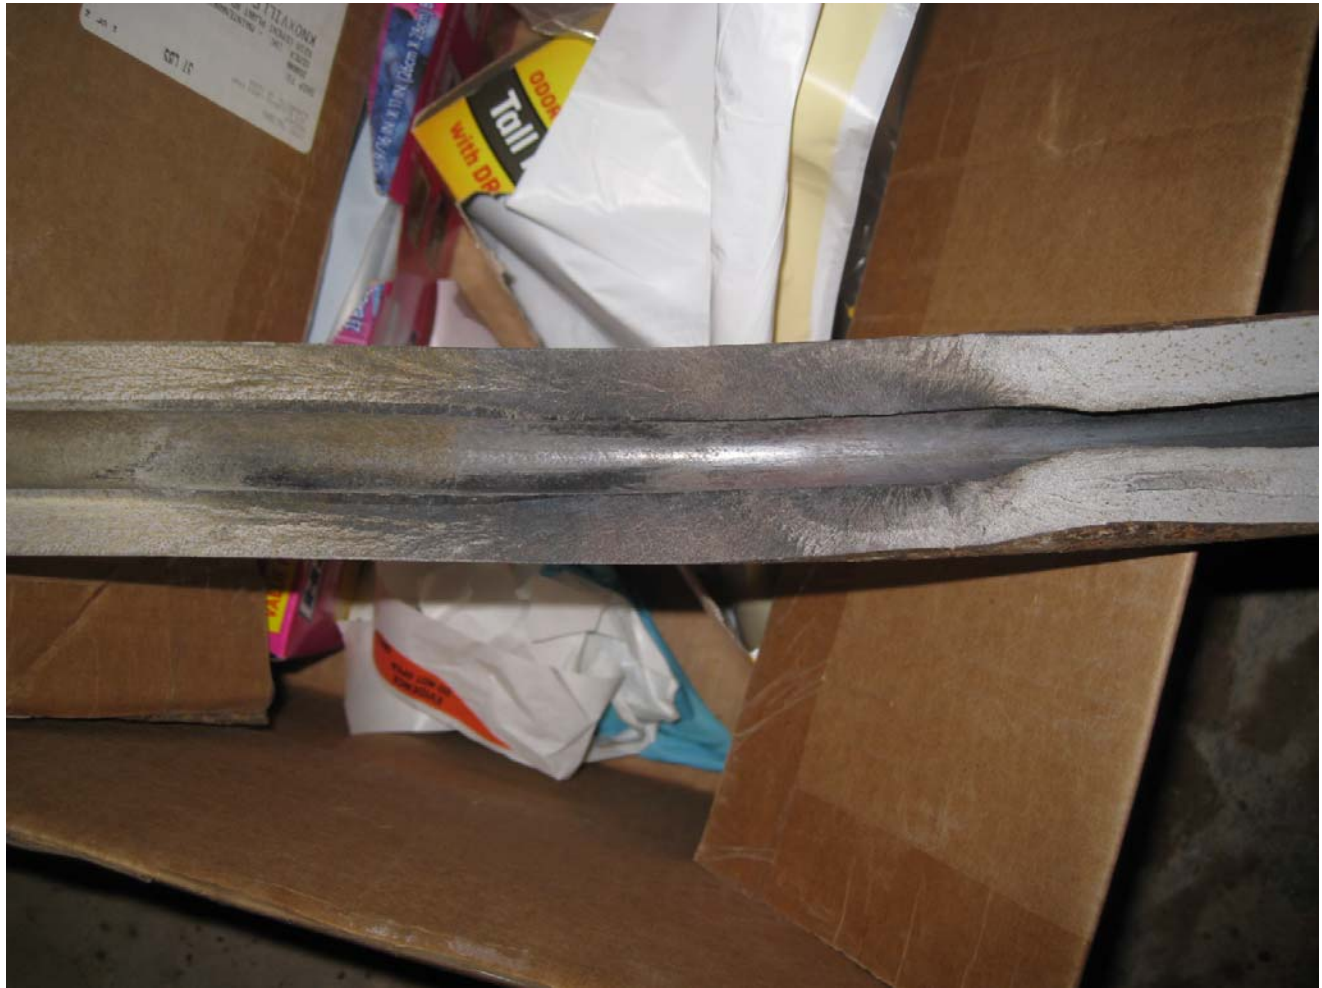
Catastrophic failure of the drill steel did not occur in the immediate area of the cut but small sections around the cut area did fail and break away. The drill steel shattered along a length of approximately 8 feet. The exact location(s) of initiation of the structural failures along the length of the drill steel could not be determined without further metallurgical examination. However, fracture patterns observed on recovered shards of the drill steel appeared to indicate that failure of the drill steel initiated in more than one area. The soot like material observed on the shard in Photo No. 7 (labeled Item No. 20 during the investigation) highlights the fracture patterns in this area, with these fractures pointing back to the general origin of the soot like material within the bore of the drill steel. Similarly, the earth colored material observed on the shard in Photo No. 6 highlights the fracture patterns on another shard, with the fractures also pointing back to the general origin of the earth colored material within the bore of the drill steel. Having multiple areas where failures initiated is consistent with appearances of thick walled cylinders subjected to an explosive internal pressure.

Photo No. 7: Soot Like Material on Item No. 20 and Highlighting of Fracture Pattern
Note: Observations discussed above were based on technical reference documents, photographs, and limited visual examination of the subject components. The components obtained under chain of custody were preserved. No destructive testing or other forensic examinations were conducted.
