**REPORT OF INVESTIGATION**

**Fatal Machinery Accident  
July 10, 2013**

**Ford Construction Company  
Troy Plant  
Troy, Obion County, Tennessee  
Mine I.D. No 40-02271**

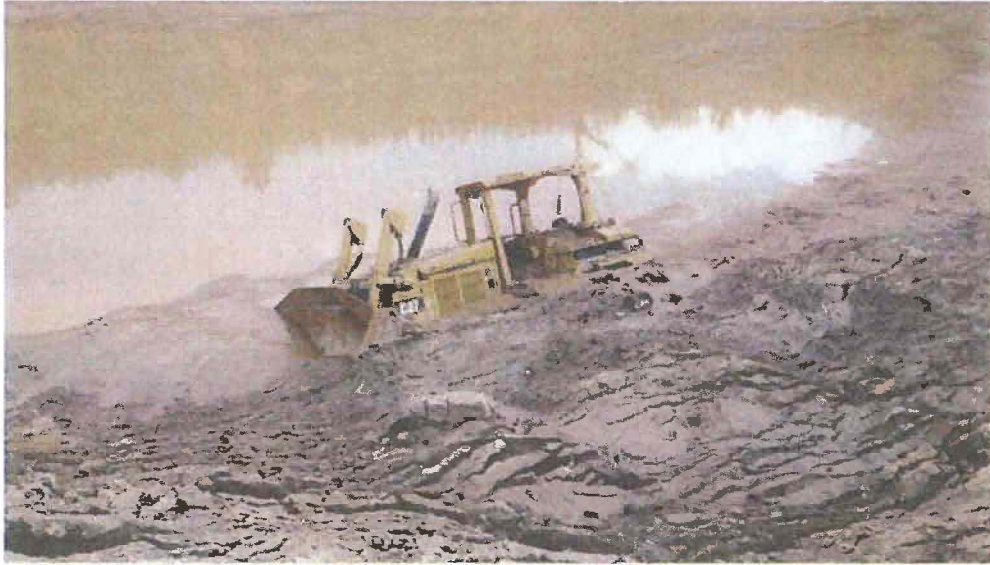
Dozer as it was being uncovered from the pond

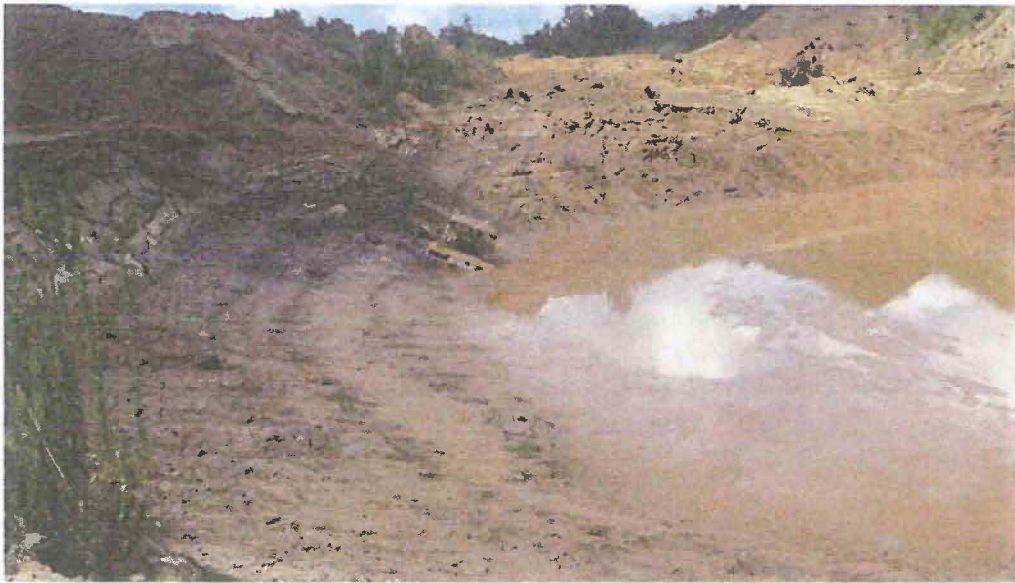
Shows the water that was pumped from the pond to recover the dozer

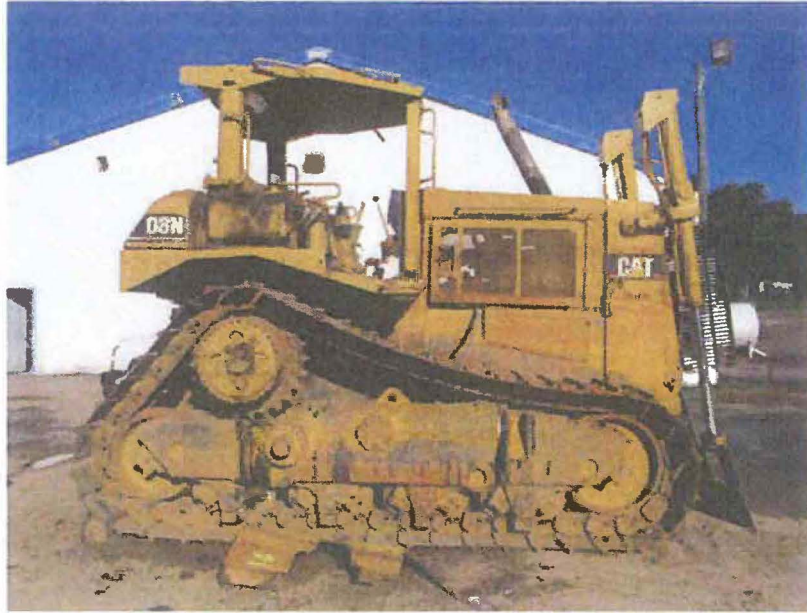
Dozer transferred to the shop for examination
