REPORT OF INVESTIGATION

**Surface Nonmetal Mine
(Crushed and Broken Limestone)**

**Fatal Blasting and Explosives Agents Accident
March 27, 2013**

**Fred Weber, Inc.
North Stone
Maryland Heights, St. Louis County, Missouri
Mine ID No. 23-00220**

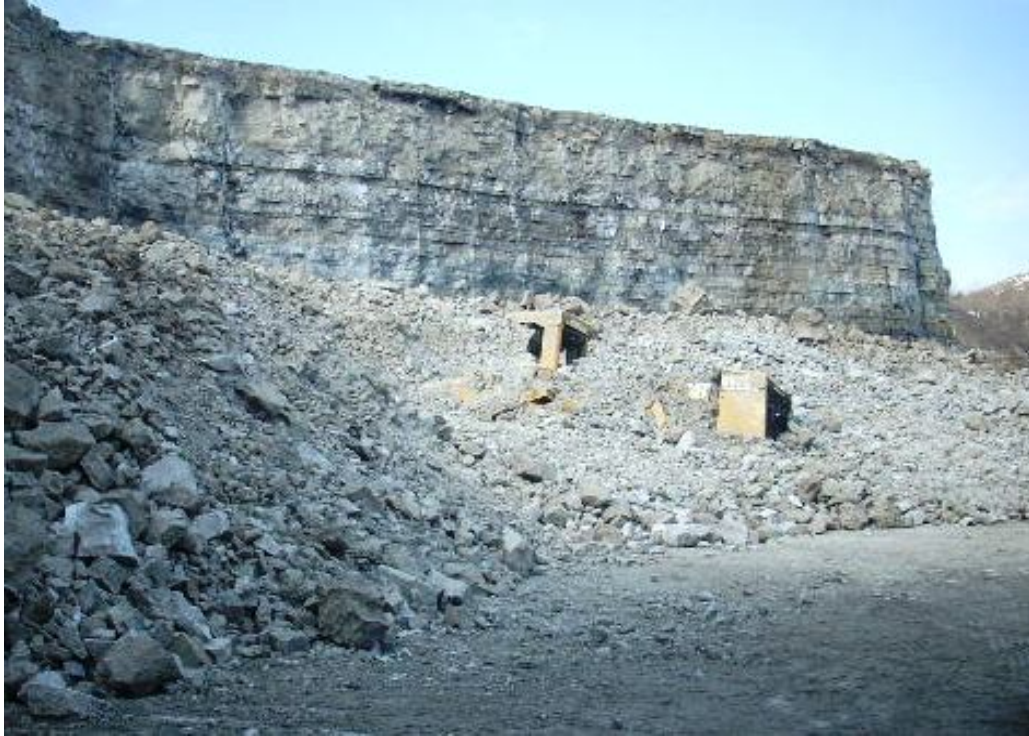
The accident occurred on the 20 ledge, in front of the 10-19 highwall of the mine pit.

The front-end loader involved in the accident was a Caterpillar 992G front-end loader. The machine was approximately 52 feet long and 18 feet, 4 inches high at the top of the canopy and weighed approximately 210,000 pounds. The front-end loader was not inspected for defects after the accident due to the severity of damage incurred from the blast. At the time of the blast, the machine was located on the 20 ledge, facing the highwall, with the front of the loader bucket about 37 feet from the closest blast hole.
