REPORT OF INVESTIGATION

Surface Coal Mine

Fatal Powered Haulage Accident  
January 8, 2008

Blue Ridge Surface Mine  
Cumberland River Coal Company  
Ovenfork, Letcher County, Kentucky  
MSHA ID No.15-18769

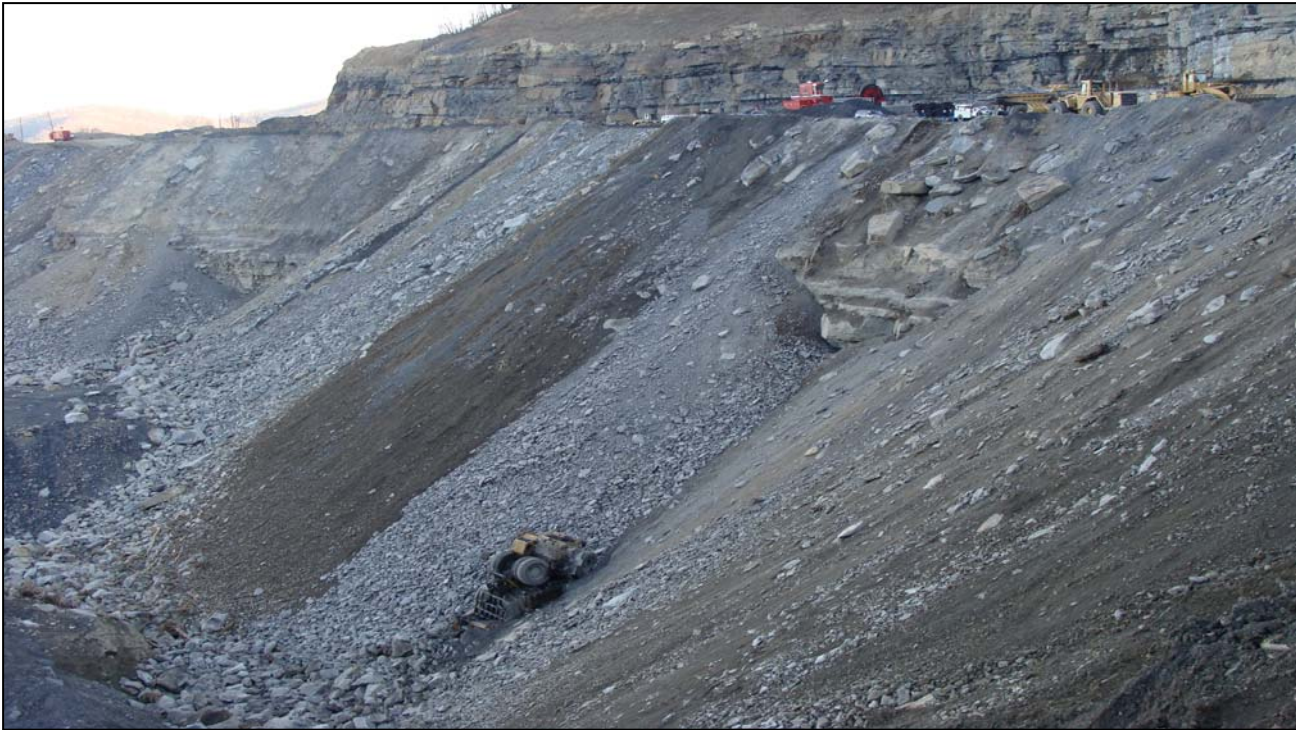
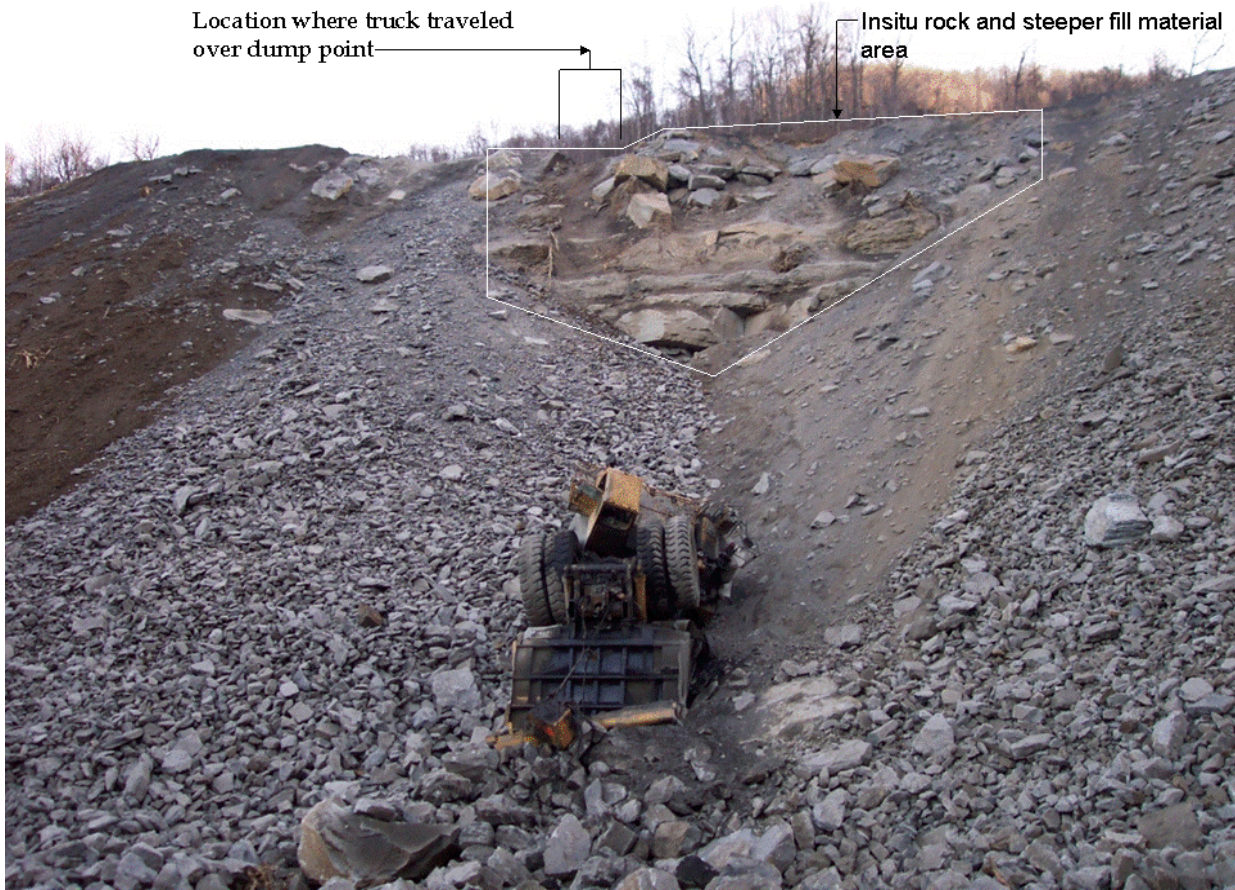
**Accident Scene**

The fatality occurred because the operator failed to provide adequate berms and failed to assure that seat belts were used by equipment operators. The berm was inadequate both in height and in the materials used to construct it. The berm appeared to have been used as a bump stop. When the berm failed, the truck traveled down the slope and the operator was ejected from the truck. When the truck cab was examined the seat belt was not buckled indicating it was not in use at the time of the accident.

The dump point berm was irregular in size and shape. Heights varied from 2 to 7 feet and the base widths varied directly with heights. The berm height should be a minimum of the mid-axle height of the largest piece of equipment using the dump point. The mid-axle height of the off-highway haul trucks present at the time of the accident was 4 feet. Berm material varied in size from silts to cobbles with mostly sandstone and shale comprising the larger particles. Areas in which the berms were built with the finer material showed evidence that haul trucks had been backing (bumping) into the berms.

The distance between the remaining berms was measured at the point where the truck went over the edge. At ground level it was approximately 17 feet across and along the top of the berms it was approximately 22 feet across. The right side rear tire tracks appeared to have traveled over the dump point berm. Larger rock particles were depressed into the softer berm

material in this area. The adjacent berm was approximately 2 feet in height and contained primarily blocky cobbles and gravel. There was no indication of a slope failure in this location.

The driver side rear tire tracks appeared to have traveled into the berm footprint. A small scarp was observed in the material beneath the berm. The berm adjacent to this location was primarily silty sands with a few cobbles and was approximately 4 feet in height. The adjacent berm also appeared to be partially perched on two boulders within the fill material. A perched berm is not fully founded upon the work surface and can provide an operator with an inaccurate indication of the edge of the dump point.

- The berm was constructed in many areas of fine grained materials which did not effectively resist penetration by the backing truck tires
- The berm was inadequate in height and cross section in many areas, including the location where the truck backed over the dump point
- In some areas, boulders protruding out of the out-slope of the fill material allowed the berm to be perched beyond the actual crest of the dump point
- Haul truck tire tracks were observed in adjacent berms indicating some operators were either using the berm as a physical means for determining the edge of the dump point or the drivers were misjudging the stopping distances and impacting the berms.

*Corrective Action:* The ground control plan should address the proper materials to be used when constructing berms as well as the appropriate height based on the maximum mid-axle height of the largest truck utilizing the dump point. An agent of the operator should ensure compliance of the Ground Control plan.

*Corrective Action:* Implement a plan that requires all operators to wear seat belts while operating their equipment and also add a separate check on their pre-operational check list, to insure that all seat belts are operational as required.
