**UNITED STATES  
DEPARTMENT OF LABOR  
MINE SAFETY AND HEALTH ADMINISTRATION**

**REPORT OF INVESTIGATION**

**Fatal Fall of Highwall  
January 12, 2008**

**Sulphur Springs Strip  
Luminant Mining  
Sulphur Springs, Hopkins County, Texas  
MSHA I.D. No. 41-02776**

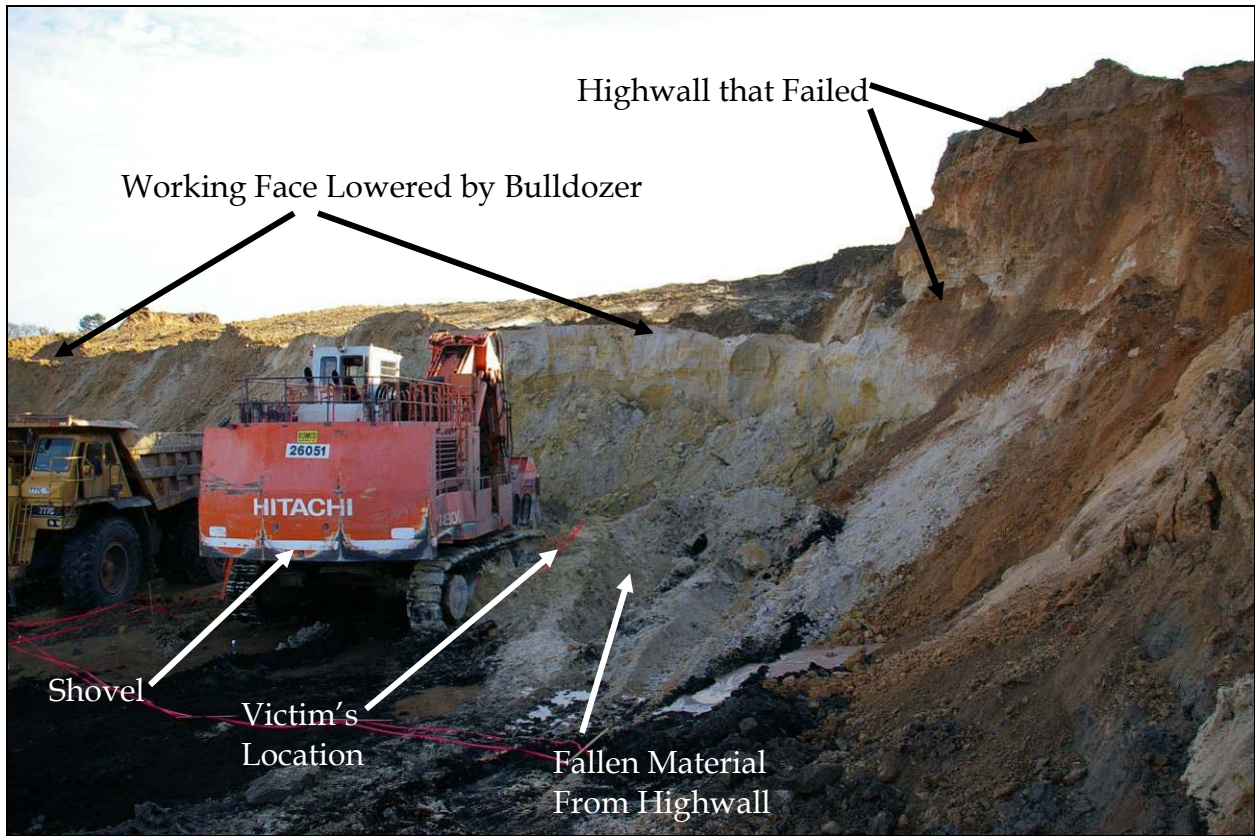
# VIEW OF ACCIDENT SCENE

*Failed Area:* The highwall failure was a shallow circular-type failure that occurred on the western limit of the southern highwall near the mid-point of the shovel length. The failure was delineated by an arc-shaped failure surface that originated approximately 15 feet above the toe of the highwall and extended to the highwall crest. The area delineated by the failure surface was approximately 30 feet high, 18 feet wide, and 7 feet thick. The corresponding volume of failed material was approximately 30 cubic yards. At the time of the investigation, two cracks were observed on the south highwall. One crack ran the full height of the highwall and one was a third the height of the highwall, approximately 10 feet apart.

*Factors Contributing to the Highwall Failure:* The primary factors that contributed to the highwall failure include the steep slope angle of the highwall and the sandy highwall material. Statements from witnesses indicated that the highwall “was nearly straight up and down” or vertical. The steep slope angle of the highwall produced shear stresses in the highwall that exceeded the strength of the sandy highwall material. The combination of these factors resulted in the highwall failure. Other factors that may have contributed to the failure include the relatively shallow depth of the groundwater table in the vicinity of the failure and the high rate of seepage from the lower portion of the highwall. The groundwater may have increased the shear stress in the highwall as well as reduced the strength of the sandy highwall material. The high rate of seepage may have eroded material from the lower portion of the highwall face and removed support for the upper portion of the highwall.

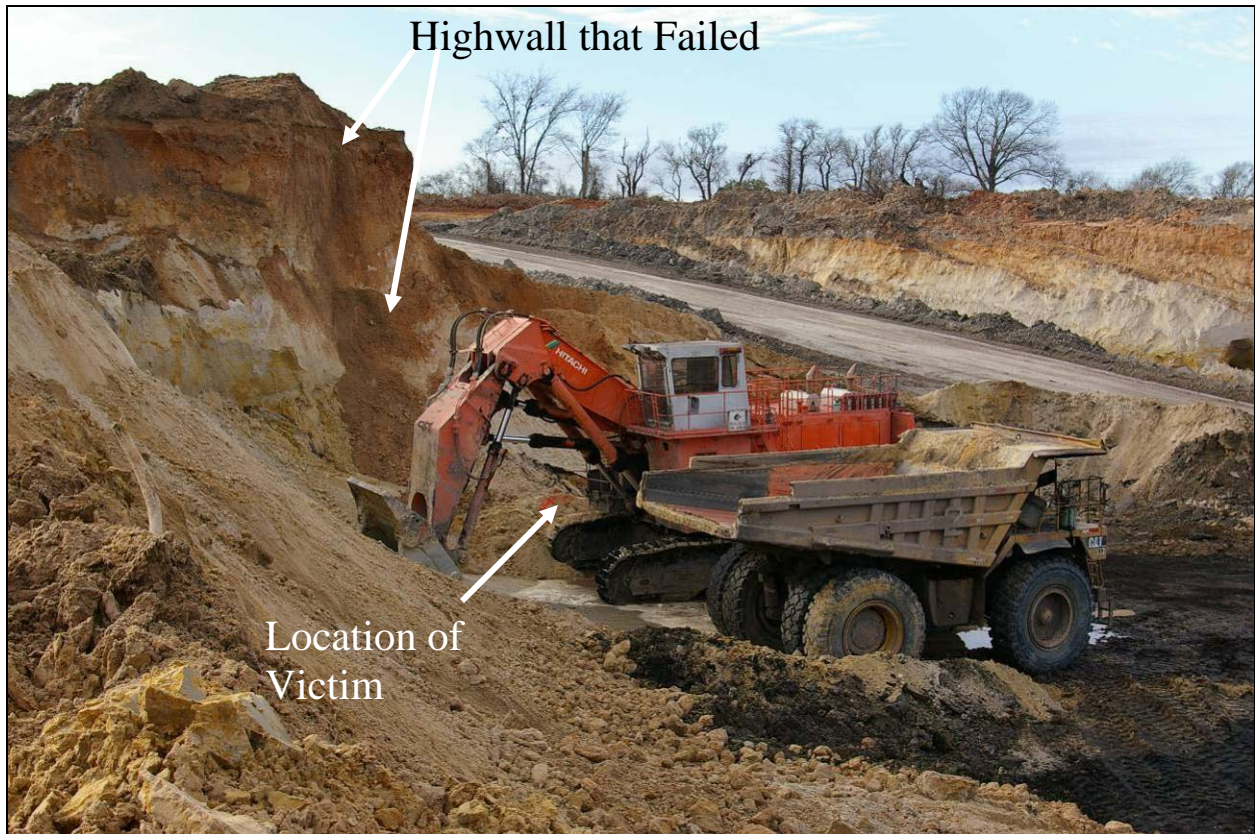
View of Accident Scene from Top of Working Face

*Accident Scene:* At the time of the accident, the shovel was located in the southeast corner of Pit 11. The mid-point of the shovel length was located approximately 100 feet east of the area G haul road (or West Ramp) and approximately 50 feet west of the Pit 11 working face. The shovel was oriented generally parallel to the pit boundary and was facing east in the direction of mining. In that position, the side of the shovel was situated along the toe of a highwall that

When the accident occurred, the southern highwall was approximately 45 feet high and approximately 75 feet wide. The southern highwall had a slope angle of approximately 70 degrees at the time of the accident investigation. The highwall at the working face in front of the shovel (to the east) had a height of approximately 20 feet. The height of the working face had been reduced by a bulldozer that had been pushing material to the shovel. The pushed material was deposited along the working face at an angle of approximately 40 degrees.

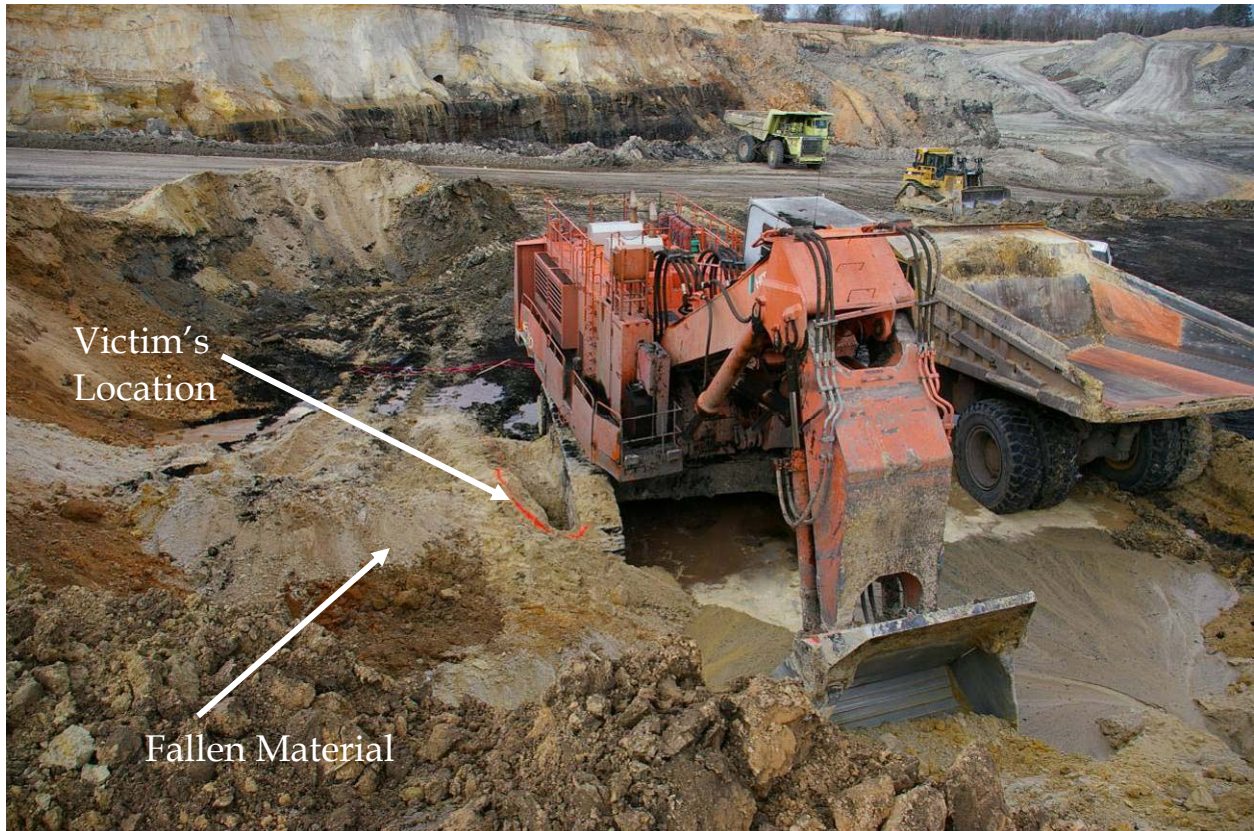
### View of Fallen Material and Victim's Location From Top of the Working Face

The victim was discovered on the floor of the pit where he was pinned in an upright position against the middle of the track side-frame assembly by material that fell from the southern highwall. The failed material extended across the 40-foot-wide section of the pit floor between the shovel track and the highwall. The depth of the failed material at the location of the victim was approximately 4.5 to 6 feet. The width of the failed material at the location of the victim was approximately 25 feet, extending from the rear track tumbler to just beyond the front of the track.

feet deep along the right side of the shovel. The material did not damage the shovel but covered the right side even with the top of the track that was 6 feet high. The victim was buried with the material up to his head midway down the center of the right track.

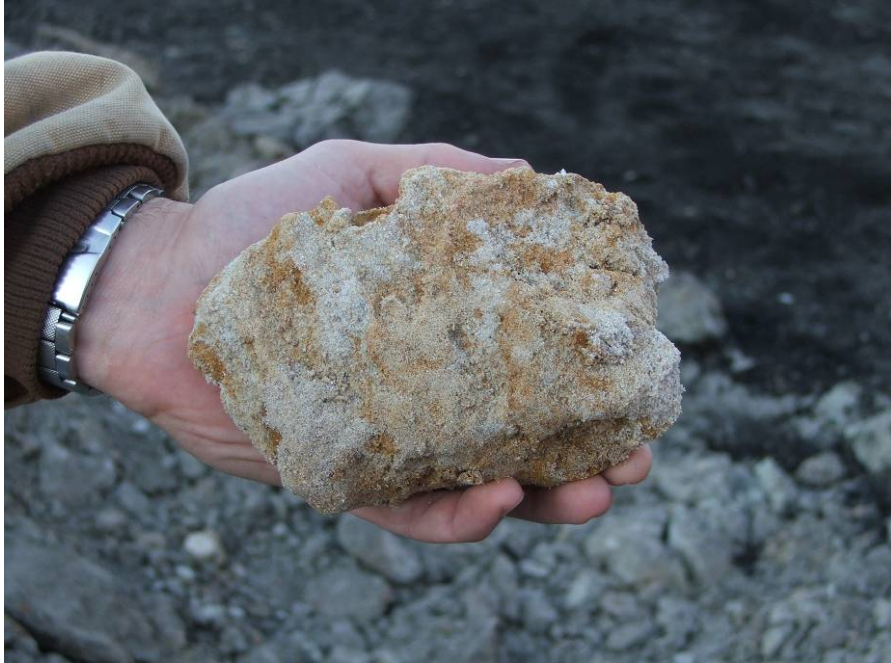
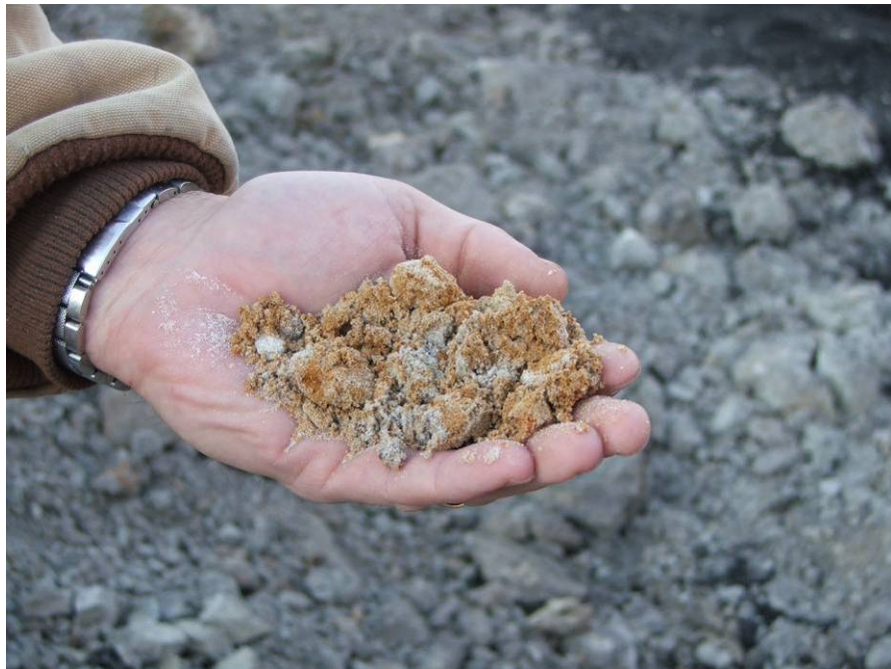
### View of Fine-Grained Silty Sand that Fell From Highwall

*Failed Material:* The majority of the failed material consisted of a fine-grained sand containing silt that varied in color from white to orange. The sand had a relatively uniform gradation and a high moisture content resulting from the relatively shallow depth of the groundwater table. Data obtained from borings previously advanced by the company in the vicinity of the failure (borings THD-1 and THD-2) indicated that the total weight of the failed material was approximately 42 tons. The failed material created a pile approximately 25 feet long, 40 feet wide, and 4.5 to 6
