REPORT OF INVESTIGATION

**Fatal Fall of Highwall
January 12, 2008**

**Sulphur Springs Strip
Luminant Mining
Sulphur Springs, Hopkins County, Texas
MSHA I.D. No. 41-02776**

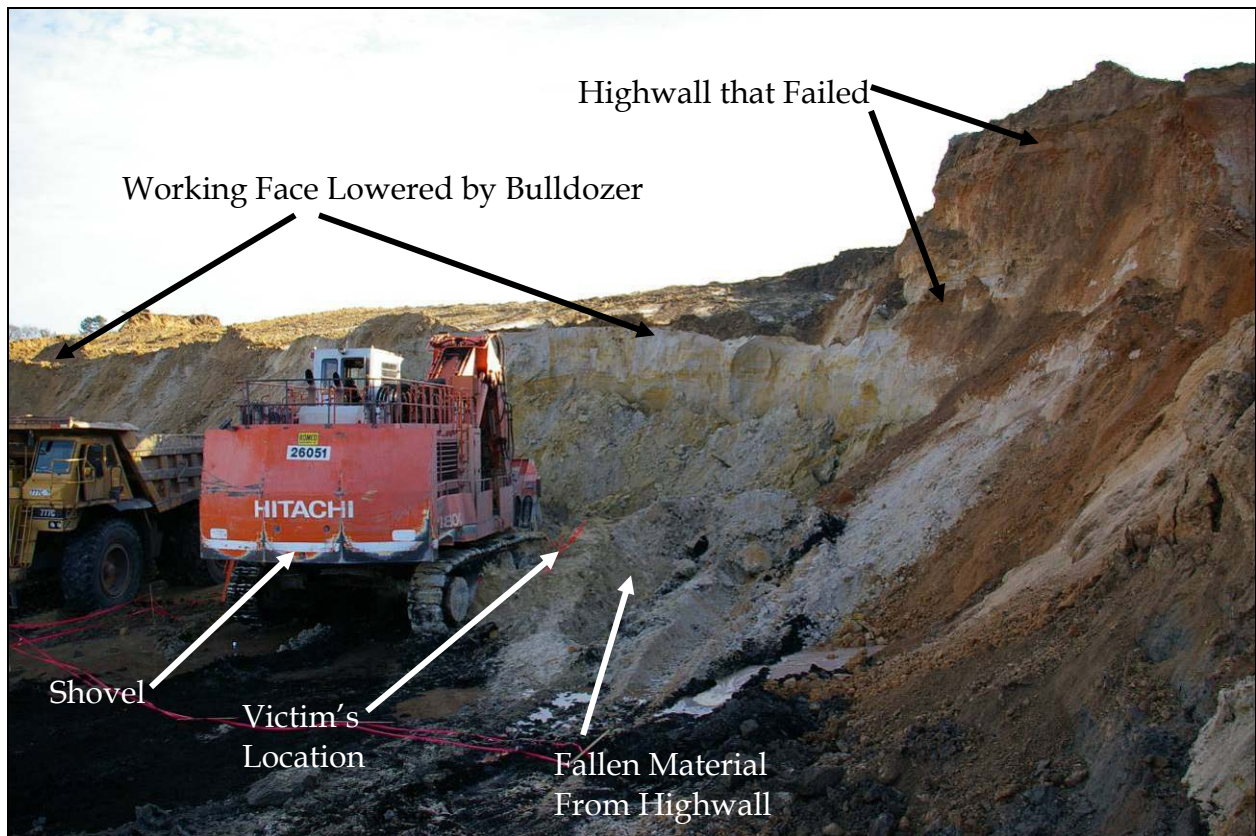
VIEW OF ACCIDENT SCENE

Accident Scene: At the time of the accident, the shovel was located in the southeast corner of Pit 11. The mid-point of the shovel length was located approximately 100 feet east of the area G haul road (or West Ramp) and approximately 50 feet west of the Pit 11 working face. The shovel was oriented generally parallel to the pit boundary and was facing east in the direction of mining. In that position, the side of the shovel was situated along the toe of a highwall that

The victim was discovered on the floor of the pit where he was pinned in an upright position against the middle of the track side-frame assembly by material that fell from the southern highwall. The failed material extended across the 40-foot-wide section of the pit floor between the shovel track and the highwall. The depth of the failed material at the location of the victim was approximately 4.5 to 6 feet. The width of the failed material at the location of the victim was approximately 25 feet, extending from the rear track tumbler to just beyond the front of the track.

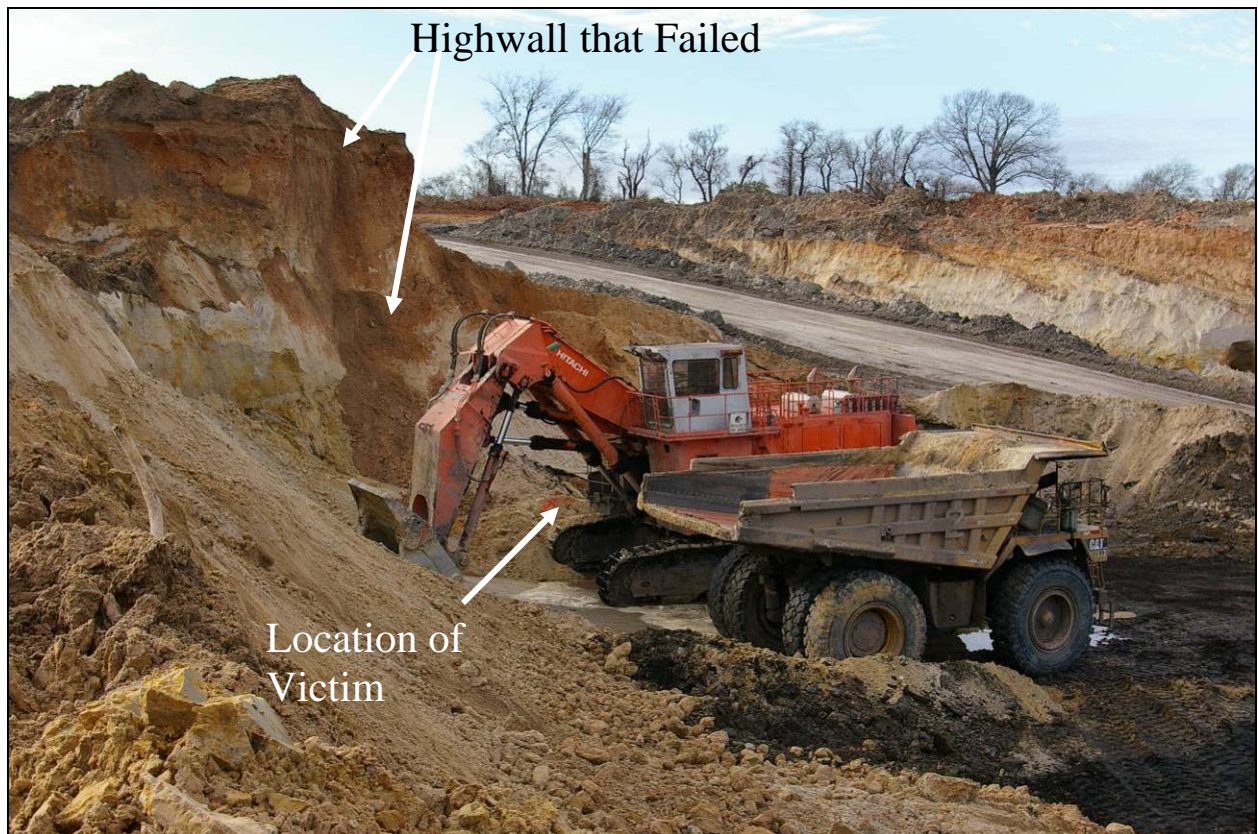
Appendix B

View of Accident Scene from Top of Working Face

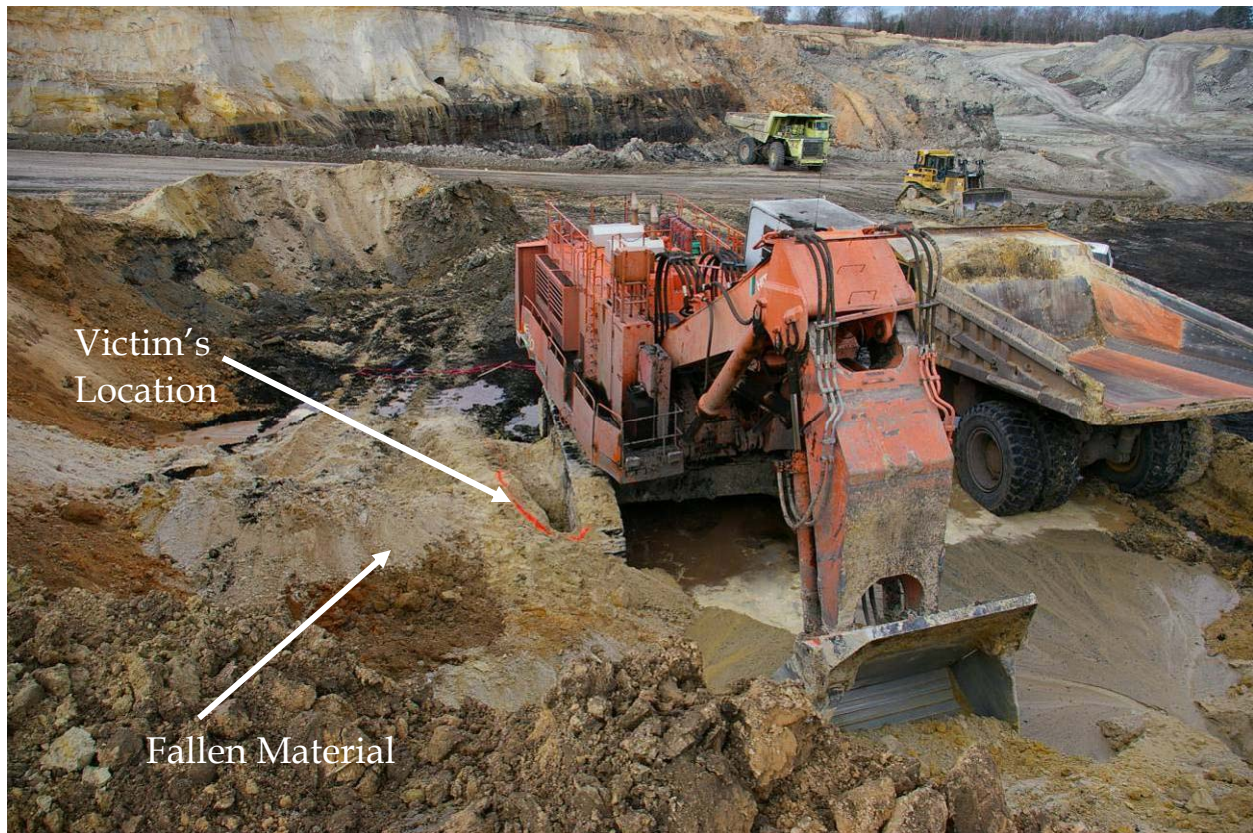
Appendix C

Failed Area: The highwall failure was a shallow circular-type failure that occurred on the western limit of the southern highwall near the mid-point of the shovel length. The failure was delineated by an arc-shaped failure surface that originated approximately 15 feet above the toe of the highwall and extended to the highwall crest. The area delineated by the failure surface was approximately 30 feet high, 18 feet wide, and 7 feet thick. The corresponding volume of failed material was approximately 30 cubic yards. At the time of the investigation, two cracks were observed on the south highwall. One crack ran the full height of the highwall and one was a third the height of the highwall, approximately 10 feet apart.

feet deep along the right side of the shovel. The material did not damage the shovel but covered the right side even with the top of the track that was 6 feet high. The victim was buried with the material up to his head midway down the center of the right track.

View of Fallen Material and Victim's Location From Top of the Working Face

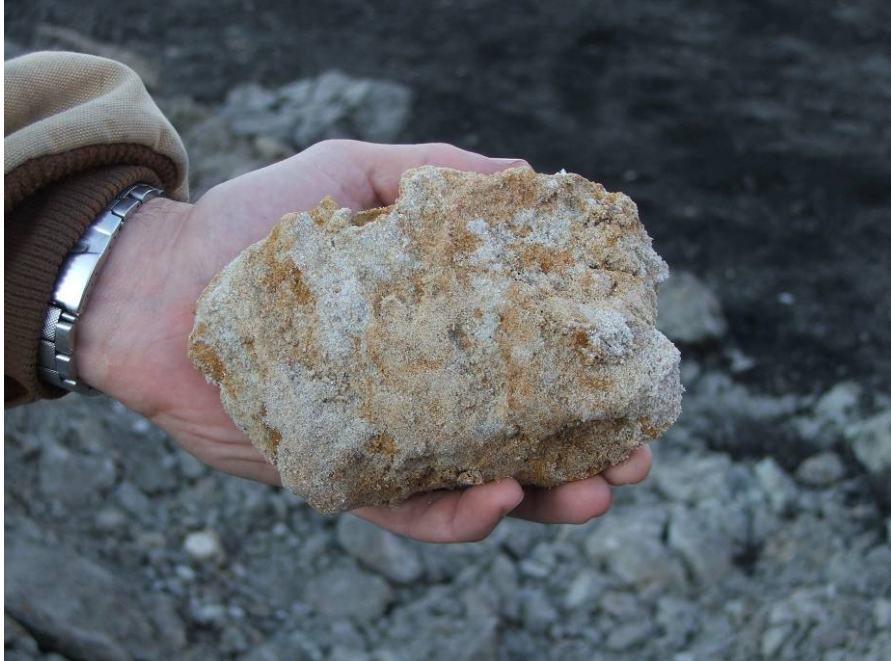
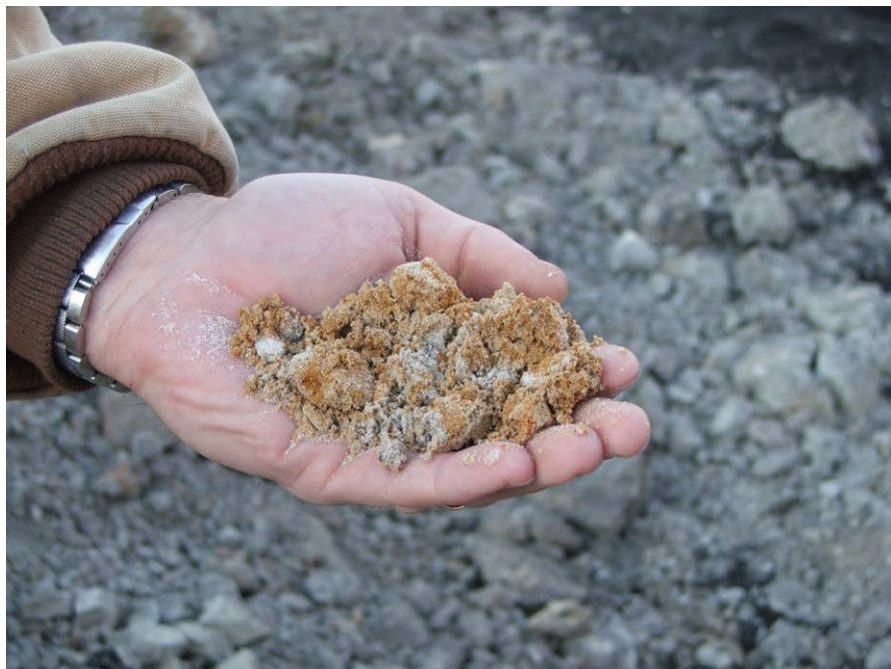
Appendix D

Failed Material: The majority of the failed material consisted of a fine-grained sand containing silt that varied in color from white to orange. The sand had a relatively uniform gradation and a high moisture content resulting from the relatively shallow depth of the groundwater table. Data obtained from borings previously advanced by the company in the vicinity of the failure (borings THD-1 and THD-2) indicated that the total weight of the failed material was approximately 42 tons. The failed material created a pile approximately 25 feet long, 40 feet wide, and 4.5 to 6

Factors Contributing to the Highwall Failure: The primary factors that contributed to the highwall failure include the steep slope angle of the highwall and the sandy highwall material. Statements from witnesses indicated that the highwall “was nearly straight up and down” or vertical. The steep slope angle of the highwall produced shear stresses in the highwall that exceeded the strength of the sandy highwall material. The combination of these factors resulted in the highwall failure. Other factors that may have contributed to the failure include the relatively shallow depth of the groundwater table in the vicinity of the failure and the high rate of seepage from the lower portion of the highwall. The groundwater may have increased the shear stress in the highwall as well as reduced the strength of the sandy highwall material. The high rate of seepage may have eroded material from the lower portion of the highwall face and removed support for the upper portion of the highwall.

View of Fine-Grained Silty Sand that Fell From Highwall
