REPORT OF INVESTIGATION

Surface Coal Mine
Fatal Electrical Accident
February 18, 2008

A-FN Machine Technology, Inc. (Contractor ID R317)
New Kensington, Pennsylvania

Consolidation Coal Company 14-North Impoundment
Consolidation Coal Company
Harmarville, Allegheny County, Pennsylvania
MSHA ID 36-08094

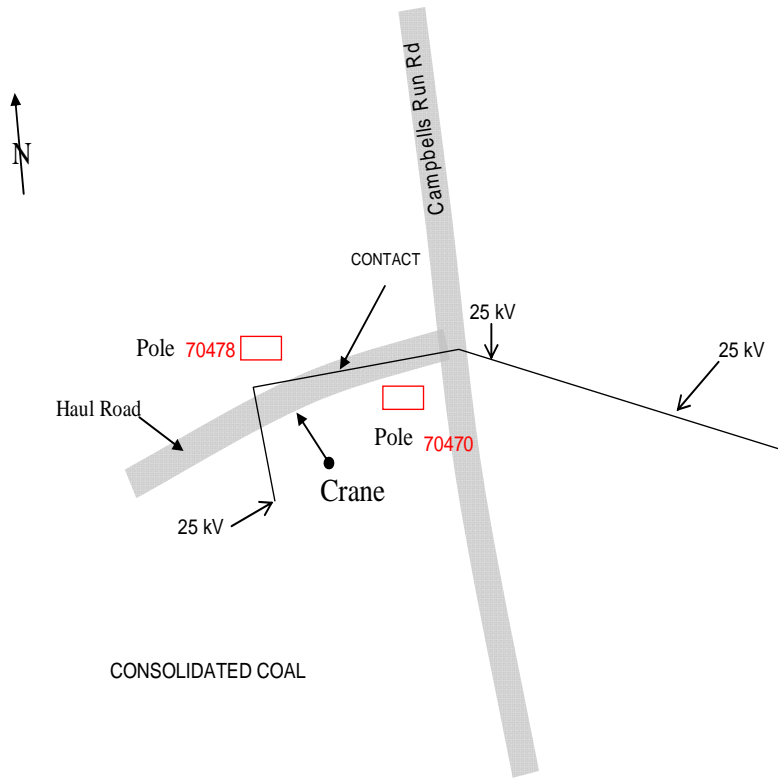
Appendix B illustrates the orientation of the electrical lines. Figure 1 shows a top view of the power lines in reference to the haul road. Figure 2 shows a side view of the communication and power lines and was the typical view for the barrier placement along the haul road except during the accident. The A-phase power line was 35.5 ft. from ground level, when measured, at the point where it was contacted by the boom. Two communication lines were located beneath the power lines in the vicinity of the accident. One communication line was 21.9 ft. from ground level and 13.6 ft. beneath the A-phase power line. The second communication line was 19.3 ft. from ground level and 16.2 ft. beneath the A-phase power line. Figure 3 shows a top view of the communication and power lines when the accident occurred. This was the first time barrier placement was attempted at this position. The lower communication lines are oriented beneath the center (B-phase) 14,400 volt to ground power line. The A-phase 14,400 volt to ground power line energized the crane. The communication lines are not as obvious to see when comparing the accident location (Figure 3 & page ii) versus the prior placement location along the haul road (Figure 2). Therefore, viewing the communication lines from a different position complicated the process. The complexity of using the communication lines as a safe reference point varied based on the location of the crane set-up.

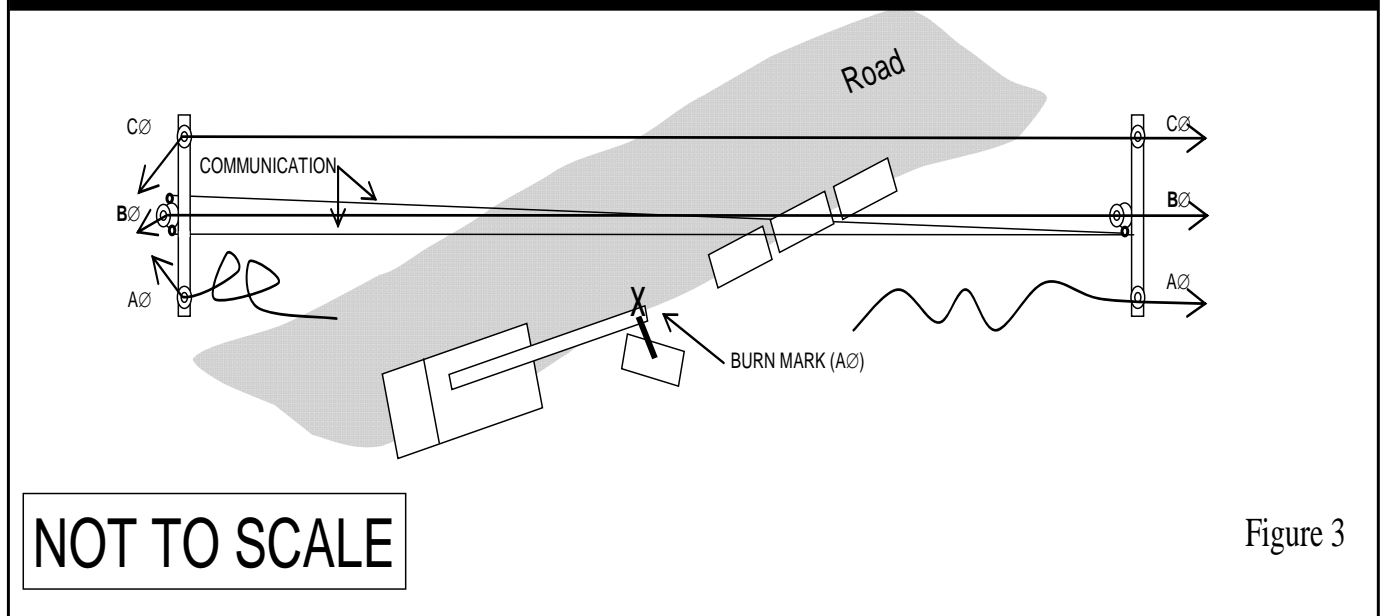
Figure 3

When the accident occurred, the boom was raised above the boom rest at the rear of the bed. The boom was not in a horizontal position and it was not beneath the communication lines. The crane operator had to monitor the victim's hand signals, the load (concrete barrier), and the electrical lines. Also, additional obstacles were encountered during the last set-up position. The additional obstacles encountered included the tree-line on the driver's side and high voltage lines located in front, behind, and on the passenger side of the boom truck. This set-up position added additional monitoring to the task. Broken tree branches and damaged saplings from crane operations were observed during the investigation.

1. *Root Cause:* The practice of using the lower communication power lines as a visual aid to provide clearance from the higher power lines gave a false sense of security when the boom truck crane was re-positioned to install the last two concrete barriers. This procedure contributed to the crane operating within ten feet of the energized overhead power line.

Corrective Action: When using visual aids, procedures such as viewing from all directions may necessitate high visibility markers along with a spotter with direct communications with the crane operator.
