REPORT OF INVESTIGATION

Fatal Powered Haulage Accident
February 25, 2008

CME Engineering LP (L814)
Latrobe, Pennsylvania

Nolo Mine
AMFIRE Mining Company LLC
Nolo, Indiana County, Pennsylvania
MSHA ID 36-08850

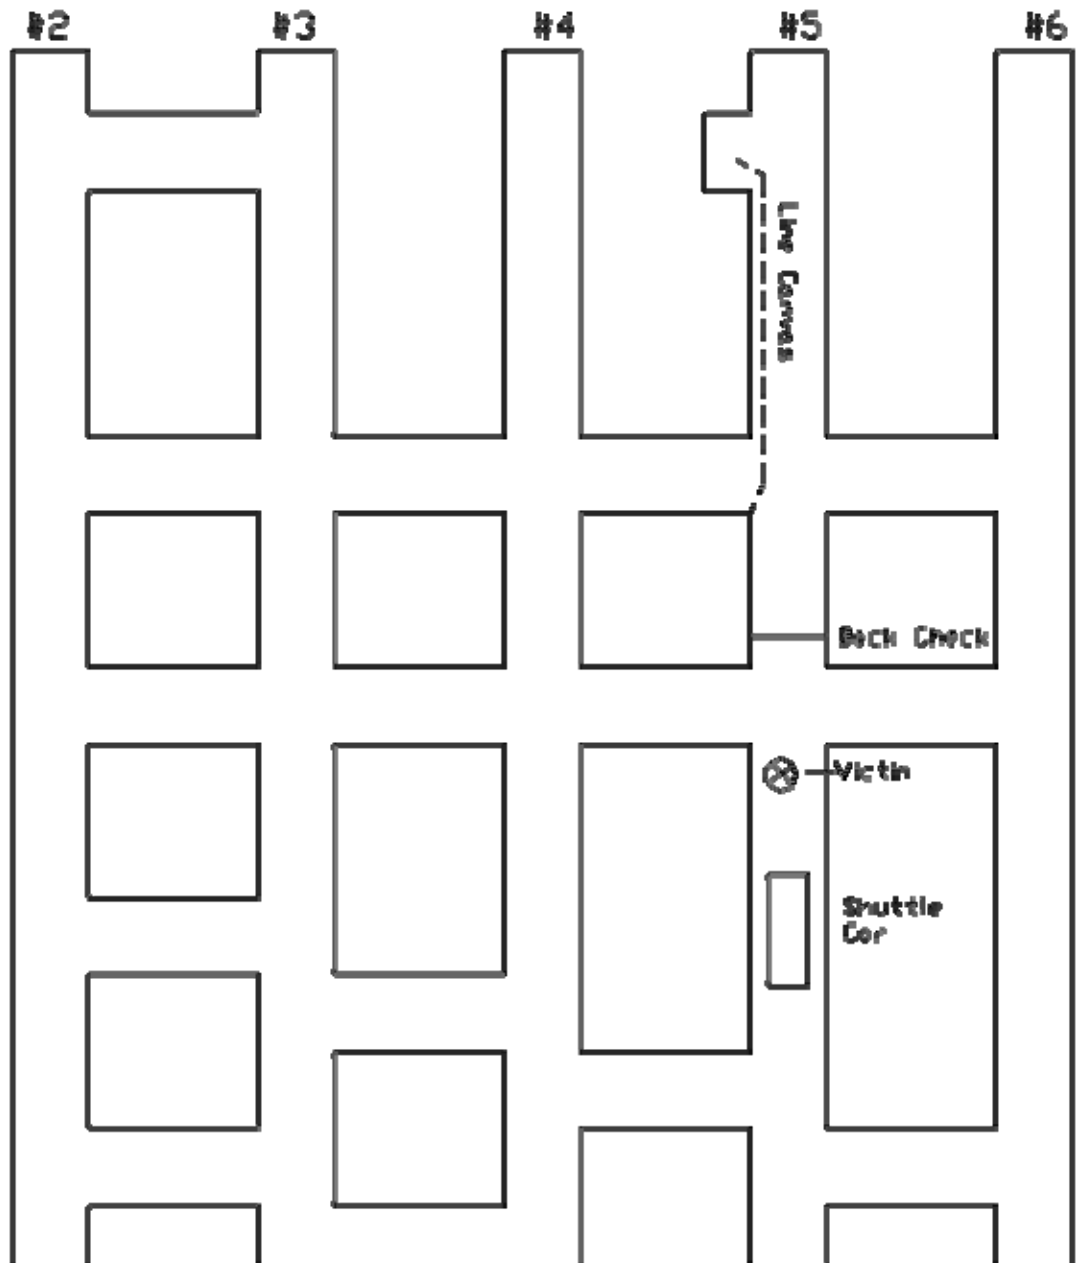
**ACCIDENT SITE
NOLO MINE
2 RIGHT
SOUTH MAINS**

The accident occurred at survey station No. 7085 in the No. 5 entry of 2 Right South Mains. A run-through check curtain was installed 30 inches in by survey station No. 7085. The check curtain was a heavy weight translucent plastic curtain, attached at the top to the mine roof by wire ties. The check curtain was used as a ventilation control to maintain the desired amount of ventilating air at the working faces. The check curtain was attached at the top only, so equipment can pass through without pulling the curtain down.

The mining height at survey station No. 7085 measured 57 inches and the width of the entry was 18 feet 2 inches. The area was dry with the exception of a pool of standing water 15 feet out by survey station No. 7085 measuring up to 3 inches in depth approximately 10 to 12 feet in diameter. Roof bolts were utilized for roof support and no obstructions were present in this area.
